**Bridgemaster Axle Bolt Torque  
Inspection****Date:** February 22, 2022**Bulletin Name:** MXR-TSB-029**Model:** Bridgemaster V model 93**Model Year:** 2020-2021**Units Affected:** Units with standard bolts  
(not Huck Bolts)**Purpose:**

Inspection and possible rework required on certain bolts on the Bridgemaster® V axle regarding torquing specifications.

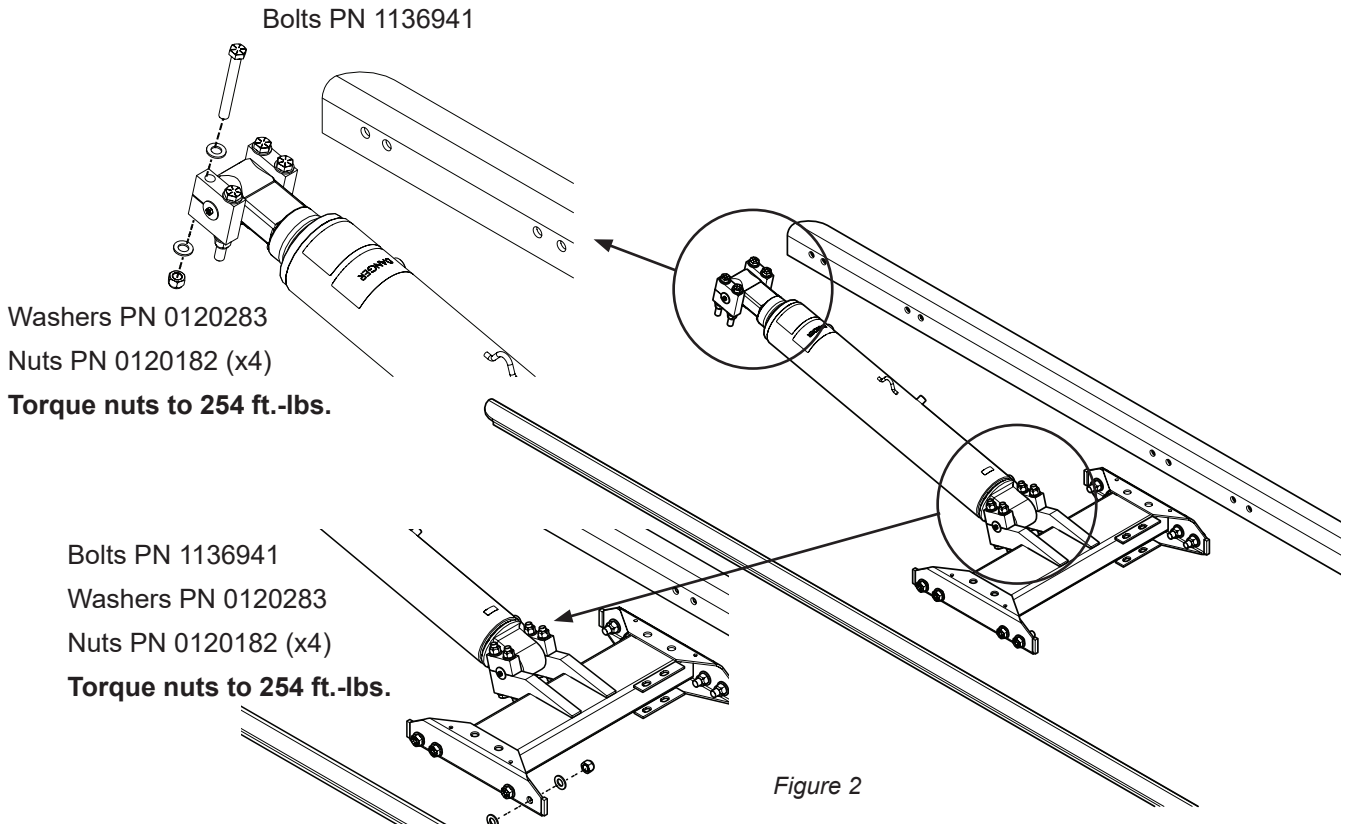
**NOTE:** Make sure to check the torque of each set of hardware called out (four sets on each end of the cylinder).

4. Use the torque wrench to check the torque of **each hardware** as called out in Figure 2 and Figure 3.
  - If the torque specification is accurate for **each** hardware, then the inspection is complete and the truck can be returned to service.
  - If **any** hardware was not torqued to the specification, then that hardware must be replaced.

- Use the torque wrench to torque to the proper specifications (as shown in Figures 2 and 3). Make sure to torque the hardware from the nut side.

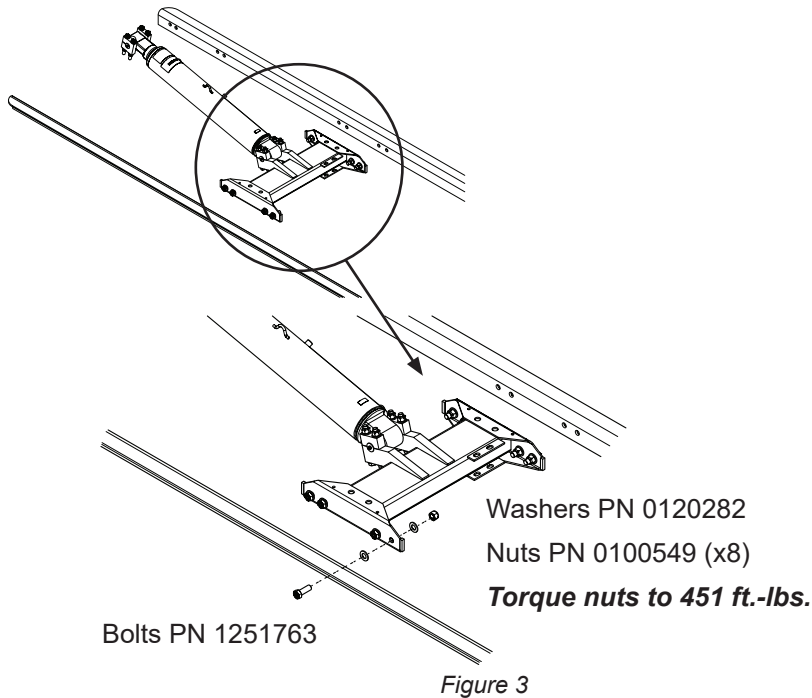
**NOTE:** If the Bridgemaster truck has Huck fasteners, then there is no need to inspect these for the cross member.

**NOTE:** Make sure to check the torque of each set of hardware called out in Figure 3 (eight sets total).
