**NUMBER:** 05-75-20

SERVICE BULLETIN

APPLICABILITY: 2017-19MY Impreza

**SUBJECT:** Front Coil Spring- Design Change to Address

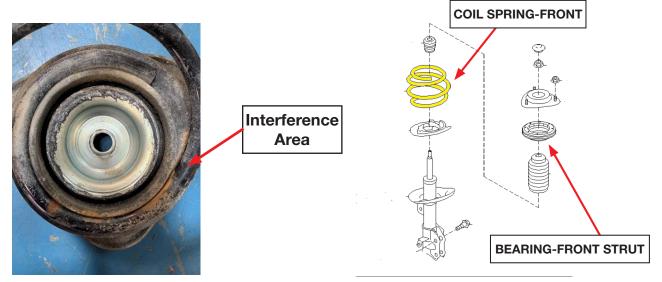
This bulletin announces a design change of the front coil spring to address a cracking-type sound coming from the suspension when turning left or right. The sound is a result of interference between the front coil spring and the strut bearing. The design change increases the amount of turns in the coil spring which minimizes the area between the spring and strut bearing and eliminates the sound.

**NOTE:** Impreza has a turn increase from 4.2 turns to 4.4. Crosstrek Hybrid has a turn increase from 4.83 turns to 4.87. These changes have been incorporated into the 2022MY vehicle production.
