## Volvo Chassis - FSB 284 - 069, Exhaust Particulate Sensor, Repair ( 2017 Vehicles )

## FSB 284-069, Exhaust Particulate Sensor, Repair

(November 2021)

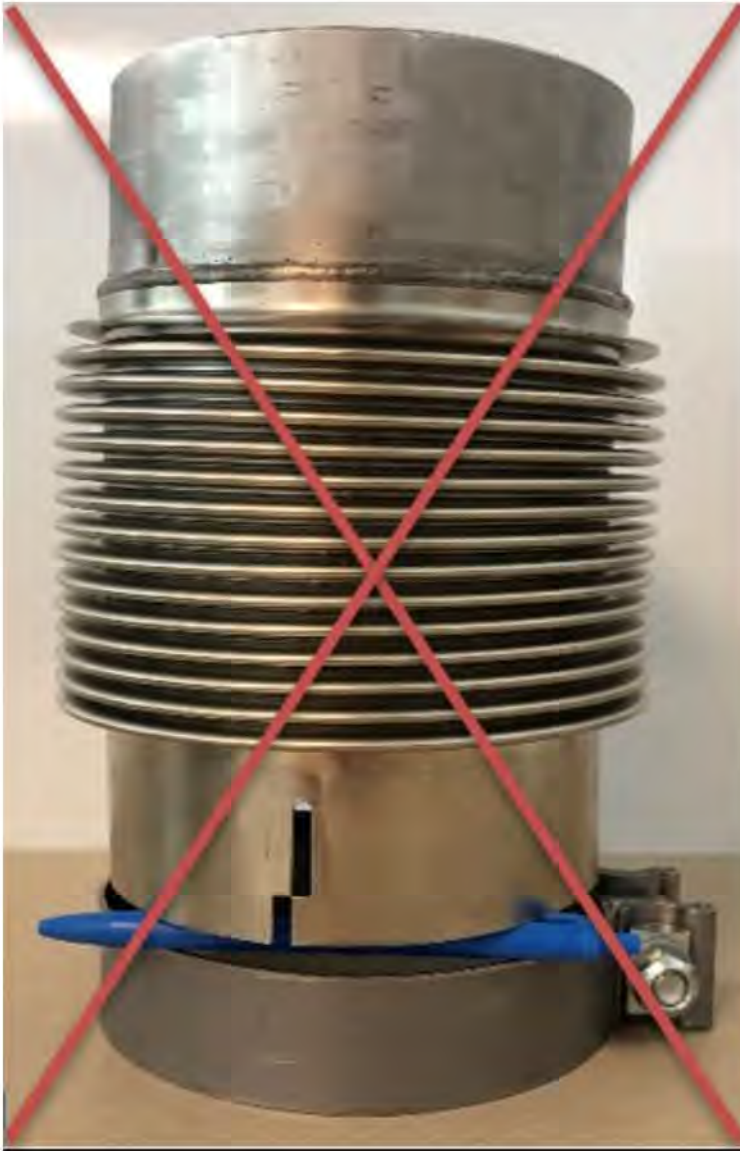
| | <p>Scenario 1</p> <p>This style Flex Pipe and Clamp will no longer work with the upper adjacent connecting pipe. The below parts in scenario 2 are required to perform this FSB.</p> <p>Follow the</p> |

repair below  
that is  
applicable for  
your  
configuration.
