Instructions for navigating the document

NEW TOPICS 3

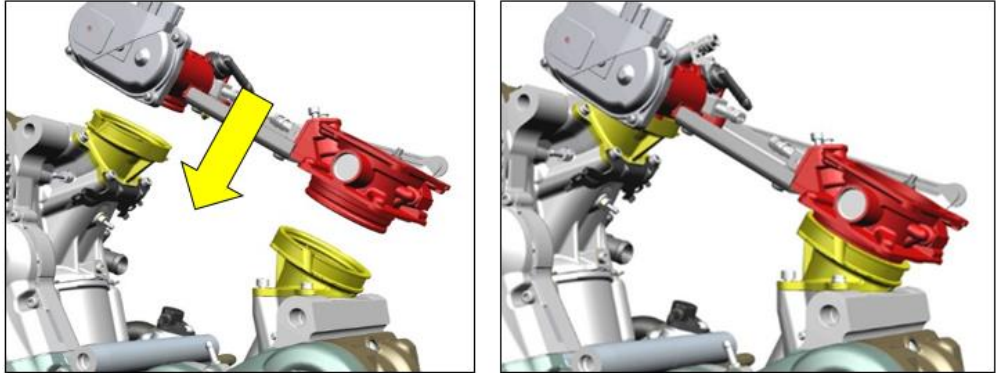
no.	Symptom	Subject	Photo	Notes and Indications - Corrective action
1	<p><u>ONLY</u> <u>Monster 821</u> <u>Monster 1200</u> <u>SuperSport</u></p> <p>Possible engine popping sound during deceleration and/or irregular idling</p>	Airbox

<p>We have received some complaints about a possible engine popping sound during deceleration. The performed analyses have shown that this symptom could be caused by an incorrect installation of the throttle bodies in the relevant intake manifolds (possible deformation of the rubber profile).</p> <p>Therefore, if you find any similar symptoms, we kindly ask you to check the correct installation of the Airbox on the motorcycle and in particular that:</p> <ul style="list-style-type: none">- throttle bodies are correctly inserted inside rubber intake manifolds, along the whole perimeter;- the rubber profile of the intake manifolds is not deformed.- the 2 fastening ties are correctly positioned in the seat on the intake manifolds <p>Please be reminded that, in order to make throttle body insertion easier on rubber intake manifolds, the use of silicone lubricant or similar product is absolutely necessary.</p>

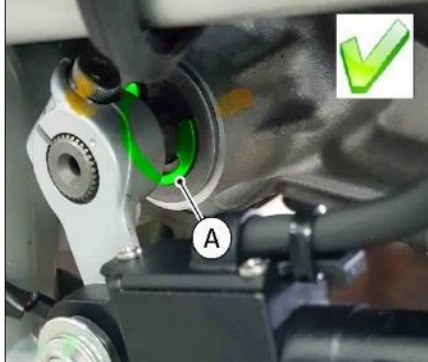
2	<p><u>ONLY</u> <u>Panigale V4</u> <u>(all versions)</u> <u>Streetfighter V4</u> <u>(all versions)</u></p> <p>Introduction of gear selector shaft certification</p>	Gear selector

<p>We have received some isolated reports of a possible loss/absence of the snap ring (A) of the gear selector shaft. We would like to inform you that an additional certification on all Desmosedici Stradale engines between snap ring, washer, and crankcase at the outlet of the gear selector shaft has been added along the production line. The first engine serial number with this new certification is ZDM1100WC #001513#.</p> <p>Upon the first workshop service, you are thus invited to check for the presence of the snap ring (A) on all engine serial numbers preceding the one specified above.</p>

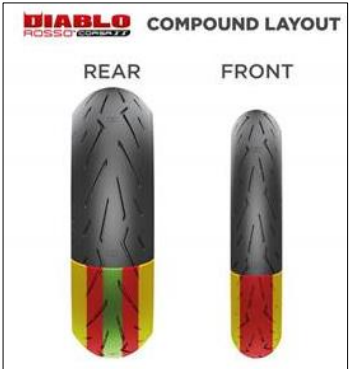
8	<p>Possible formation of a well-marked "band" in correspondence with the central area of the Pirelli Diablo Rosso Corsa II rear tyre</p>	<p>Pirelli Diablo Rosso Corsa II rear tyre</p>

<p>We have received some isolated reports of the appearance of a "band" in correspondence with the central area of the Pirelli Diablo Rosso Corsa II rear tyre.</p> <p>We would like to inform you that, since these are extremely sporty tires with 5 different compound zones at the rear, it can happen that, depending on the type of use of the motorcycle, they wear out in a different way causing the above mentioned phenomenon to occur; sometimes this occurs on the shoulder area, sometimes in the central area but, in general, it is a purely aesthetic phenomenon that does not affect the performance of the tyre itself.</p>

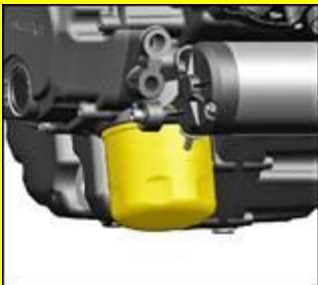
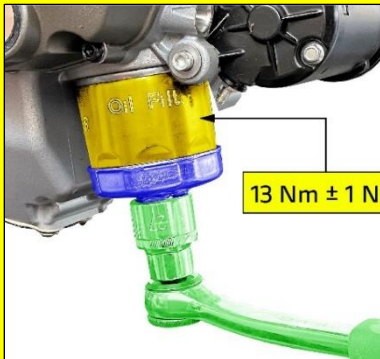
<p>Please, be informed that following changes concerning the engine oil filter cartridge, the tightening torque has been increased from 11 Nm to <u>13 Nm ± 1 Nm</u>.</p> <p>Please be reminded to lubricate the oil filter cartridge seal with engine oil and to use a commercial tool for tightening, as shown in the figure.</p>

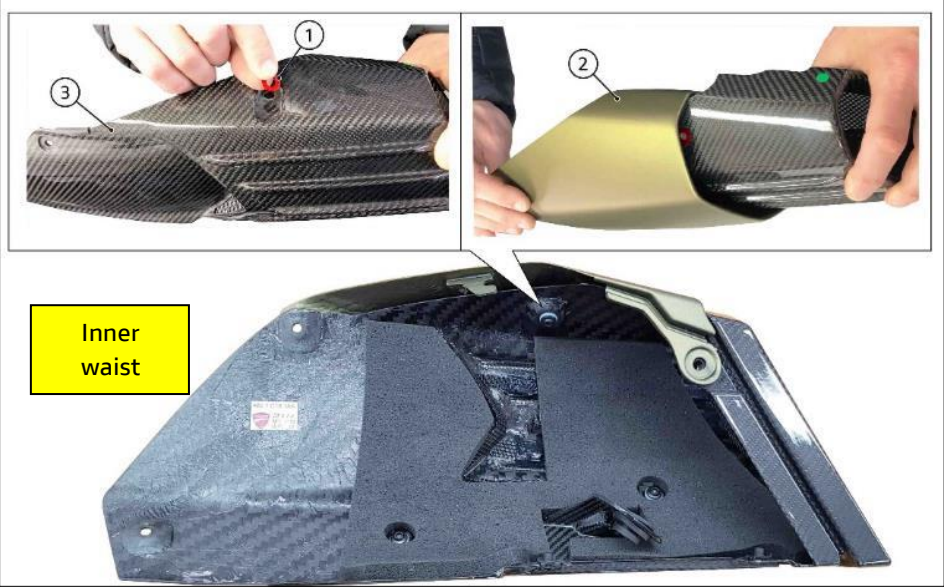
<p>We have received some isolated reports about a possible indentation of the RH and/or LH outer cover of the air conveyor.</p> <p>To avoid this phenomenon, it is necessary to position washer (1) 4x14x1 Part no. 85240171A between outer cover (2) and carbon air conveyor (3) in the upper fixing point, as shown in the figure.</p>

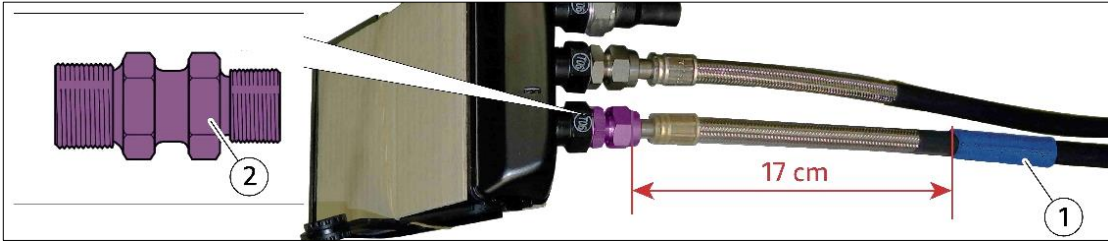
no.	Symptom	Subject	Photo	Notes and Indications - Corrective action
3	<p><u>ONLY</u> Multistrada 950 MY 17-20 Multistrada 1200 MY 15-17 Multistrada 1260 MY18-20 (all model versions)</p> <p>Possible superficial damage to the oil cooler return pipe</p>	Oil cooler pipes

<p>We have received some isolated reports of possible surface damage to the oil cooler return pipe due to rubbing with the top of the coolant radiator, over time. <u>This phenomenon is purely aesthetic and does not affect the correct operation of the system.</u> We inform you that for the models:</p> <p>a) Multistrada 1260: starting from the frame number ZDMAC03AAAKB011354 (on 27/05/2019) the anti-abrasion sheath (1) part no. 4601H701A has been introduced on the oil cooler return pipe, positioned at a distance of 17 cm measured from the upper end of the fitting. (This solution is also applicable to all Multistrada 1200 versions Model Year 2015-2017).</p>

<p>b) Multistrada 950:</p> <ul style="list-style-type: none"> - starting from the frame number ZDMAD00AAKB002259 (on 10/05/2019) the anti-abrasion sheath (1) part no. 4601H701A has been introduced on the oil cooler return pipe, positioned at a distance of 17 cm measured from the upper end of the fitting; - starting from the frame number ZDMAD00AALB005691 (on 12/03/2020) the longer fitting (2) part no. 81510391A has been introduced at the oil return pipe outlet from the cooler.

<p>We ask you to always check the condition of the oil cooler return pipe, and to replace it ONLY if the rubber sheath is damaged and the metallic braided hose can be seen. Follow the assembly notes indicated above according to the reference model. The spare part catalogue has been updated.</p>

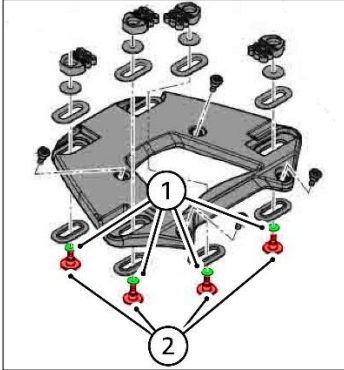
8	<p>ONLY <u>Multistrada V4</u> <u>(all model versions)</u></p> <p>Possible incorrect operation of the swinging system - Top Case accessory kit part no. 96781531AA</p>	Top Case Part no.96781531AA

<p>We inform you that the first Top Case accessory kits part no. 96781531AA delivered may not operate correctly with the swinging system, which may seem "too braked". To improve this condition, it is possible to insert 4 copper washers (1) part no. 85250231A on the 4 screws (2) retaining the bottom plate to the top one.</p> <p>For a better understanding of the assembly procedure of the Top Case accessory kit, a video has been made which can be viewed at the following link: https://youtu.be/DVEHKVvdKQI.</p> <p>All Top Case kits in stock will be restored by February 2021.</p>

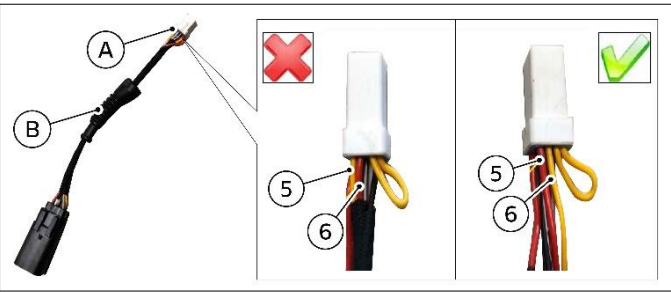
<p>After having installed the anti-theft system Kit Part no. 96681081AA and enabled it on the BBS control unit, some malfunctions may occur during activation due to a possible incorrect pin arrangement in the connector of the wiring branch supplied with the kit.</p>

<p>The kits currently in stock have been restored.</p>

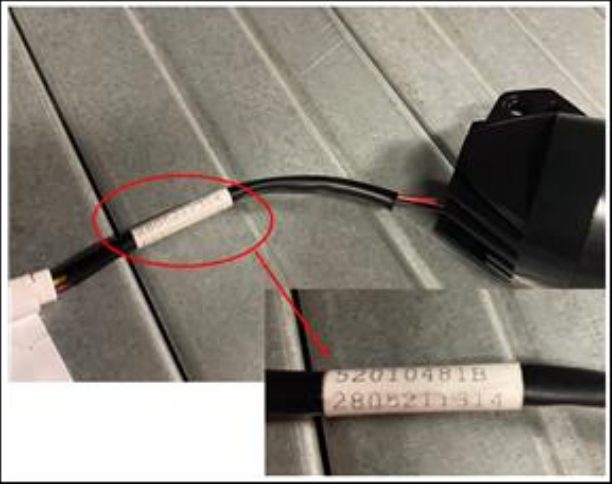
no.	Symptom	Subject	Photo	Notes and Indications - Corrective action
39	<p><u>Multistrada V4, ONLY</u> <u>(all versions)</u></p> <p>Possible water infiltration into the fog lights</p>	Fog lights

<p>We have received some reports of unusual infiltration of water into the LED supplementary lights, which are available as spare parts – accessory part no.: 96681031AA. For this reason, the supplier has introduced some considerable improvements in the assembly, which should avoid the problem. In case of an unusual presence of water, please check the manufacturing date indicated on the label on the wiring:</p>

<p>The first line corresponds to the part number (52010481B). The second line contains the date: the first two digits correspond to the day, the next two digits correspond to the month and the following two digits correspond to the year. The last four digits correspond to an internal serial code.</p> <p>E.g. code in figure 2805211314 → 28 May 2021</p>

<ul style="list-style-type: none"> - If the date is prior to 01 August 2021 and you notice water infiltrations, replace the lights. - If the date is the same or after 01 August 2021, inform your Area Manager with a specific YouTech, explicitly indicating the date on the headlight, and attaching any photographic documentation.

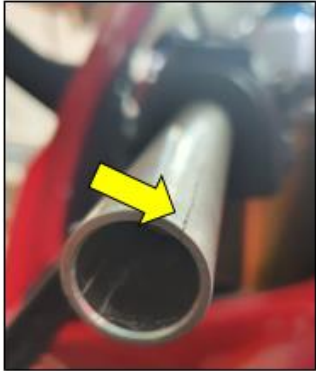
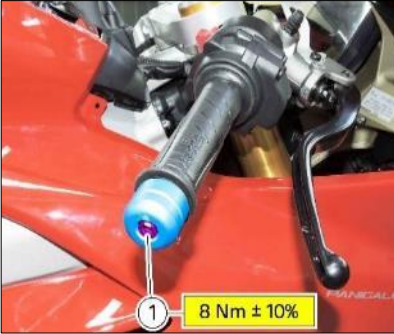
2	<p><u>ONLY</u> <u>Panigale V4</u></p> <p>Precautions during PDI: installation of the balancing weights on the handlebar</p>	Balancing weights on handlebar

<p>We received some isolated claims about the possible triggering of a longitudinal crack on the handlebar, on balancing weight side. Our laboratory analyses found that said crack is due to an excessive tightening torque applied when installing the balancing weights.</p> <p>When installing balancing weights on the handlebar, please comply with the tightening torque specified for the M6x55 screw to 8 Nm ± 10%, as indicated on the bulletin introducing the model and on the Workshop Manual.</p>

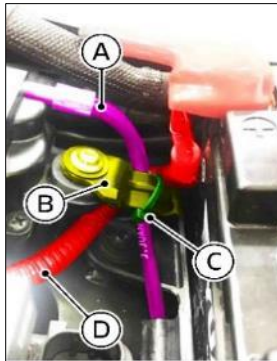
5	<p><u>ONLY</u> Scrambler 1100 PRO (all versions)</p> <p>Irregular operation at idle speed and engine power loss</p>	Vertical cylinder LH spark plug cable	-	<p>As a result of continuous quality tests on the product, we have found a possible irregular operation at idle speed and engine power loss. This phenomenon is due to a settling of the vertical cylinder LH spark plug cable on the coil caused by the contact with the fitting of the oil return pipe from cooler (visible on motorcycle RH side). The MIL light does not come on.</p> <p>We ask you to always check the conditions of vertical cylinder LH spark plug cable and to apply the protective sheath Part no. 4601C581A (cut in half and secured in place with two small self-locking ties) on the fitting of the oil return pipe from cooler to avoid the above-described phenomenon.</p>

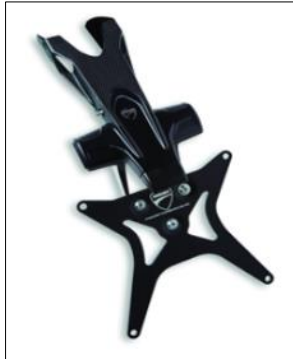
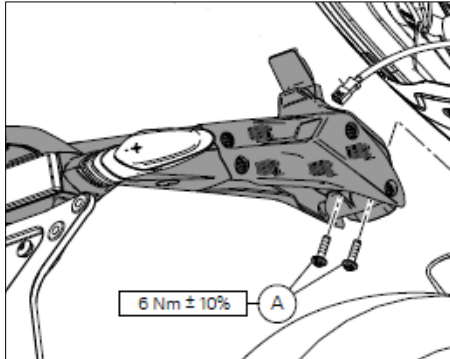
<p>When assembling the Ducati Performance carbon number plate holder unit part no. 97381161CA, we remind you to always apply LOCTITE 243 on the threads of the 2 screws (A) for fixing the unit to the rear subframe and tighten them to the specified torque of 6 Nm ± 10% as indicated in the relevant instructions.</p>
