Subject: UPHOLSTERY SURFACE STAINS	M-Tips No.: MT-001/22
	Last Issued : 02/04/2022

APPLICABLE MODEL(S)/VINS

2013-2022 CX-5	2016-2021 CX-3	2020-2022 CX-30
2014-2022 Mazda3	2016-2022 CX-9	2022 MX-30
2014-2021 Mazda6	2016-2022 MX-5

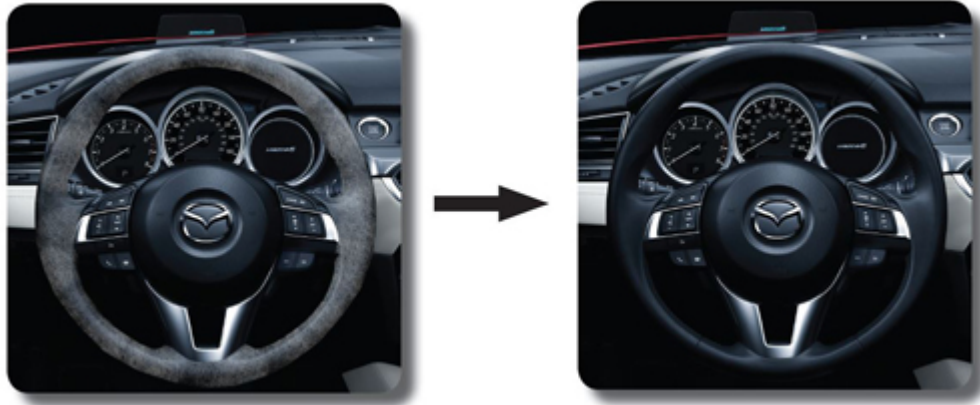
Some customers may report concerns with interior upholstery surface stains particularly on high contact areas (e.g.: steering wheel, door panels, shifter...etc.). This may be caused by skin oils or chemicals such as hand lotions.

Steering wheel stained

Steering wheel after cleaning

Use a clean towel dampened in leather/vinyl cleaner or mild soap to clean the steering wheel.
