Service Alert

Subject: "LOW BATTERY RISK. START VEHICLE TO CHARGE 12V BATTERY" WARNING MESSAGE	Service Alert No.: SA-002/22
	Last Issued : 02/10/2022

2021-2022 Mazda3 (Japan built) with VINS lower than JM1BP*****500044 (produced before November 6, 2021)
2021 Mazda3 (Mexico built)
2021 CX-30

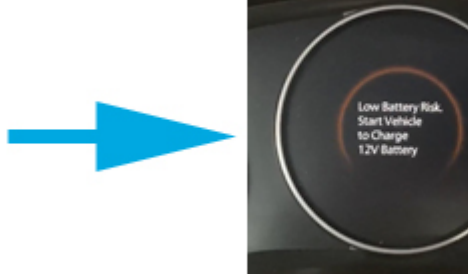
DESCRIPTION	CAN network accumulated awake time count reaches 30 min without engine running. This will trigger Sleep Mode (forced sleep) to prevent battery charge depletion.	
SLEEP MODE FUNCTION INDICATION	<ul style="list-style-type: none"> • Opening the liftgate • Depressing the brake pedal • Pressing the push button start • Operations that wake-up the network

<p>"Low Battery Risk. Start Vehicle to Charge 12V Battery" warning message and 30 second alarm</p>
ACTION TO BE TAKEN	No dealer visit is required. The warning message can be cleared by starting the engine and idling or driving for 5 minutes or longer.	
VEHICLE NETWORK WAKE-UP TRIGGER	<p>After ignition OFF:</p> <ul style="list-style-type: none"> • Open any door • Unlock doors • Open liftgate • Depress brake pedal • Push start/stop button (without engine start) • Other operations that wake-up the CAN network
