Service Alert

Mazda North American Operations Irvine, CA 92618-2922

MELTED OR WARPED MIRROR COVER OR OUTSIDE TRIM

Service Alert No.: SA-008/22

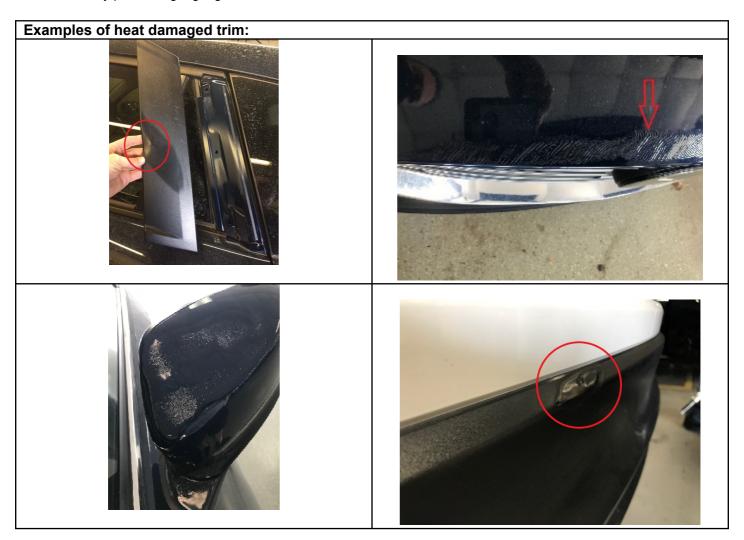
Some vehicles may experience exterior trim heat damage when parked near a glass building or Low-E windows. This may be caused by the sun's reflection.

If a structure's windows create enough of a curve, the concave glass can focus the sun's rays onto a small area and acting like magnifying glass direct the sunbeams into a hot pinpoint of light. This magnification of the sun's rays can cause damge to vehicle trim (see examples). Additional information and exemplar images regarding this phenomenon can be found by performing a google search.

Repair or replace the affected part(s) as needed.

If the customer regularly parks the vehicle where there is exposure to such conditions as described in the description above, explain to the customer that parking location may need to be reconsidered.
