## Model Year 2017, 2018 - US17 GHG Common Rail Fuel System Component Electrical Faults

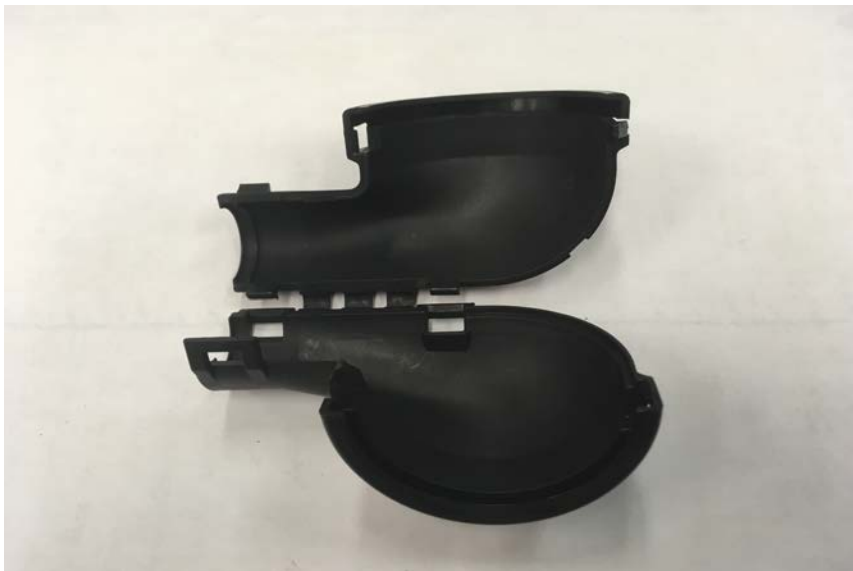
Follow Guided Diagnostics for any of these components with associated electrical faults. However, the cause for some of these faults has been identified with terminals not locked properly in place on the VCI 1 and VCI 2 connector. The VCI connectors are located on the lower valve cover base. The plastic wire cover on the connector should be removed for better visual inspection. This is an area where special attention should be taken to inspect for an issue.

Picture below of plastic wire cover on the VCI connectors.

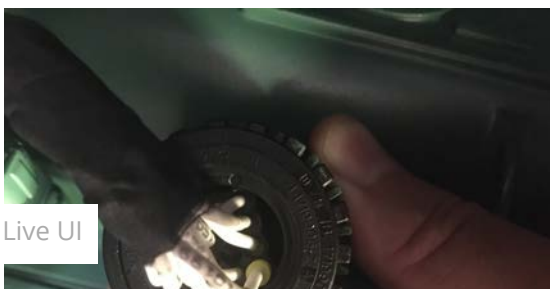
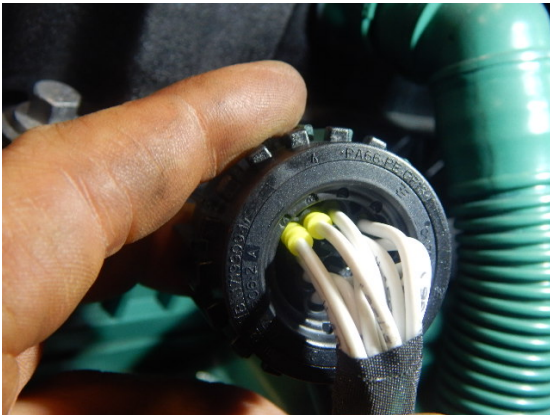
Examples of terminals not properly locked in the VCI connectors causing electrical faults. See pictures below

**NOTE:** if terminal will **NOT** properly lock in the vci connector, the external engine harness will **NEED** to be replaced.
