MAZDA DEALER EMAIL

Subject: Notification of Emission Recall 5421K - 2019 CX-5 Diesel - Selective Catalytic Reduction (SCR)/AWD Harness concern

Emissions Recall 5421K – 2019MY CX-5 Diesel – SCR/AWD Harness Concern

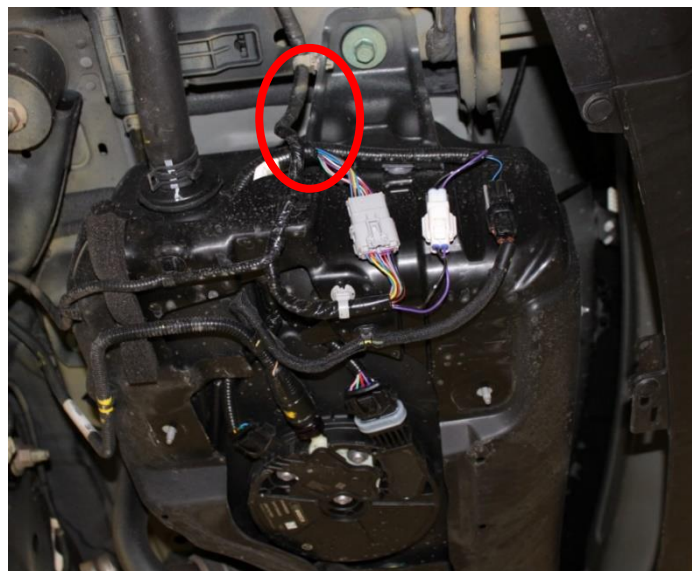
2. Inspect insulation/wires for damage as shown on photos below

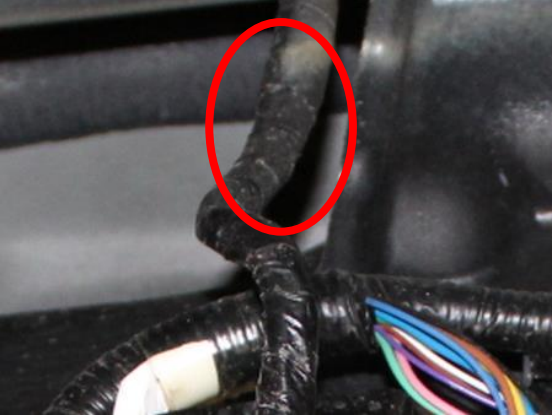
OK	NG
<p data-bbox="164 302 592 336">Core wires are not exposed. OK</p>

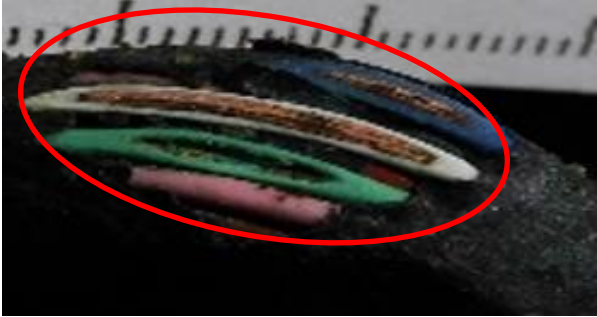
<p data-bbox="746 302 1378 336">Some core wires are exposed. HARNESS REPAIR</p>

3. If no damage is found to the Core Wires as in the left column examples, proceed with installation of PVC tubes, step "Installation of PVC tubes" of this repair procedure. This is 90% of the vehicles.
4. If damage is found, proceed with next step to check for corrosion in the connectors of the damaged wiring harness.

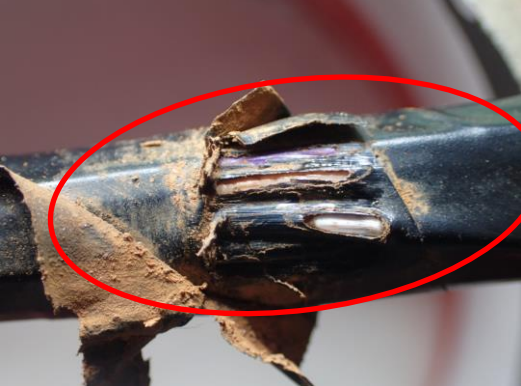
<p data-bbox="164 790 592 824">Core wires are not exposed. OK</p>

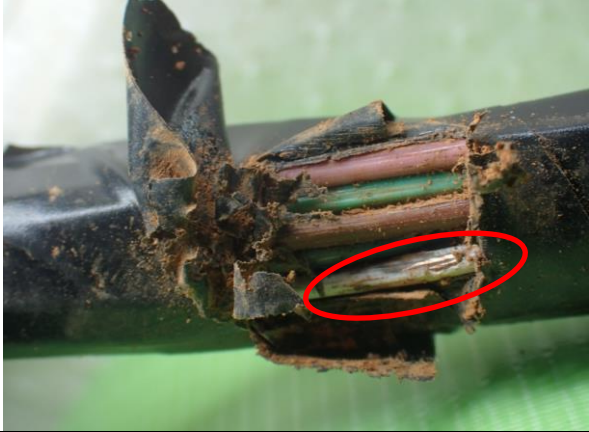
<p data-bbox="746 790 1378 824">Core wire of white is exposed. HARNESS REPAIR</p>

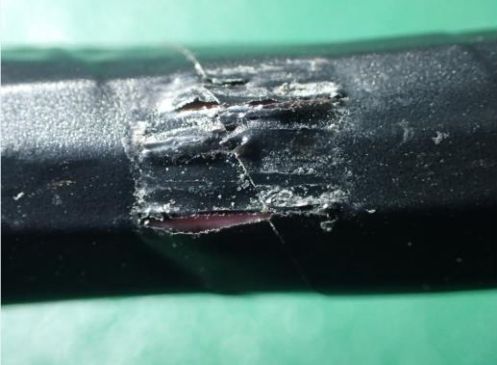
<p data-bbox="164 1294 592 1328">Wire cores are not exposed. OK</p>

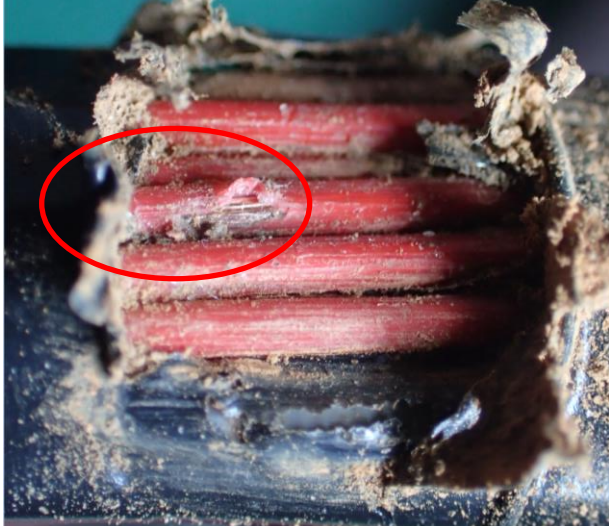
<p data-bbox="746 1294 1378 1328">One Red wire core is exposed. HARNESS REPAIR</p>

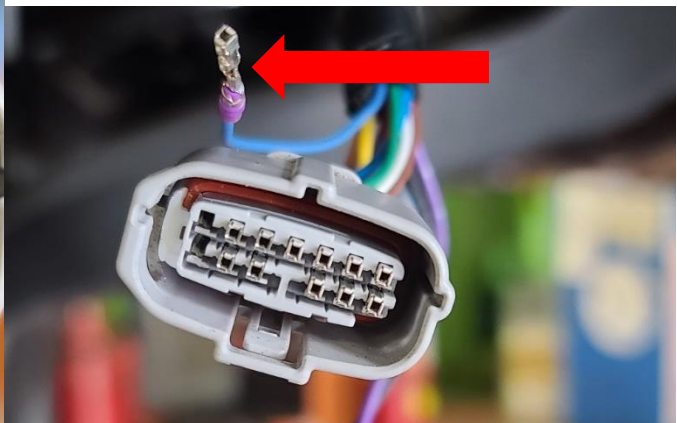
Example – Damaged Core Wire Terminal

7. Replace exposed harness with new one according to **"Installation of Repair wires"**
8. Install PVC tubes according to **" Installation of PVC tubes"**
(Include Re-installation of the Urea tank cover and Re-connect battery ground terminal)
