# McLAREN GT HVAC HIGH PRESSURE HOSE IDENTIFICATION & POTENTIAL REPLACEMENT

| <b>Campaign reference:</b> | SCB 22 F 001 |
| <b>Affected vehicles:</b> | McLaren GT – specific VINs |
| <b>Date:</b> | 3 <sup>rd</sup> February 2022 |

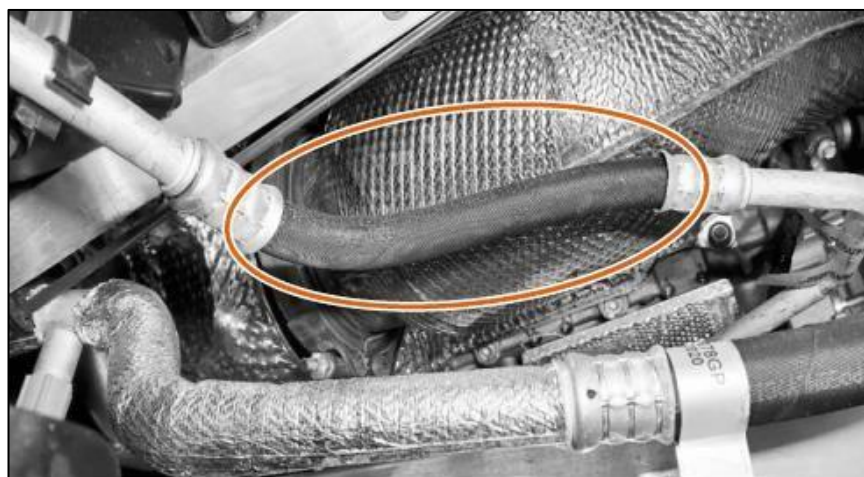
Through continuous product quality monitoring, McLaren Automotive has identified that a number of McLaren GT vehicles may have been fitted with an HVAC high pressure with a potential manufacturing issue. The hose supplier has identified and communicated the batch number of the hoses in question. Therefore, inspection of the part and potential replacement may be required.

Image 1 – Location of HVAC hose

- a. Secure/Lift vehicle on platform
- b. Remove/Install wheel – Rear
- c. Remove/Install Wheel arch liner
- d. Inspect the hose for the batch code (refer to section 4 'Warranty Information' for location of the batch code on the part)
- e. If the batch code printed on the part is **T990** the hose **must be replaced**
- f. If the batch code does not match this batch number, no further action is required g. **End of procedure**

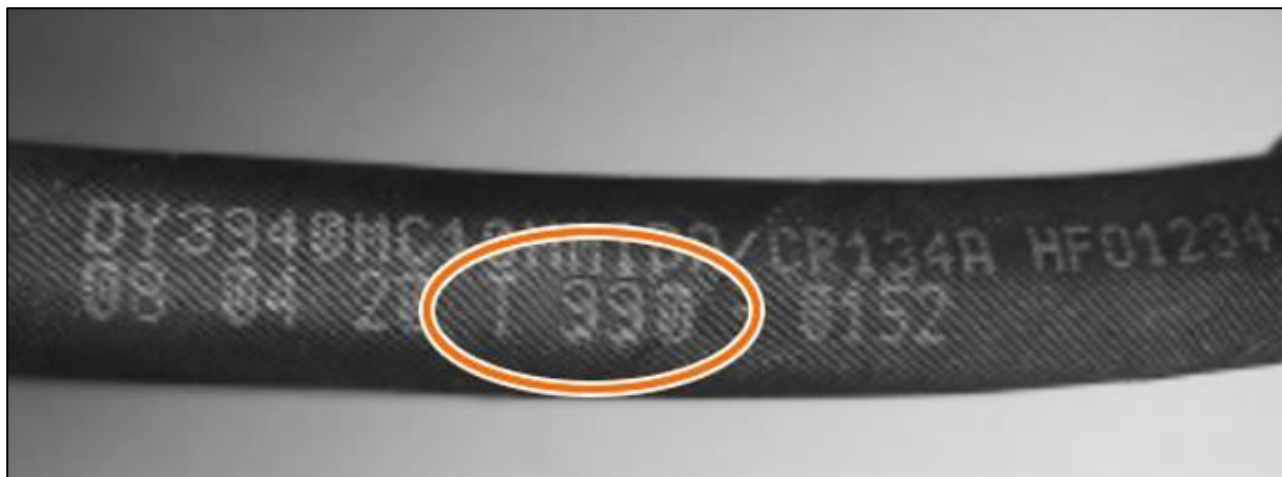
Please ensure when claiming for a replacement hose, you include a photograph of the concerned batch code which can be found printed on the rubberised section of the part as shown below. Failure to do so will result in the claim being returned for correction. A photograph of the part number and production date label attached to the hose is also required in the Warranty claim submission.

Image 2 - Example of batch number location

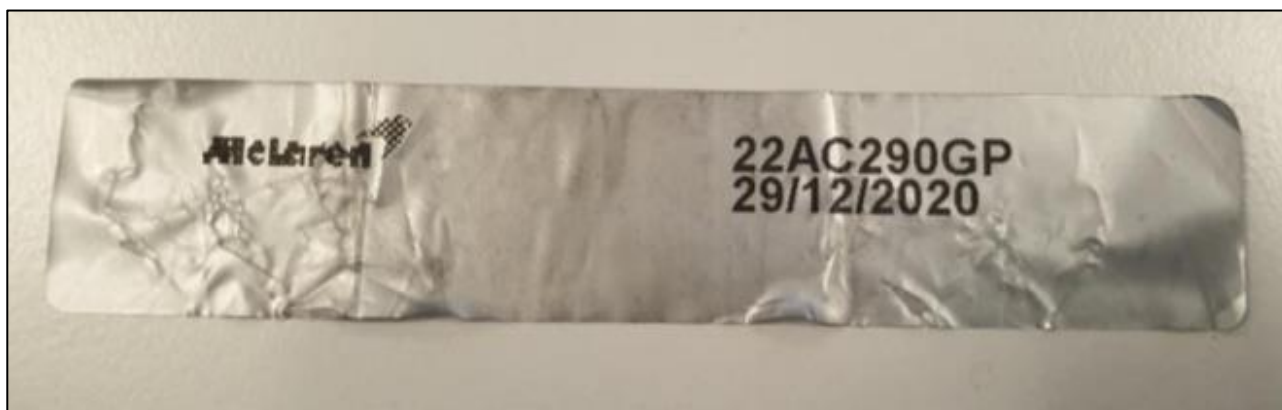
Image 3 - Example of part number and production label
