971 – Fuel Delivery and Suspected Fuel Vapor Lock

Vehicles Affected

| Models | Model Year | Model Type | VIN Range | Vehicle-Specific Equipment |
|---|---|---|---|---|
| Panamera | As of 2017 | 971 | N/A | N/A |

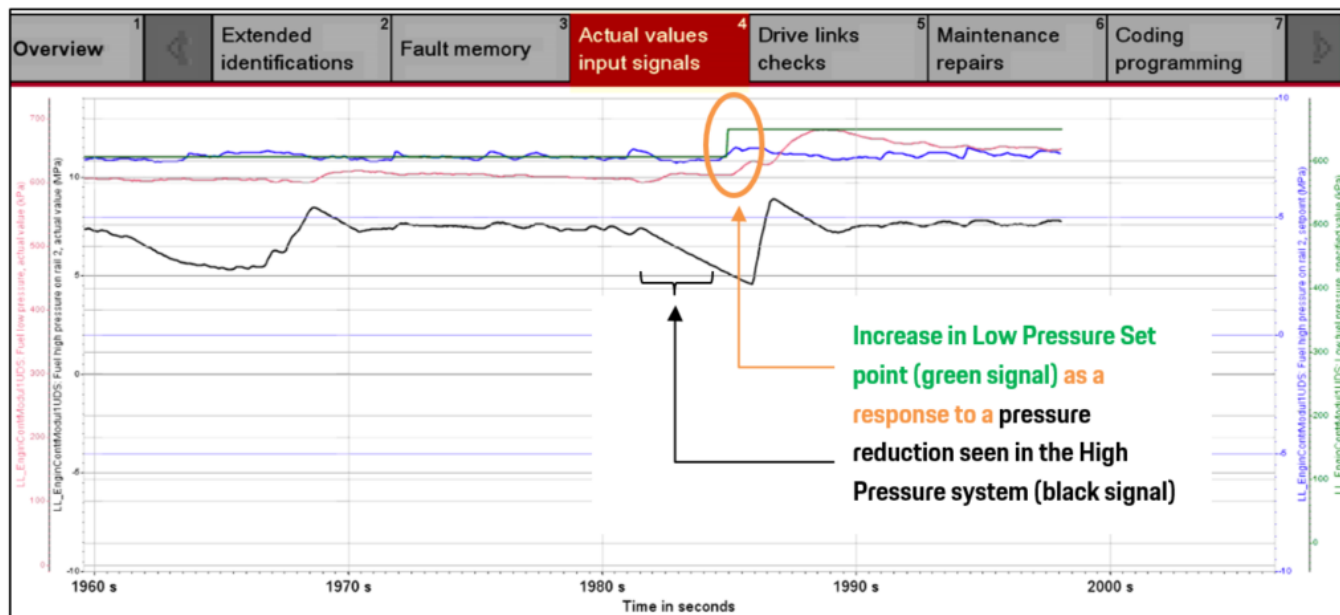
Figure 1 - Fuel Pressure Operation at Idle of a G2.I Configured with V8

Actual: Low-pressure fuel (≈ 5.5 – 6.5 bar)

Set point: Low-pressure fuel (6 – 6.5 bar)

Actual: High-pressure fuel bank (≈ 70 bar at idle)

Set point: high-pressure fuel bank 2 (≈ 70 bar at idle)

Figure 1 cites an example of properly functioning high and low pressure fuel circuits. The signals in Figure 1 illustrate the behavior of the low-pressure circuit as controlled by the DME when significant drops in high-pressure occur. (This specific function only exists in V8 equipped order types.) Specifically, we see the step-change in the low-pressure set point from 6 to 6.5 bar (green) to better supply the high-pressure circuit. The result in this instance is a correction to both the low- and high-pressure fuel systems, as witnessed by their respective actual values. In instances of extreme fuel volatility, vapor lock can otherwise result (see Figure 2). The design countermeasure exhibited in Figure 1 can be helpful in most cases, but might not remedy all highly volatile situations. It is important to first diagnose the high- and low-pressure circuits individually, starting with the low-pressure side, to rule out any physical issues with the systems (e.g. a blockage and/or a faulty fuel pump).
