SERVICE BULLETIN

APPLICABILITY: 2017-18MY Forester 2.5L

NUMBER: 09-85-22

SUBJECT: Front Exhaust Pipe Cover Replacement

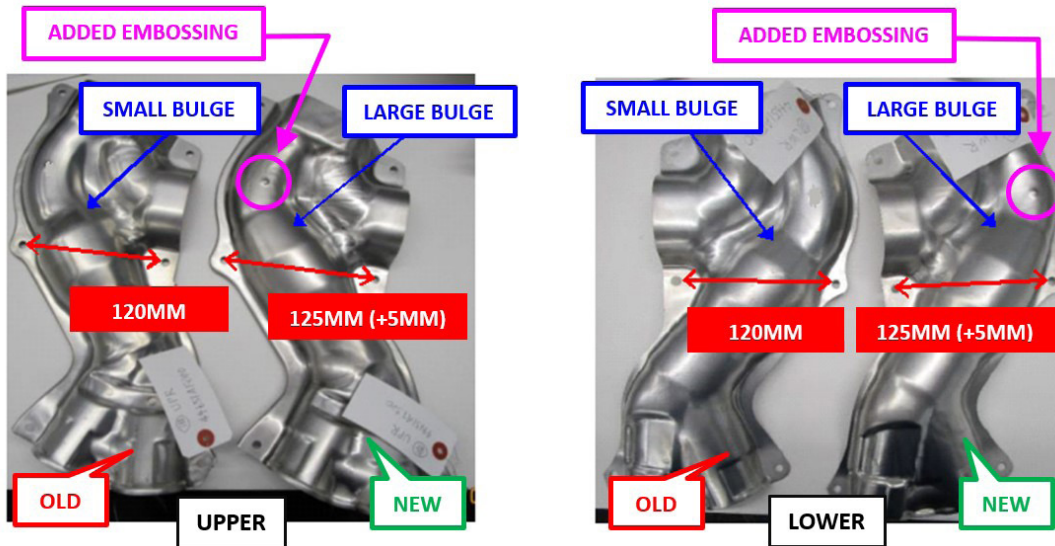
Details of Changes:

This bulletin announces design changes made to the front exhaust pipe covers. The covers have a re-designed shape to provide a more streamlined fit with the previously re-designed front exhaust pipe bellows.

- The parts listed above in gray are **one-time use** parts.
- If a situation occurs **where** one of the old-style covers need replacement, the covers **MUST** be replaced as a set. If the covers have BOTH been previously replaced with the new-style parts, they can be replaced individually.
