## SERVICE BULLETIN

**APPLICABILITY:** 2016-18MY Legacy/Outback  
 2016-18MY Impreza  
 2016-18MY Crosstrek  
 2016-18MY Forester  
 2017-18MY WRX

**NUMBER:** 15-291-22

**SUBJECT:** Gen1 Telematics DCM Replacement for continued operation post-3G Sunset

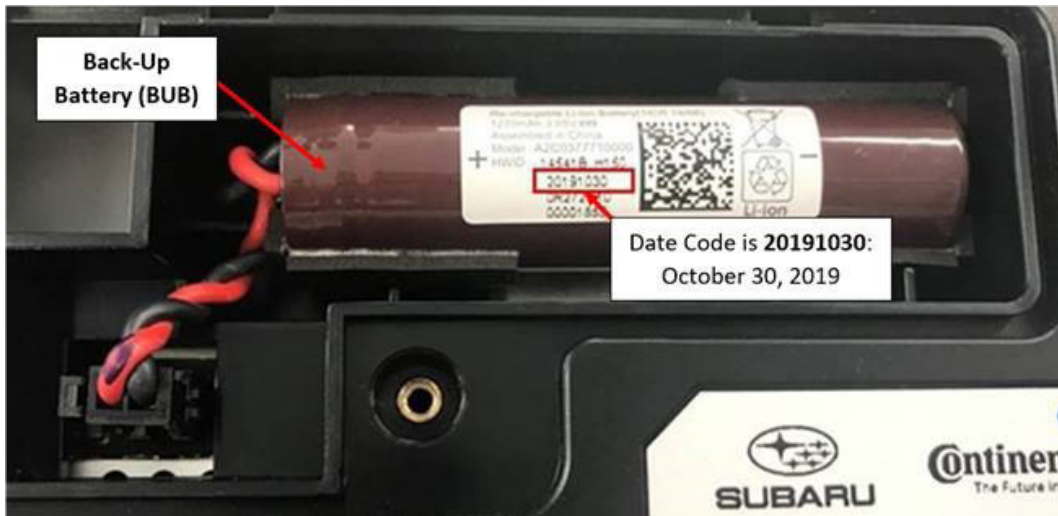
**NOTE:** Always check the current DCM for any DTCs before replacing it. If the BUB requires replacement due to failure (DTC B2A07) or, the repair date is five (5) years past the date stamp on the BUB (see image for decoding the BUB date stamp), the replacement BUB must be ordered and installed separately as a maintenance item. If any other DTCs are found, they must be resolved prior to DCM replacement to avoid carrying over the concern and possibly damaging the new DCM

Replacement DCMs will have the new software preinstalled. The new DCMs will **NOT** come with a new backup battery (BUB). Technicians must transfer the existing BUB to the replacement DCM.
