SERVICE INFORMATION BULLETIN

APPLICABILITY: 2019MY Legacy and Outback w/ 8-in. Navi System **NUMBER:** 15-255-19R
 2019-22MY Impreza and Crosstrek w/ 8-in. Navi System **DATE:** 11/08/19
 2019-22MY Crosstrek Hybrid w/ 8-in. Navi System **REVISED:** 02/22/22
 2019-22MY Forester w/ 8-in. Navi System
 2019-22MY WRX WRX STI w/ 7-in. Navi System
 2019-22MY Ascent w/ 8-in. Navi System
 2019-22MY BRZ with 7-in. Navi System

SUBJECT: Map Data Update Procedure for Harman Gen 3.1
 Navigation Equipped Head Units (H/U)

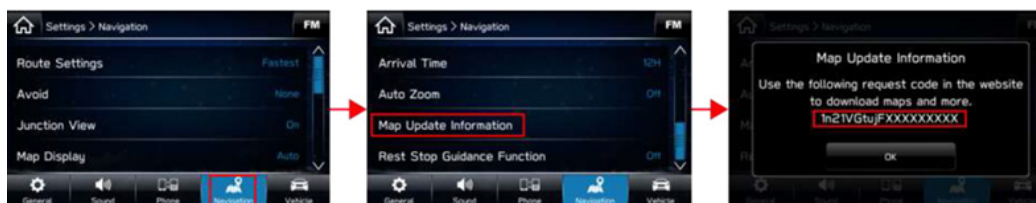
A. How to check Request Code from the vehicle Head Unit

- You can check Request Code. Home>Settings>Navigation>Map Update Information.
- Please take a picture / memo of Request Code.

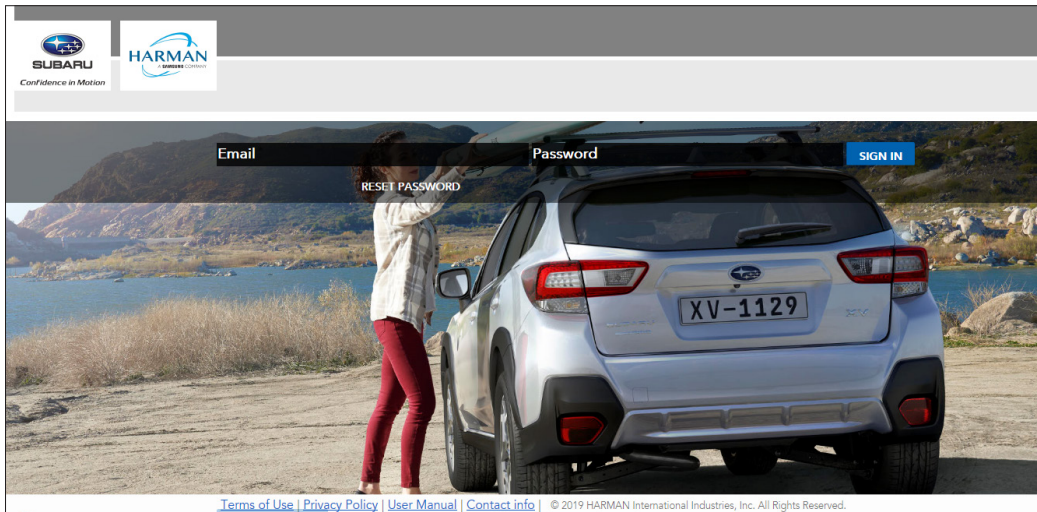
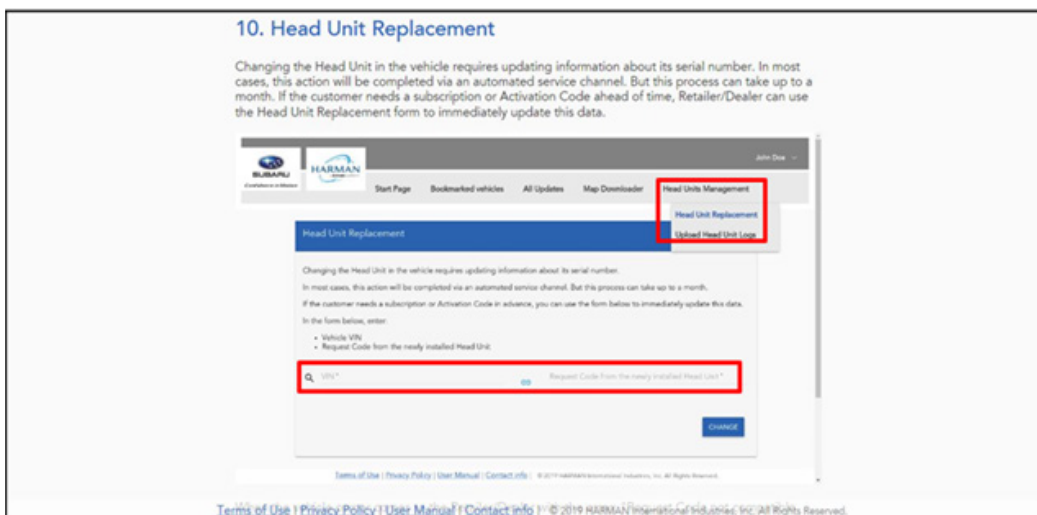
Please input VIN and Head Unit Request Code on “10.Head Unit Replacement” in the URL below, referring to “User Manual”.

After LogIn ➡ Head Unit Management ➡ Head Unit Replacement ➡ input VIN & Request Code.
