SERVICE BULLETIN

APPLICABILITY: 2020-21MY Legacy & Outback
 2019-21MY Forester
 2021MY Crosstrek

NUMBER: 09-80-21
DATE: 02/28/22

SUBJECT: DTC # P2682 & P26Ax** / Thermo Control Valve – Design Change

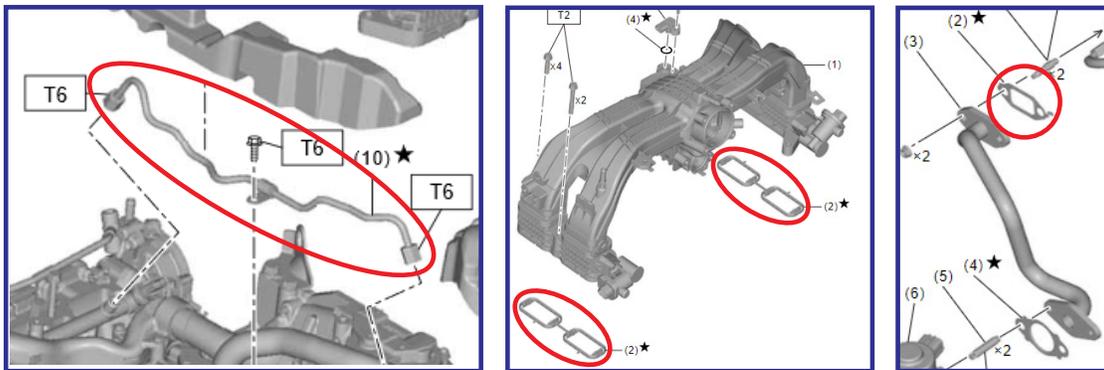
- The Service Manual uses a black star (★) in the component breakdown illustrations to indicate one-time use parts. The high-pressure fuel delivery pipe, intake manifold gaskets, and EGR cooler gaskets are one-time use parts (shown below).
