LTB01090NAS2

TECHNICAL BULLETIN

07 FEB 2022

Indicator / Wiper Stalks Inoperative or Intermittent Function

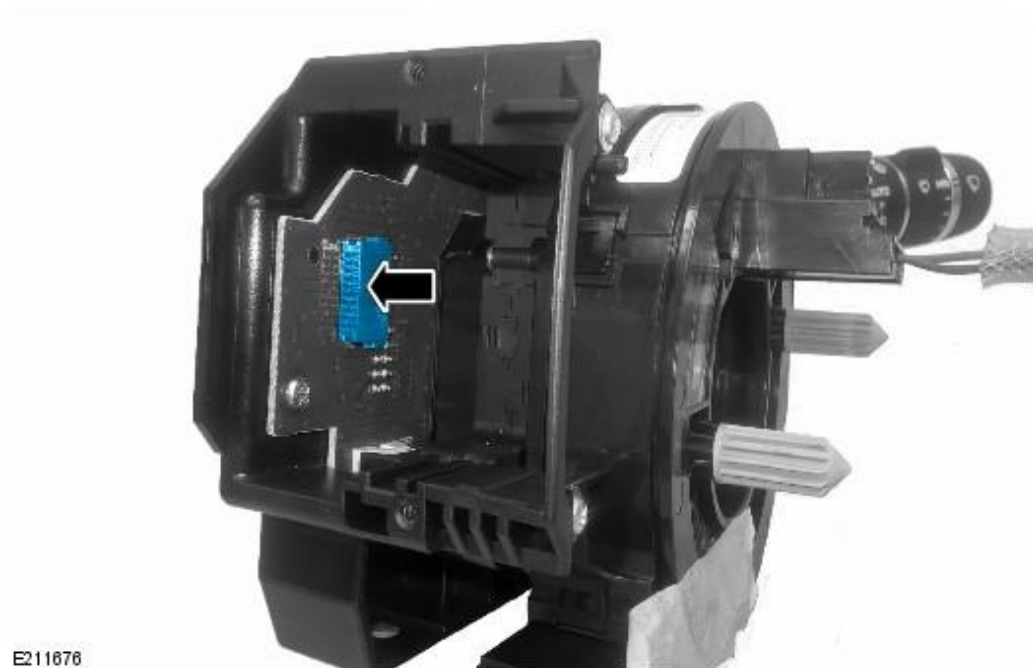
2.

The lighting control switch and/or the wiper control switch may not operate or operates intermittently.

This may be caused by a poor electrical connection at the lighting control switch and/or the wiper control switch.

- Do not apply Nyogel to the lighting control switch connector.
- Make sure there is an even coating of Nyogel on the electrical contacts surface.
- Remove any excess Nyogel.

With the lighting control switch removed, apply the Nyogel to the electrical contacts surface.
