SERVICE INFORMATION BULLETIN

APPLICABILITY: 2020-22MY Legacy & Outback

NUMBER: 07-204-22

SUBJECT: Tentative Select Monitor Procedures When Replacing and/or Diagnosing Combination Meters

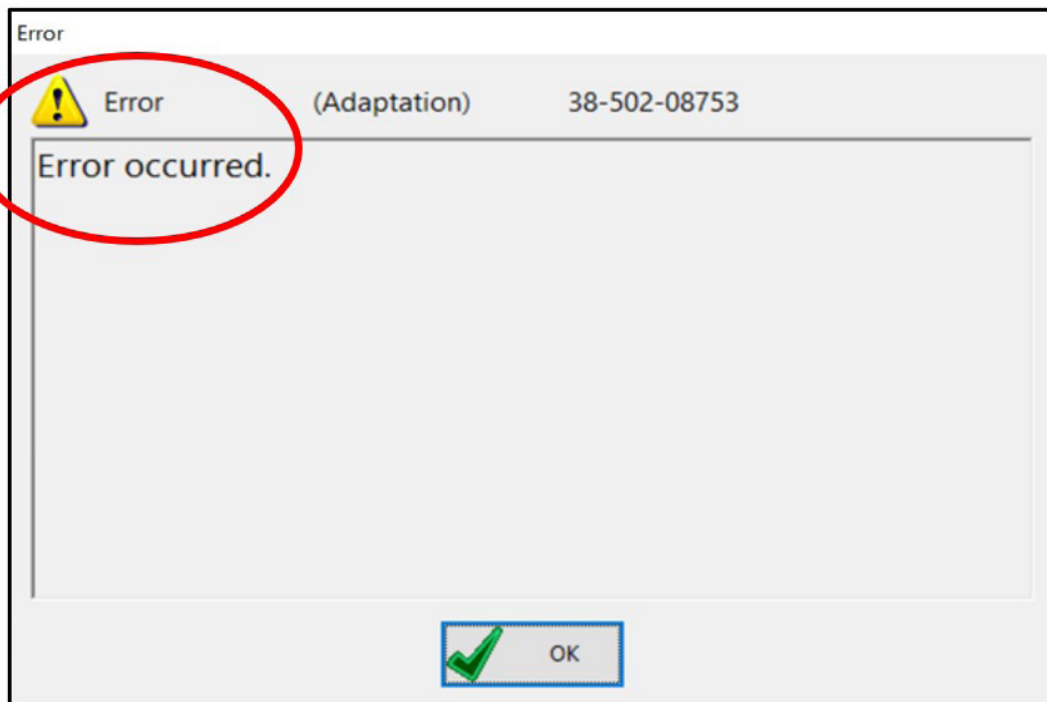
In order to avoid the error shown above, follow the procedures listed below. **DO NOT** disconnect the battery.

An error message may occur when replacing the combination meter. The Subaru Service Manual (Body & Electrical/WIRING SYSTEM > INSTRUMENTATION/DRIVER INFO > Combination Meter) instructs the Technician to disconnect the battery sensor from the ground terminal in the first step of the work procedure. Doing so can cause an error during the process of transferring the odometer value to the NEW combination meter. This occurs because the central gateway was previously reset by the battery sensor/ground terminal disconnection. If the error occurs after the odometer value has been detected within the SSM, the carry-over of the odometer value **CANNOT** be performed.

1. **DO NOT** disconnect the battery sensor from the ground terminal.
2. Remove fuse number 6, 37, and 22 from the fuse box. Refer to the image to the right for fuse locations.
 - **Fuse 6** – MET IG 7.5A
 - **Fuse 37** - MET B 15A
 - **Fuse 22** - DMS B 10A
3. When following these procedure steps during replacement of the combination meter, it is possible for DTC U0155 to be set and/or stored. This fault is to be ignored and cleared once all combination meter replacement work has been completed. **NOTE:** If the battery was disconnected prior to replacement, reconnect the battery, cycle the key, and continue using the procedures provided above.

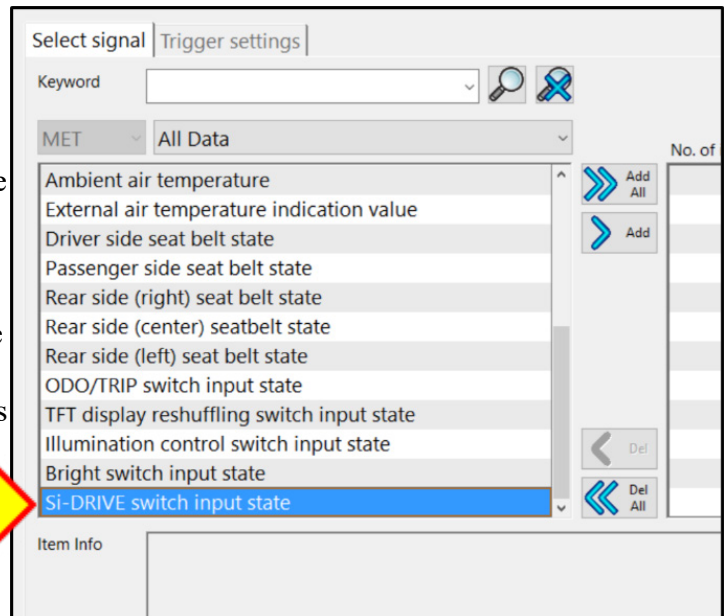
An error message may be displayed on Subaru Select Monitor when performing diagnostic work with the combination meter.

- To avoid an error message while using the “Data Monitor” portion of SSM, confirm the monitor item labeled “Si Drive” is **NOT** selected/added when working on a vehicle not equipped with Si Drive before proceeding. If selected on a vehicle not fitted with Si Drive and data monitoring is attempted, the error message will display.

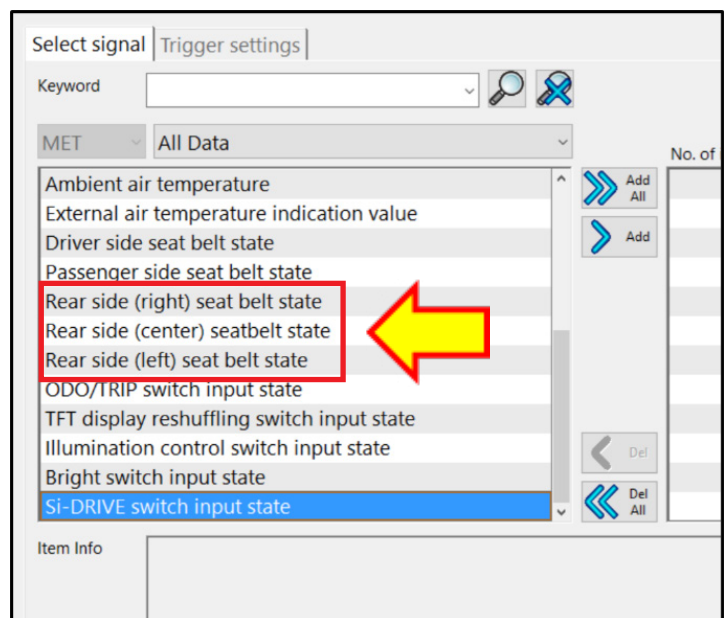
- To avoid an error message while using the “Data Monitor” portion of SSM, confirm the Rear side (right, center or left) seat belt state selection is accurately selected in accordance with vehicles fitted with or without rear seatbelt warning.

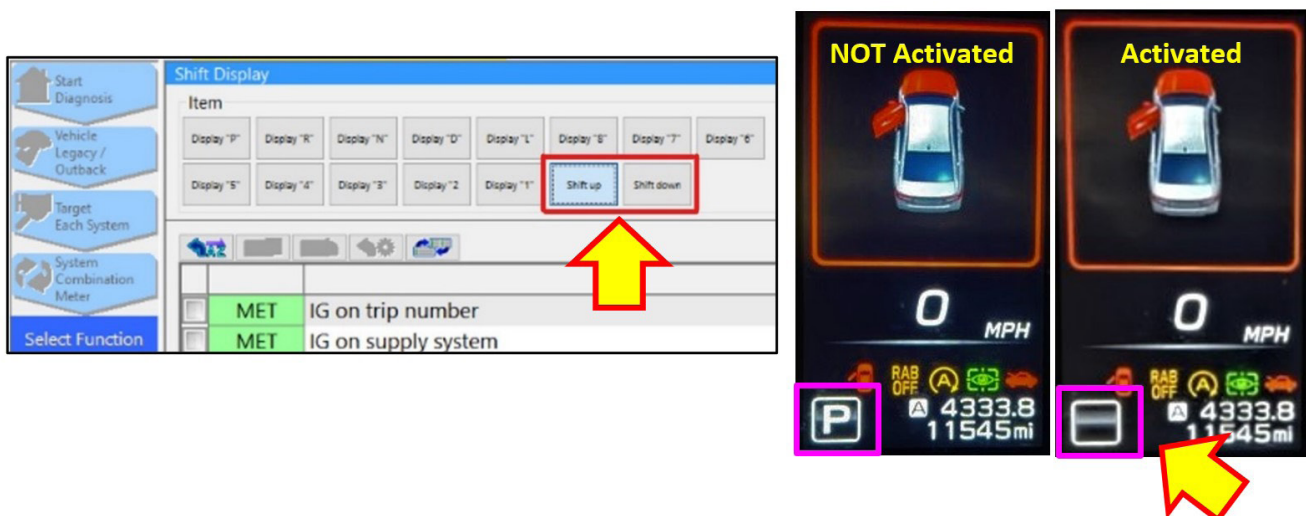
- When using the Shift up and Shift down display request item (pictured lower left), the combination meter will only display a blank indication instead of the desired gear selection (pictured lower right.)
