## Flush-mounted door handle jams when it is pulled out

Topic number	LI72.10-P-074316
Version	2
Function group	72.10 - Front door
Date	2/24/22
Validity	MODEL 297 with CODE 889 up to manufacturing date January 24 2022 MODEL 223 with CODE 889 up to manufacturing date January 24 2022
Reason for change	Remedy adjusted

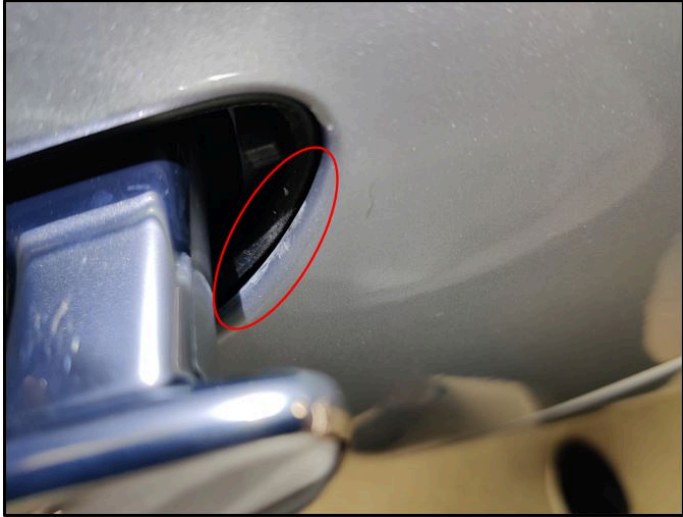
Attachments	
File	Description
<a href="#">Bild 1.JPG</a>	Picture 1

- The flush-mounted door handle could jam when it is pulled out and may move in a jerky manner when doing so.
- In the area of the paneling section of the door, paint damage could be present (picture 1) and/or an abrasion point could be present at the door handle (picture 2).

3.) Repair paint damage at door paneling (see picture 1) according to manufacturer specifications, using spot repair procedure if necessary.
