# PRODUCT ADVISORY

## PA705

**SUBJECT:** 2017 – 2020 Model Year Ford F550 Frame Reinforcement

**SUBJECT: Customer Satisfaction Program 21B04**

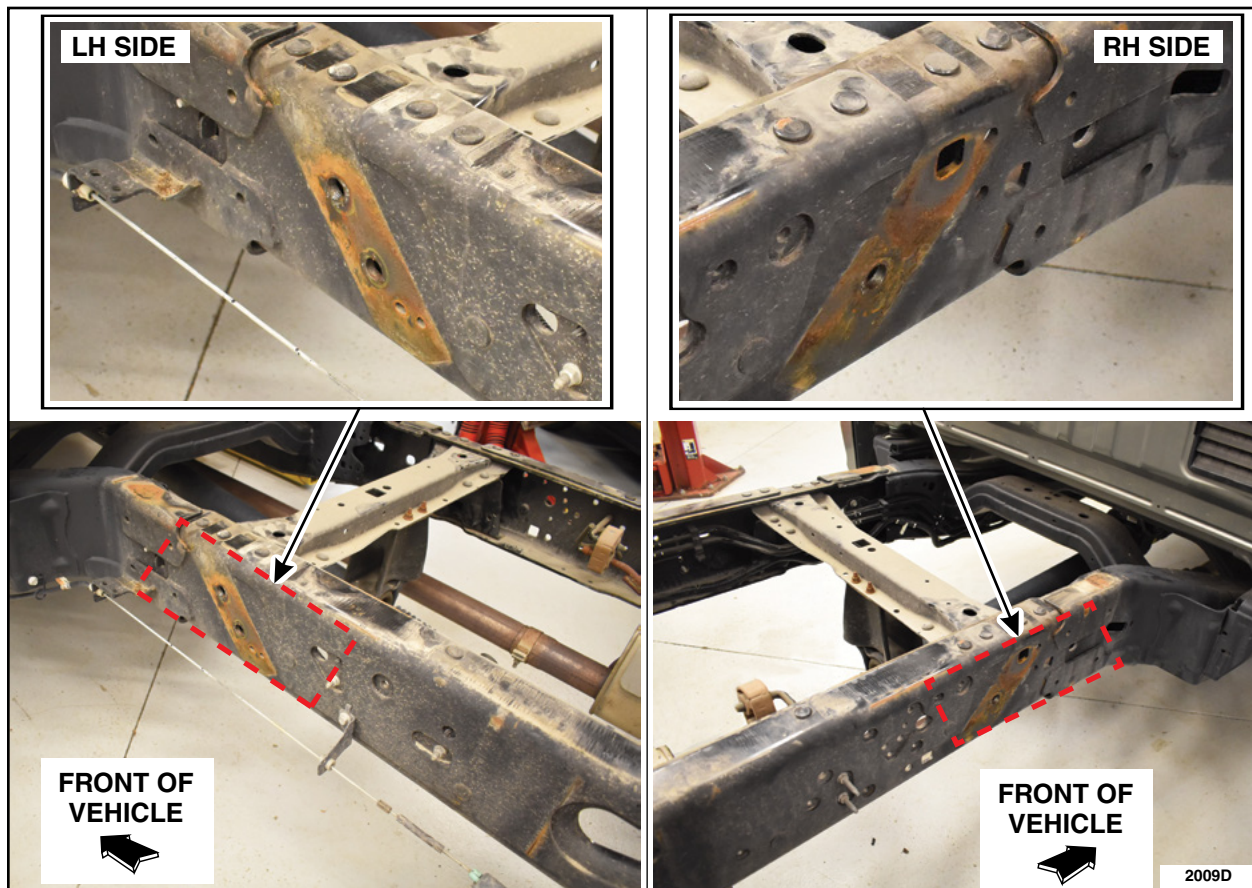
FIGURE 1

1. Identify and inspect the areas where the frame rail may exhibit signs of stress or a crack. Using compressed air, clear any debris that may be on the frame rails in the area of red dashed box. See Figure 1.

- Are there any signs of stress or cracks found on the frame rail?
  - Yes - Contact Special Service Support Center (SSSC).
  - No - Continue to procedure on Page 2.
