BULLETIN

BULLETIN NUMBER:
CB22-E-001

FTR STEERING STOP BOLT ASSEMBLY REPLACEMENT – 21V-861
(Transport Canada 2021-679)

- 2018-2021MY Isuzu FTR Vehicles

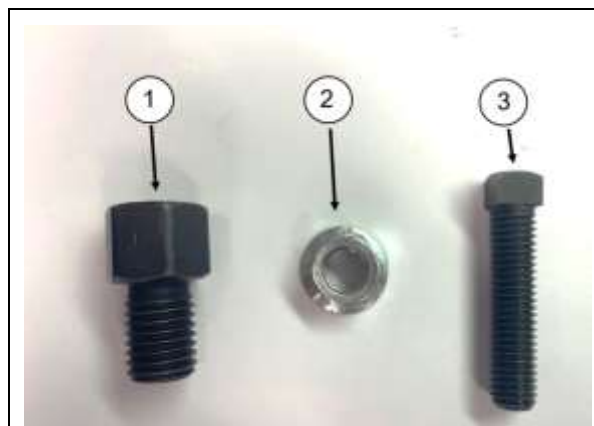
Stop Bolt Kit Components

1. Adapter Base
2. Spirallock Nut
3. Stop Bolt

Isuzu dealers will replace both right and left side stopper bolt assemblies, which include new Spirallock Nuts, and torque the new Spirallock Nut to a new specification. This service will be performed **free of charge**.
