GLOBAL SAFETY FIELD INVESTIGATIONS
DCS6069
URGENT - DISTRIBUTE IMMEDIATELY

Subject: N222359320 - Service Update
Auxiliary Battery Discharge During Idle

Models: 2020 Chevrolet Tahoe
Equipped with Police Package (RPO 9C1) and Content Theft Deterrent
Disabled (RPO UTQ)

N222359320 Auxiliary Battery Discharge During Idle

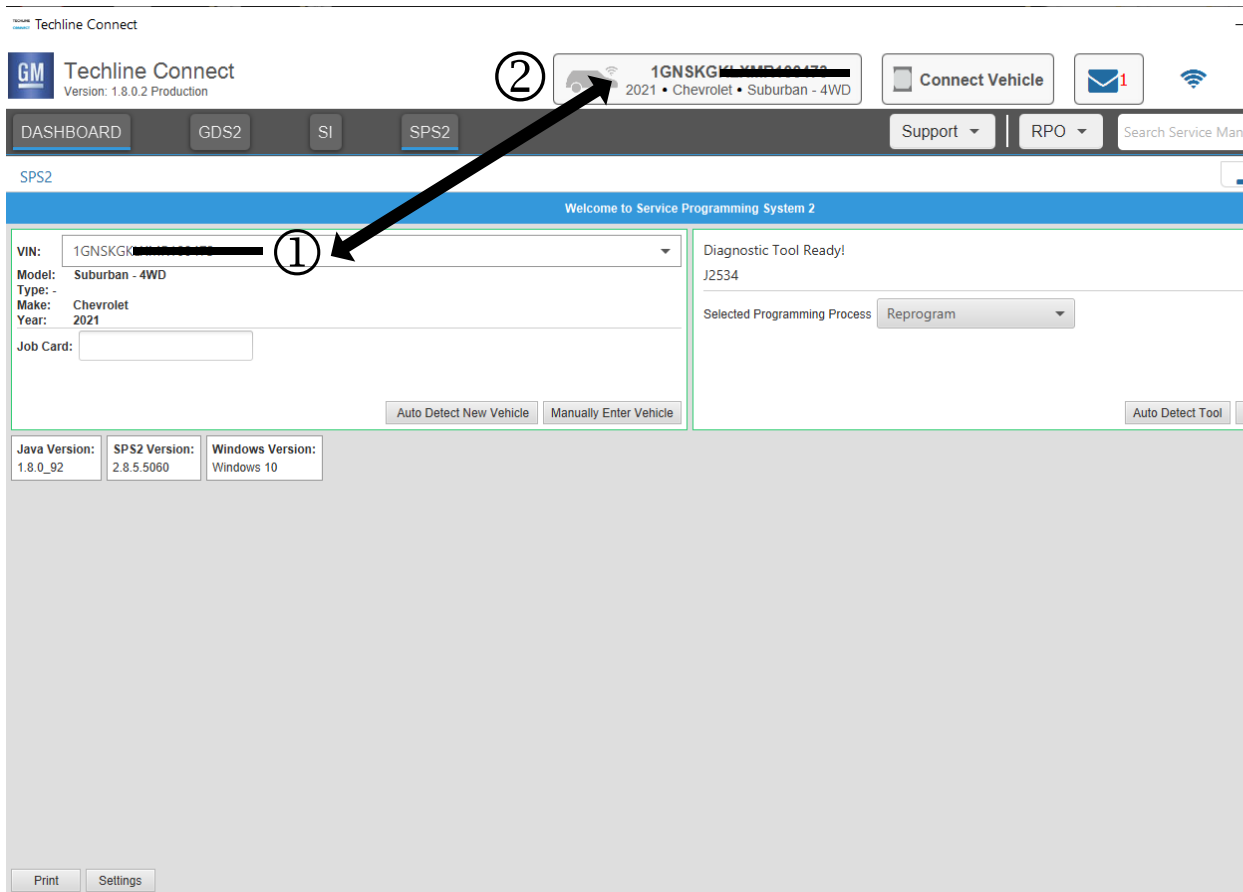
5743643

Caution: Be sure the VIN selected in the drop-down menu (1) is the same as the vehicle connected (2) before beginning programming.

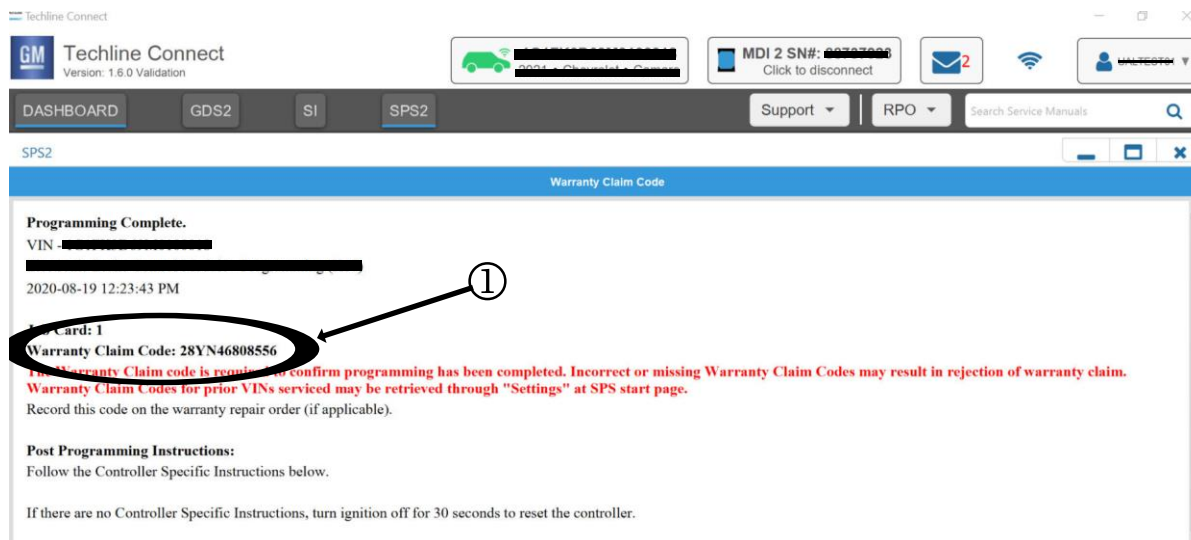
5644478

Important: To avoid warranty transaction rejections, you **MUST** record the warranty claim code provided on the Warranty Claim Code (WCC) screen shown above on the job card. Refer to callout 1 above for the location of the WCC on the screen.

3. Record SPS Warranty Claim Code on job card for warranty transaction submission.
