TECHNICAL SERVICE BULLETIN

Water Leak From A-Pillars And/Or Windshield Header

22-2074
01 March 2022

Ford 2021-2022 Bronco

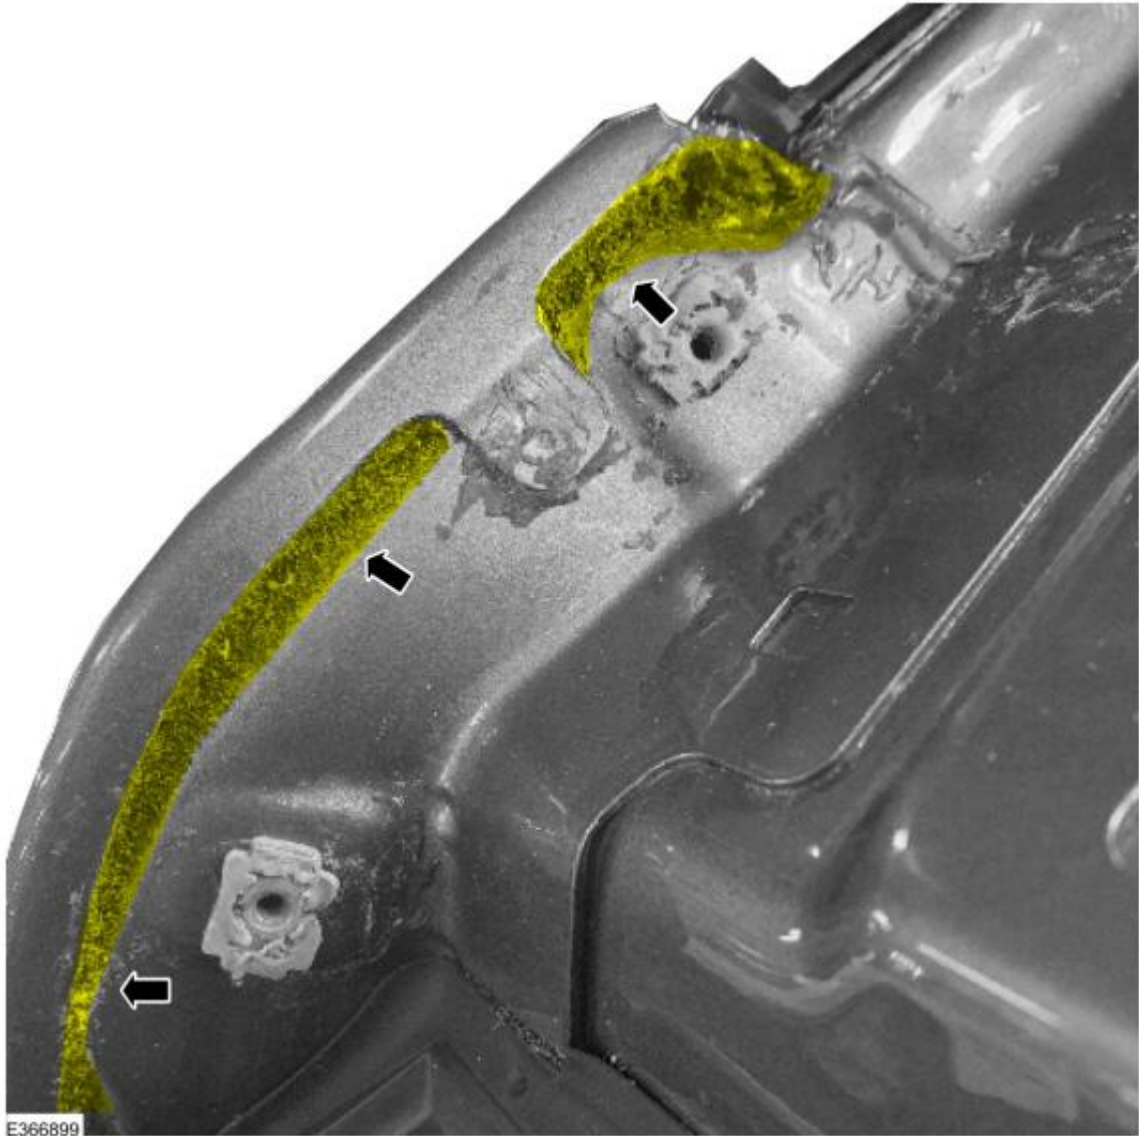
Issue: Some 2021-2022 Bronco vehicles may experience a water leak that originates from the left and/or right A-pillars and/or the windshield header. This may be due to excessive gaps in the body seams from the factory. To correct the condition, follow the Service Procedure to reseal the affected body gaps and replace the front header seal.

5. Clean the header seal mating surface on the body by removing all residual sealer left over from the old header seal. Use a plastic scraper and isopropyl alcohol wipes to clean the surface without harming the painted surface. If any painted surfaces are scratched during the cleaning process, touch up these areas with paint (covering any exposed metal) prior to proceeding.
6. Follow the instructions on the container to apply 3M™ Strip-Calk to the exposed body seams starting at the roof rack trim cover area and ending at the corner seal where the body seam ends. Do not leave a gap between the edge of the caulk and the corner seal. (Figures 5-8)
