# **TECHNICAL SERVICE BULLETIN**

## 22-2077

# Creaking/Squeaking/Grinding/Rubbing Noise While The Steering Column Is Adjusted Into Tilt Up Or Down Position

**Lincoln** 2020-2022 Corsair

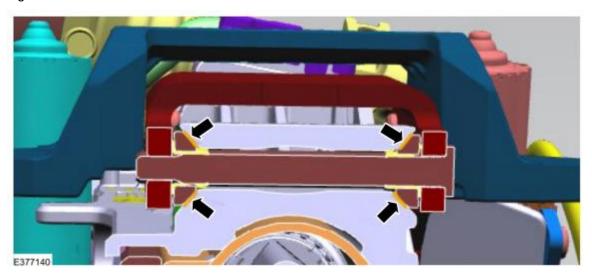
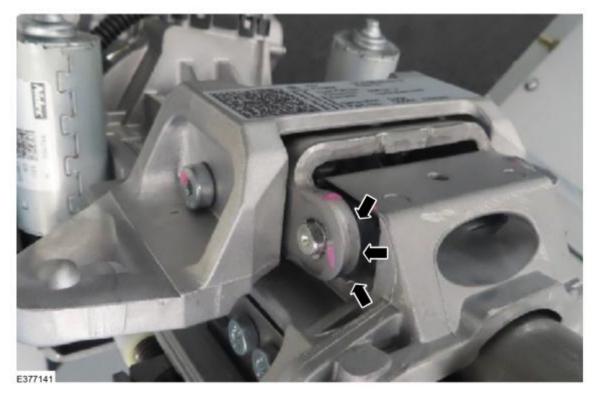
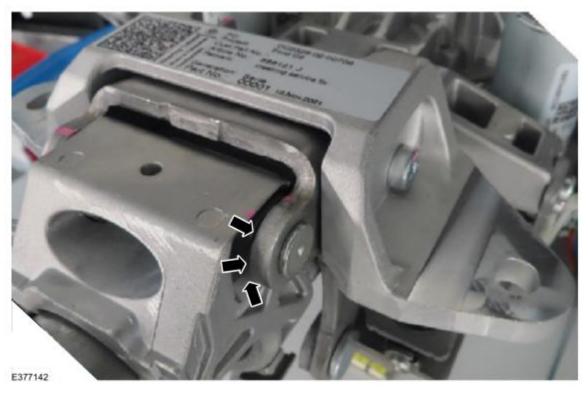
**Issue:** Some 2020-2022 Corsair vehicles equipped with a power adjustable steering column may exhibit a creaking/squeaking/grinding and/or rubbing noise while the steering column is adjusted into the tilt up or down position. This may be due to a lack of lubrication in the steering column. To correct this condition, follow the Service Procedure to perform a grease application in the steering column.

- **1.** Remove the steering column shrouds. Refer to Workshop Manual (WSM), Section 501-05 > Interior Trim and Ornamentation > Removal and Installation.
- **2.** Adjust the steering column with the steering column control switch into the full tilt down position to maximize accessibility.
- 3. Apply Motorcraft® Premium Long-Life Grease at the location shown in Figures 1-3 with a brush.
