# Technical Service Bulletin

SUBJECT:		No: <b>TSB-22-23-001REV</b>	
<b>POTENTIAL TRANSMISSION SHUDDER/SURGE WITH POSSIBLE DTC (CVT-8) - REVISED</b>		DATE: <b>February 2022</b>	
		MODEL: <b>See below</b>	
CIRCULATE TO:	<input type="checkbox"/> GENERAL MANAGER	<input checked="" type="checkbox"/> PARTS MANAGER	<input checked="" type="checkbox"/> TECHNICIAN
<input checked="" type="checkbox"/> SERVICE ADVISOR	<input checked="" type="checkbox"/> SERVICE MANAGER	<input checked="" type="checkbox"/> WARRANTY PROCESSOR	<input type="checkbox"/> SALES MANAGER

Certain vehicles with F1CJC/W1CJC (CVT-8) transmissions may exhibit a shudder or surge condition possibly caused by poor reaction of the hydraulic pressure circuit. With continued driving under these conditions, the CVT belt may slip repeatedly when accelerating, and abrasion powder may enter the hydraulic pressure circuit, causing a warning light to turn on with one of the following DTCs: P0776, P0730, P0741, P084A, P0969, P2719. The shudder/surge condition may also be described as engine flare, lack of acceleration, and/or car shake.

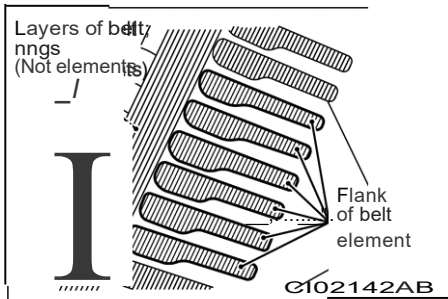
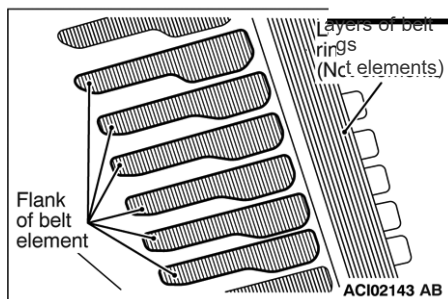
**<OK SAMPLES>**

- No damage is observed on flanks (grooved surfaces) of belt elements.

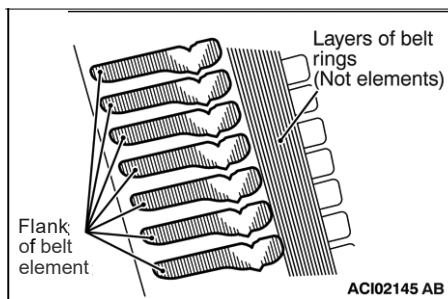
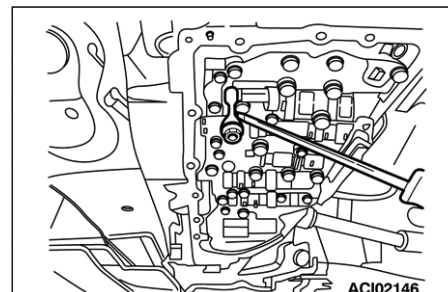
**< DAMAGE SAMPLES >**

- Damages to grooves are observed on flanks of belt elements.

- If damage is found on either side of mating surfaces of the belt, CVT assembly replacement is required.
- If no damage is found on mating surfaces of the belt, a new valve body installation is required. Follow next steps.
