Technical Service Bulletin

GROUP CAMPAIGN	NUMBER 22-01-016H
DATE FEBRUARY, 2022	MODEL(S) PALISADE (LX2)

SUBJECT: FRONT DOOR LOWER GARNISH REPAIR PROCEDURES
(SERVICE CAMPAIGN 975)

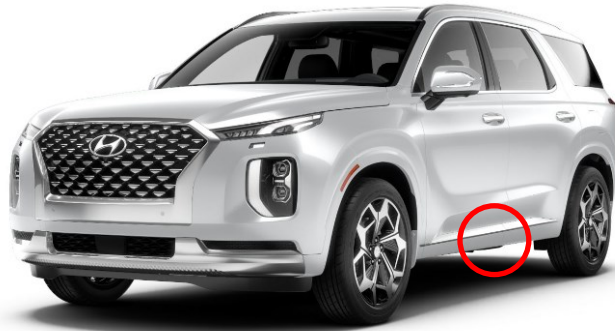
Description: Certain 2020 – 2022MY Palisade (LX2) vehicles may have been produced with a rough edge on the front door lower garnishes during manufacturing. This bulletin describes the procedure to repair the condition.

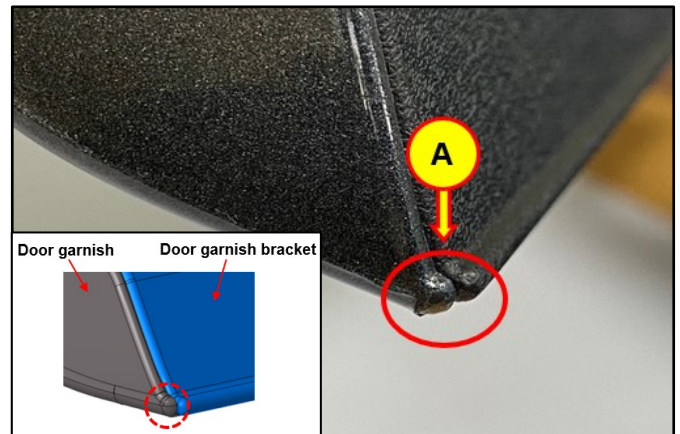
2. Inspect the lower corner where the door garnish and door garnish bracket (A) meet.

The part to be corrected is the door garnish, not the door garnish bracket.
