## **SERVICE BULLETIN**

**SB-21-025 S-SERIES VEHICLES SUBJECTED TO  
FLOOD CONDITIONS**

**GROUP: 0-GENERAL  
BULLETIN NO: SB-21-025  
DATE: 2-22-2022  
REF: SB13-X-001A**

**Subject:** 2022MY-Current S-Series trucks.

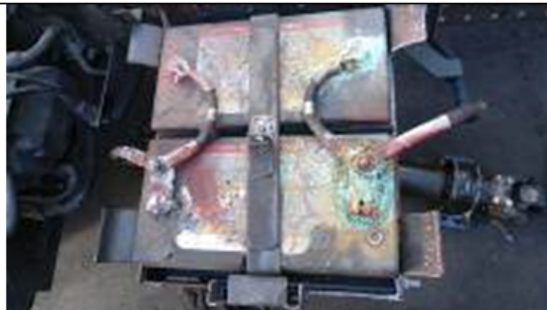
**Figure 1 – Example of Water Damage to Battery**

1. Disconnect battery cables immediately.

**IMPORTANT:** DO NOT attempt to turn on the ignition or start the truck until the extent of the damage has been determined.

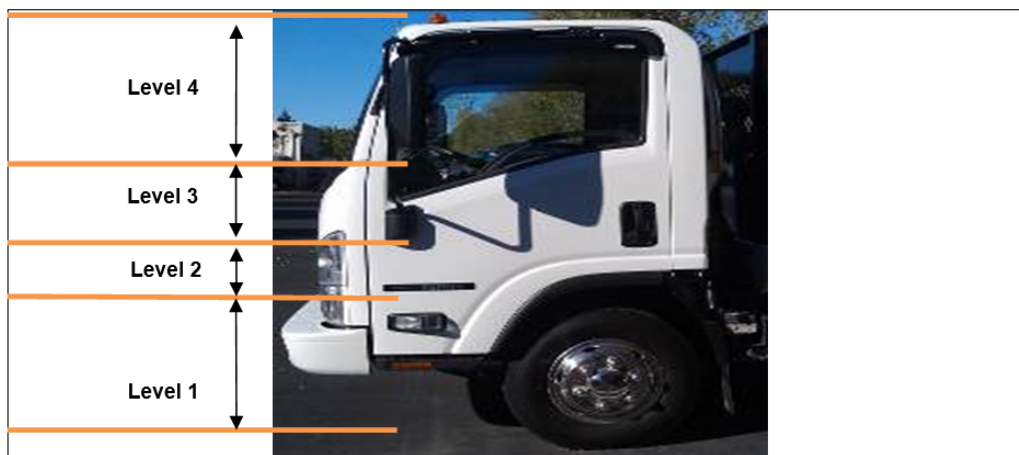
1. Determine the highest level of submersion to allow the assessment of potential damage
  - Level 1 – Under cab floor
  - Level 2 – Under seat rail
  - Level 3 – Under instrument panel cluster meter
  - Level 4 – Above instrument panel cluster meter

Figure 2 – Submersion Level Range

**Note: In most cases if the submersion levels are 2-4 – all harnesses will need to be replaced.**

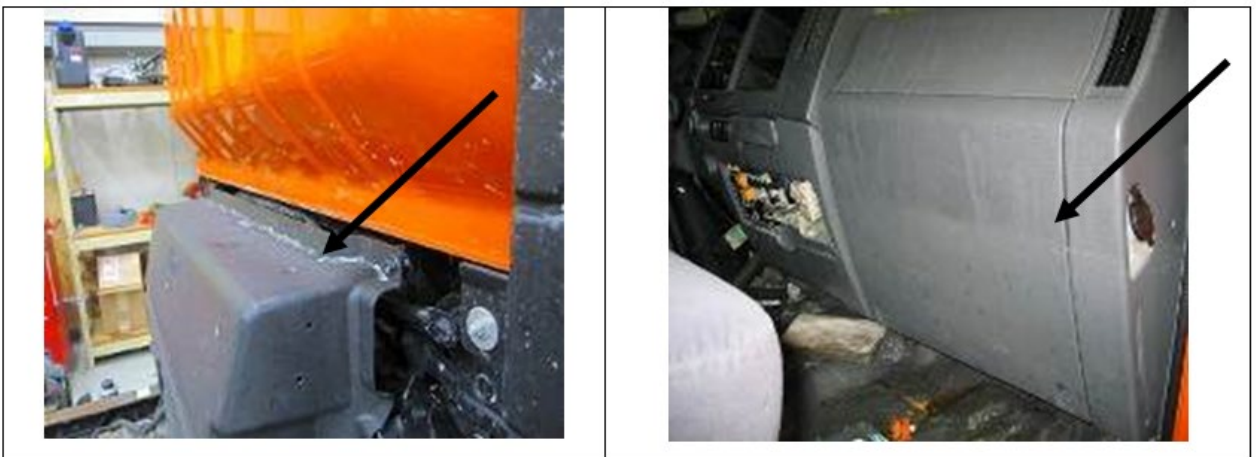
3. Inspect for water lines “witness marks” or water intrusion into components.

- Air cleaner assembly
- DPR/SCR or exhaust assemblies
- Cab and/or frame
- Engine oil dipstick/PCV system
- Transmission vent hose and dipstick
- Power steering and brake fluid reservoirs

**Figures 3-4 – Examples of “Witness Mark” Damage**

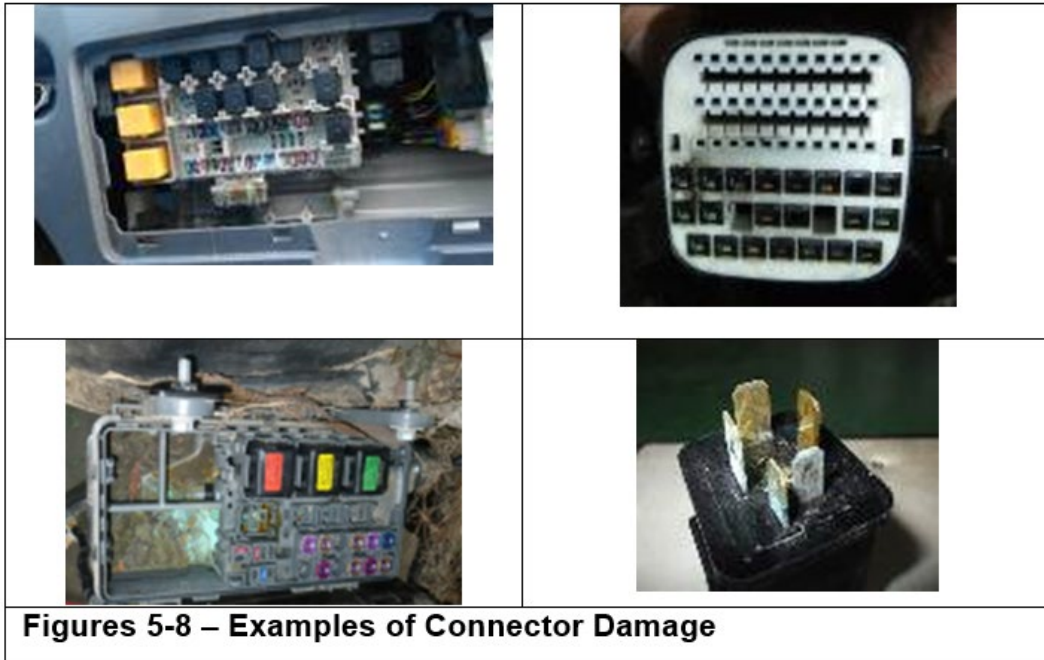
4. Inspect all wire harness connectors that were submerged.

**NOTE: Connectors and modules (whether internal or external) are not designed to be submerged under water and will suffer damage. Once a connector has been submerged for any length of time, it should always be opened up and inspected for water intrusion and corrosion. If the connector cannot be cleaned replacement will be necessary.**

**Figures 5-8 – Examples of Connector Damage**
