# Service Bulletin

Bulletin No.: 21-NA-094

**Subject:** Hood Ajar Message Displayed on Driver Information Center (DIC), Hood May Not Open Using Any Electrical Release Buttons, But Will Open Using Manual Release Cable

Brand:	Model:	Model Year:		VIN:		Engine:	Transmission:
		from	to	from	to		
Chevrolet	Corvette	2020	2021	—	—	All	All

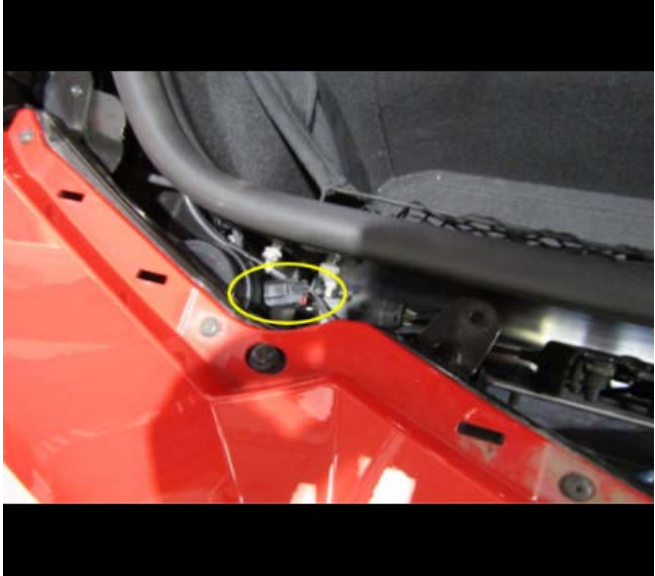
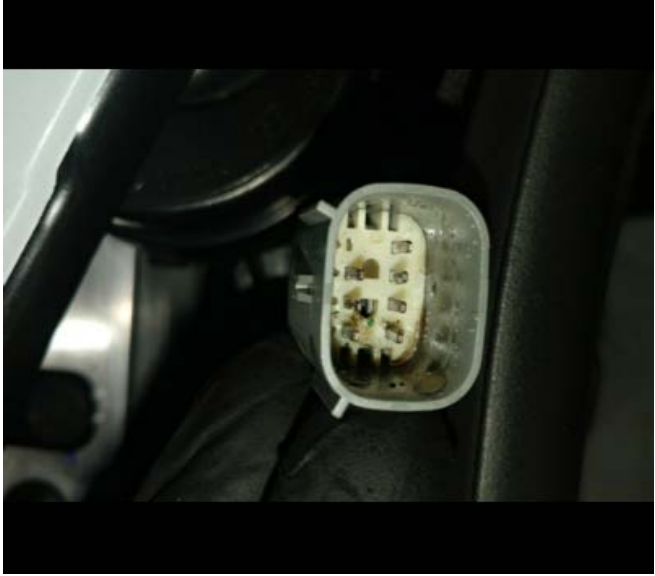
<p><b>Involved Region or Country</b></p>	<p>North America, Middle East, Japan</p>
<p><b>Condition</b></p>	<p>Some customers may comment on a hood ajar message displayed on the DIC. The hood may not open using any of the electrical release buttons but will open using manual release cable.</p>
<p><b>Cause</b></p>	<div style="text-align: right; margin-bottom: 10px;">

<p>5795581</p> </div> <p>The cause of the condition may be any, or a combination of, the bullets listed below:</p> <ul style="list-style-type: none"> <li>• Possible water intrusion and terminal corrosion into connector X103.</li> <li>• Water intrusion into the hood latch actuator itself.</li> <li>• Failure of the auxiliary hood latch release switch.</li> </ul>
<p><b>Correction</b></p>	<p>Verify the Condition and repair following the steps in the Service Procedure below.</p>
