TECHNICAL SERVICE BULLETIN

Technical Service Bulletin: 37-1478

TECHNICAL SERVICE BULLETIN 37-1478 REMEDY INSTRUCTIONS

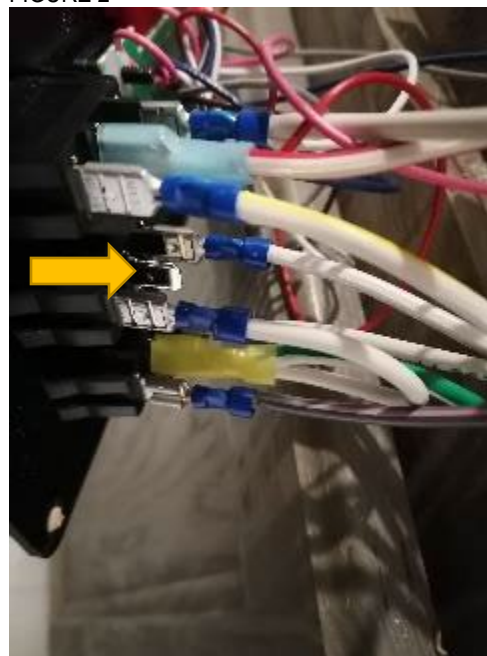
FIGURE 2

The water heaters electric element is wired incorrectly at the control panel switch. If a user attempts to turn the electric element on, the switch will only illuminate.

STEP 3: LOCATE THE WIRE THAT IS PLUGGED INTO THE SWITCHES' TOP SPADE CONNECTER. DISCONNECT THIS WIRE FROM THE TOP SPADE CONNECTER AND PLUG IT INTO THE EMPTY SPADE CONNECTER THAT IS IN THE CENTER OF THE SWITCH FIGURE 2;
