39-20-01 - Bevel Box Case Half Leak

Release date: 3/1/2022

Condition

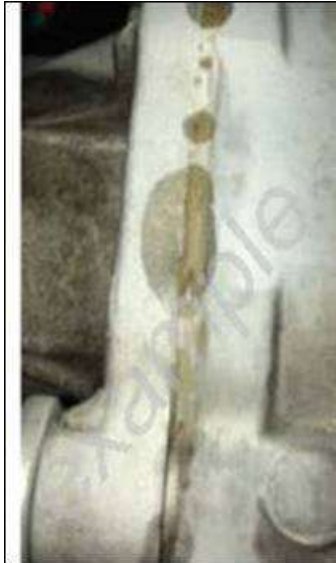
Figure 1.

Gear oil leak from the case halves of the bevel box due to currently used sealant type (Figure 1).

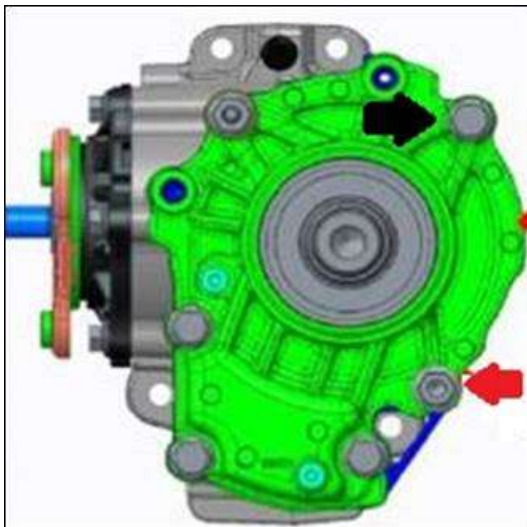
Figure 2.

Source of leak is between the case halves at the right side of the bevel box between the two bolts seen in Figure 2 (red and black arrows).
