## SERVICE BULLETIN

BT09-052I

NTB09-081I

### WINDSHIELD CRACKING

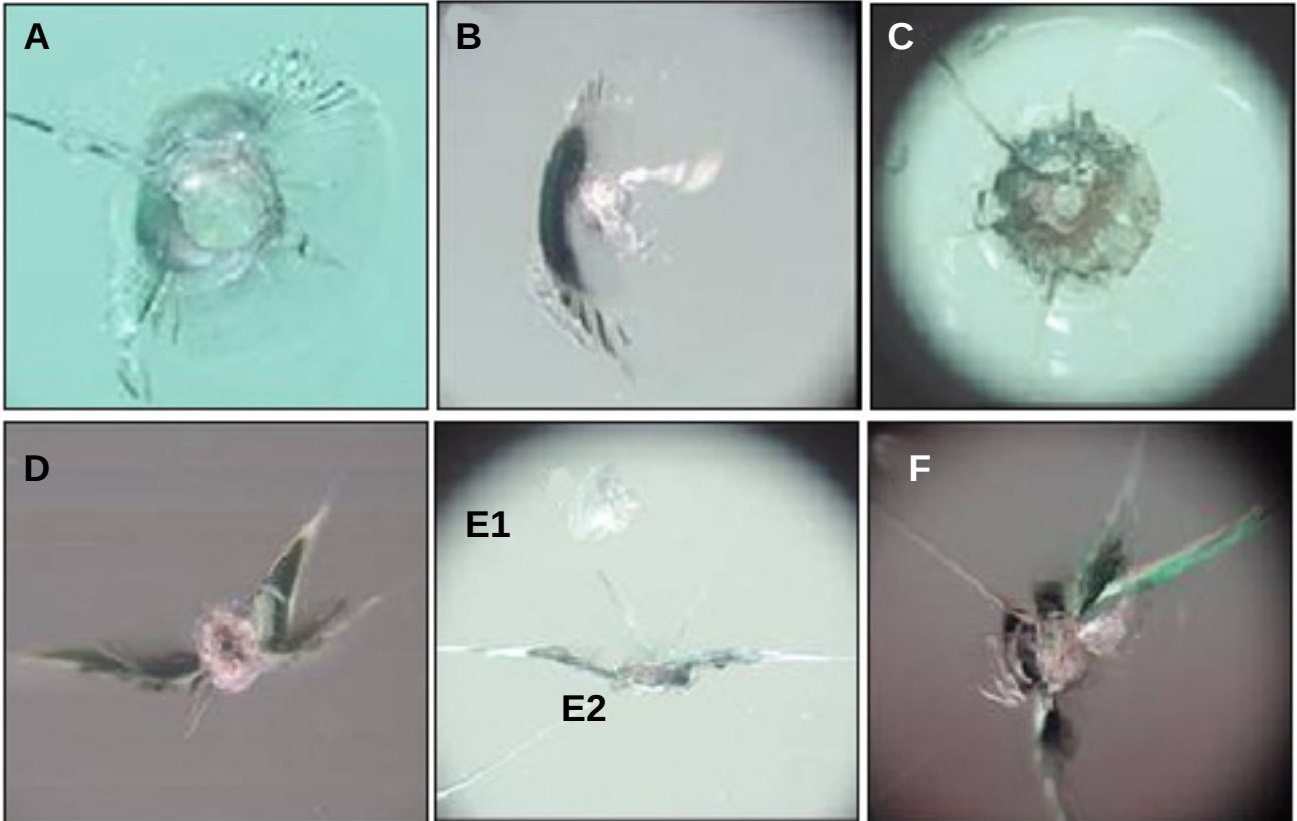
Most windshield damage that occurs due to impact is easily identified as shown below:

- Cone shaped break (A, B, C)
- Crush mark (D, E1, F)
- Star shape crack (C, D, E2, F).

Cracks can spread and become larger from the original strike point or crush mark due to:

- Thermal stresses caused by temperature fluctuation.
- External physical stresses, such as hand touch, wind force, or vehicle vibration during driving (pot holes).

A lead, or crack from one of the star cracked impact points can run to the edge of the glass and **appear** to be a low stress crack starting from the glass outside edge.

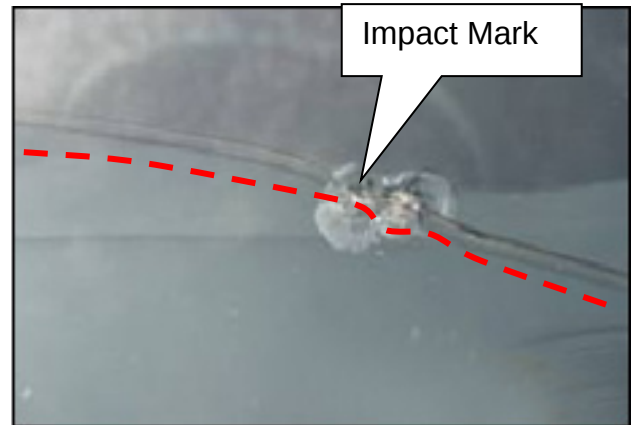
**NOTE:** A lead, or crack from an impact point can run to the edge of the glass and appear to be a low stress crack starting from the glass outside edge.

Single crack with impact mark:  
**Not Warranty**

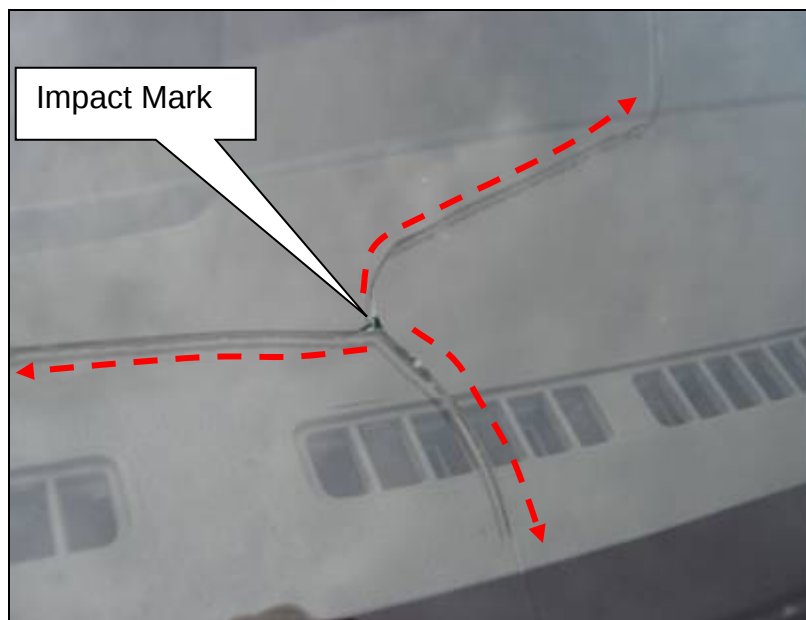
This type of crack is always caused by impact to the glass. The point of impact is located where the crack "branches out".

Compound crack: **Not Warranty**

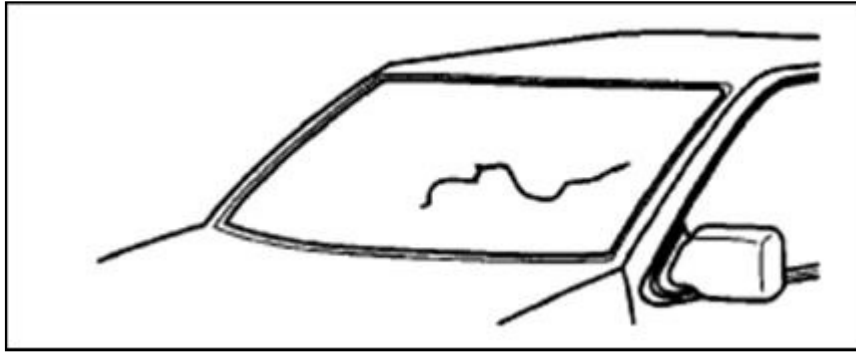
This type of crack does not begin or end at the edge of the glass.

- These cracks are always caused by an impact to the glass and are not covered under warranty.

Cracks not reaching the edge: **Not Warranty**

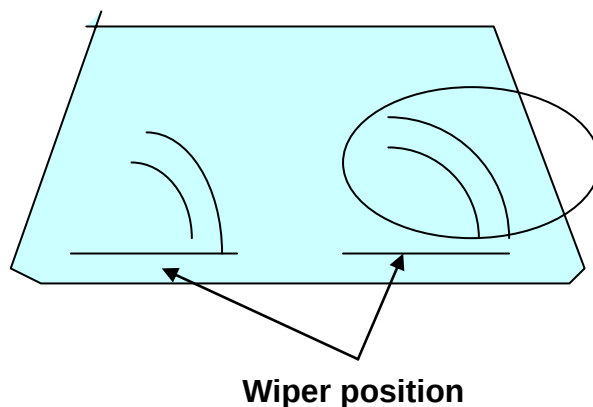
A magnifying glass (10X magnification) may be necessary to identify wiper scratches as a start point of cracks in the glass.

- Inspect the wiper paths (may be a single scratch of a group of scratches).
- Small scratches can cause a small rupture in the outer glass surface, which can lead to a crack from thermal conditions, vehicle vibration during driving, or wind pressure.

Scratch from sand/stone: **Not Warranty**

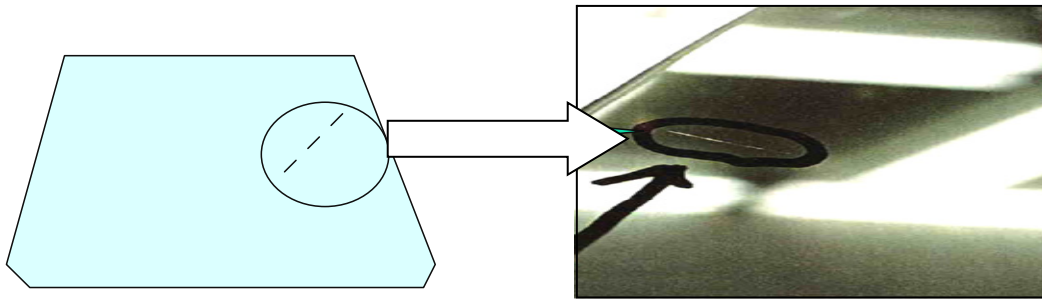
A magnifying glass (10X magnification) may be necessary to identify metal object scratches as a start point of cracks in the glass.

- Scratches can occur from metal objects such as keys and metal buttons. These scratches are typically sharp and can be found anywhere on the glass surface.
- Thoroughly examine the entire length of the crack to identify any scratch as a start point.
- Small scratches can cause a small rupture in the outer glass surface, which can lead to a crack from thermal conditions, vehicle vibration during driving, or wind pressure.

Scratch from metal objects: **Not Warranty**

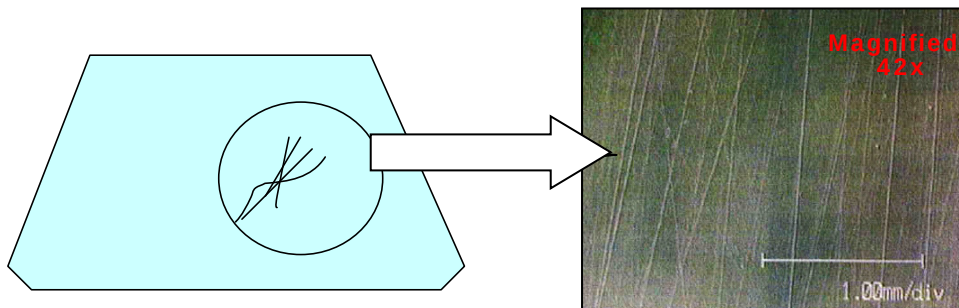
A magnifying glass (10X magnification) may be necessary to identify scratches caused by a contaminated towel as a start point of cracks in the glass.

- Scratches can occur from wiping the glass with a towel that has sand particles or dirt on it.
- These scratches are typically long and have several scratches concentrated together.
- These scratches can be found anywhere on the glass surface.
- Thoroughly examine the entire length of the crack to identify any scratch as a start point.

Scratch from dirty towel/cloth: **Not Warranty**

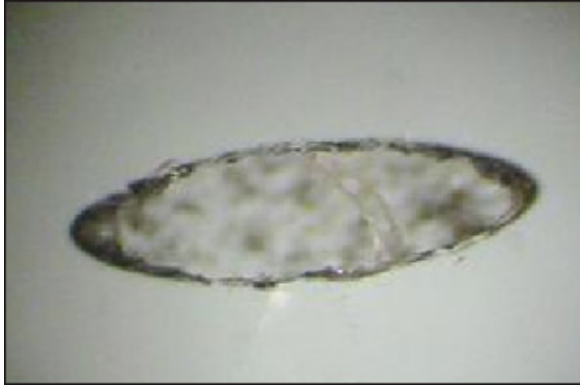
Open bubble – **Warranty**

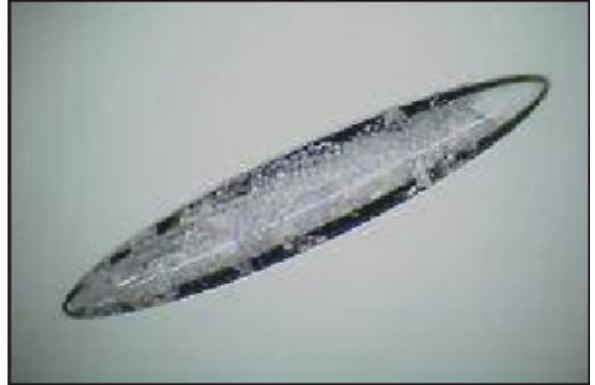
Surface blister - **Warranty**

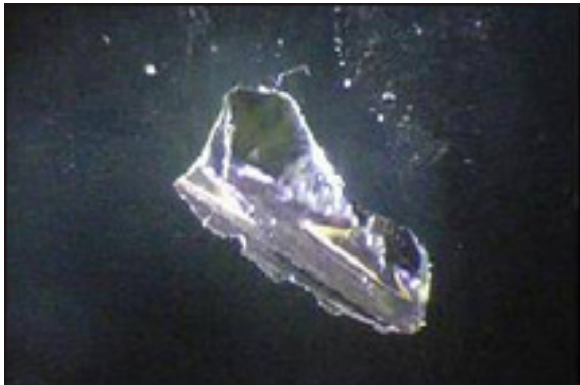
Adhesion chip – **Warranty**  
(Can occur from a manufacturing issue such as adhesion of molding to the glass surface along the glass edge.)

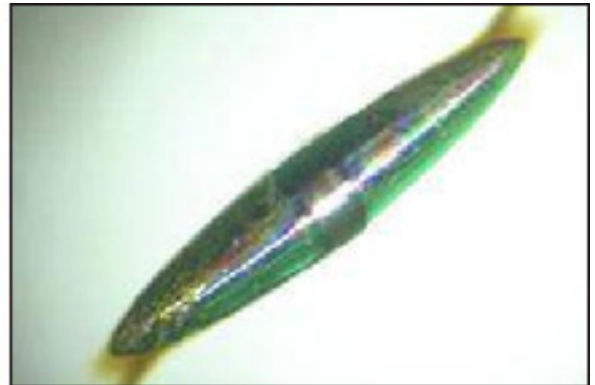
Surface blister – **Warranty**
