# Paint Stains Under Rappgard

**Service Category** Vehicle Exterior

**Section** Paint/Coatings

**Market** USA

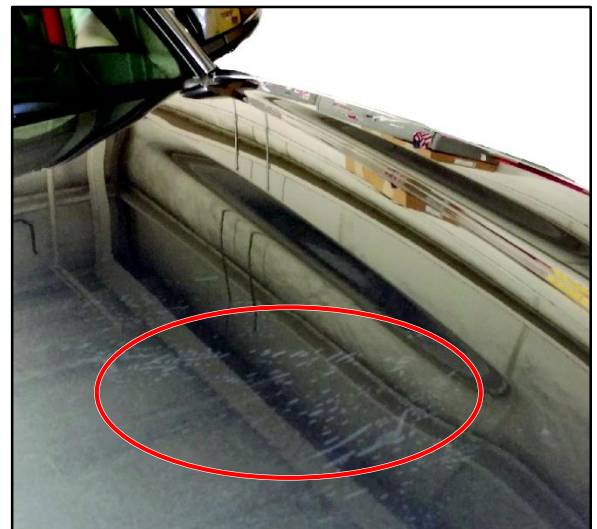
**Figure 1.**

Some 2010 – 2022 model year Toyota vehicles may exhibit paint stains after the removal of Rappgard™. The paint stains may appear to be under the clear coat but are usually under wrinkles in the Rappgard™. The wrinkles may trap water and cause the paint to stain from the trapped moisture, especially on horizontal surfaces such as the hood, roof, and trunk. Follow the Repair Procedure in this bulletin to address this condition.

1. Confirm the condition exists.  
 AFTER Rappgard™ removal, does the vehicle exhibit paint stains as shown?
  - **YES** — Continue to step 2.
  - **NO** — This bulletin does NOT apply. Continue diagnosis using the applicable Repair Manual.

It is NOT necessary to repaint the stained area.

2. Using aluminum foil or a damp cloth, cover ANY plastic and/or rubber parts located near the stain.

3. With an infrared lamp or heat gun, apply heat to the stain for 5 – 10 minutes at 158°F – 176°F (70°C – 80°C).

**Do NOT allow the surface to become hotter than 176°F (80°C). Measure the temperature with a thermometer.**

4. Wait AT LEAST 5 minutes AFTER heat application, then examine the area and determine if the stain has been removed.
