# Harsh 4 - 3 Downshift During Deceleration

YEAR(S)	MODEL(S)	ADDITIONAL INFORMATION	
2020 - 2021	Land Cruiser

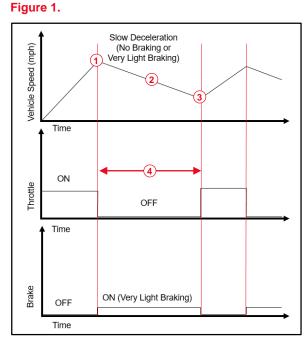
1	35 mph
2	4 – 3 Downshift
3	7 mph
4	About 25 Seconds

- 3. BEFORE performing the targeted self-learning procedure, confirm the following:
  - The transmission fluid level is acceptable.
  - The transmission fluid temperature is between 122°F 230°F (50°C 110°C).
  - There is a flat road surface available (no hills).
  - There is a smooth road surface available.
  - There are NO DTCs present.
- 4. Perform the targeted self-learning procedure until the condition is no longer present or up to 14 times.
  - A. While the vehicle is in Drive (D), accelerate to above 35 mph.
  - B. Decelerate the vehicle to 7 mph with very light braking (coasting is best).
  - C. Do NOT make any turns to keep a gradual deceleration speed.
  - Repeat this procedure until the condition is no longer present or up to 14 times.
- 5. Test-drive the vehicle to confirm the condition is no longer present.
