# SERVICE CAMPAIGN BULLETIN

Classification: EC21-016	Reference: NTB22-006	Date: February 9, 2022
-----------------------------	-------------------------	---------------------------

## VOLUNTARY EMISSION SERVICE CAMPAIGN 2013-2016 SENTRA; ECM REPROGRAM AND OXYGEN SENSOR VOLTAGE INSPECTION

**CAMPAIGN ID #:** P1A25  
**APPLIED VEHICLES:** 2013-2016 Sentra (B17) – SULEV only

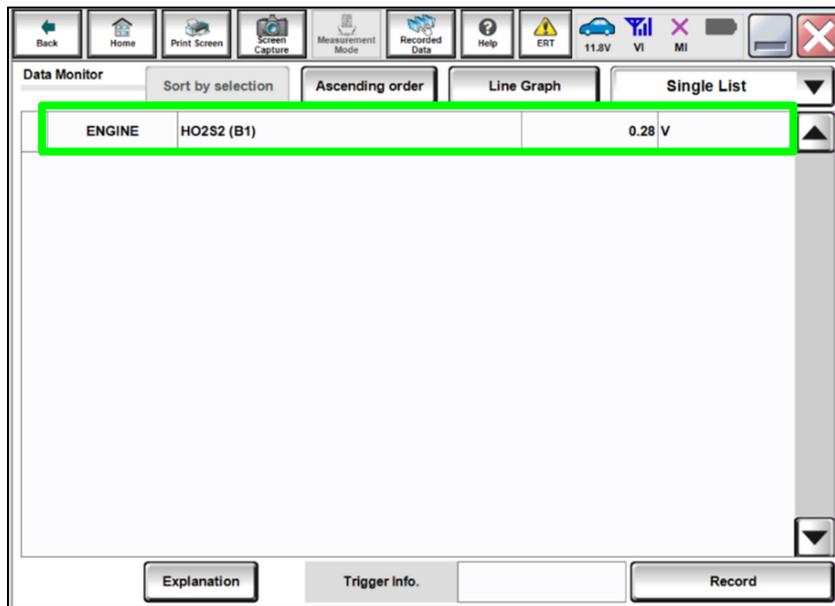
Figure 6

9. Check the Rear O2 Sensor (**HO2S2 (B1)**) voltage in the data monitor screen (Figure 6).
  - If the **HO2S2 (B1)** voltage is 0.13 V or above, no further action is needed. The inspection result is **OK** and the **SERVICE PROCEDURE** is complete, skip to **CLAIMS INFORMATION** on the last page.
  - If the **HO2S2 (B1)** voltage is less than 0.13 V, the rear O2 sensor has a short to ground condition and the inspection result is **NG**.
    - a. Print the data monitor screen and attach it to the repair order.
    - b. Diagnose and repair the Rear O2 Sensor short to ground condition by following the diagnosis steps outlined in the ESM for DTC P0137 (HO2S2).
      - Refer to the ESM: **ENGINE > ENGINE CONTROL SYSTEM > MRA8DE > DTC/CIRCUIT DIAGNOSIS > P0137 HO2S2 > Diagnosis Procedure**

**NOTE:** Follow the diagnosis and repair procedure even if DTC P0137 is not present.
    - c. Proceed to step 10 to perform the drive pattern to set the System Readiness Test (SRT) status.
