# Technical Service Bulletin

**26 Noises are heard from the exhaust at idle, DTCs P047600, P048C00, P04A000, or P301B00 are stored in the ECM**

26 22 48 2058998/4 March 10, 2022. Supersedes Technical Service Bulletin Group 26 number 21-45 dated May 18, 2021, for reasons listed below.

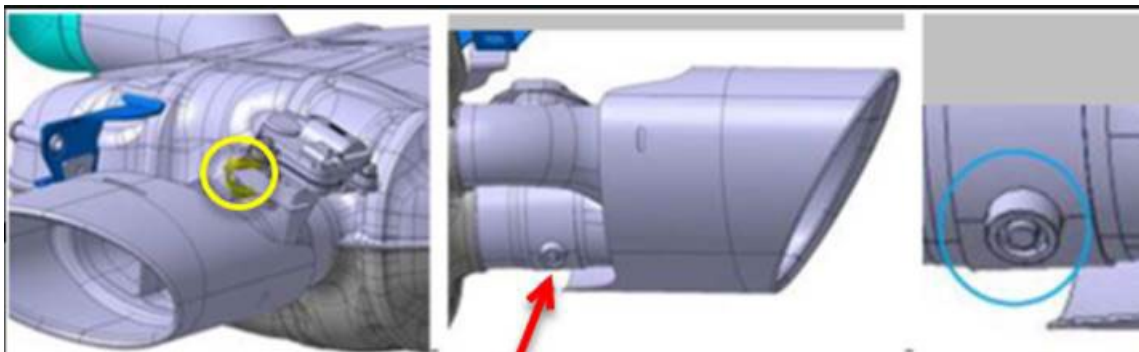
Figure 2. Old rear silencer.

- A. Old version (Figure 2): C-bracket (marked yellow) and moveable bearing (blue). **It is not compatible with an optimized control motor.** The complete rear silencer has to be replaced.

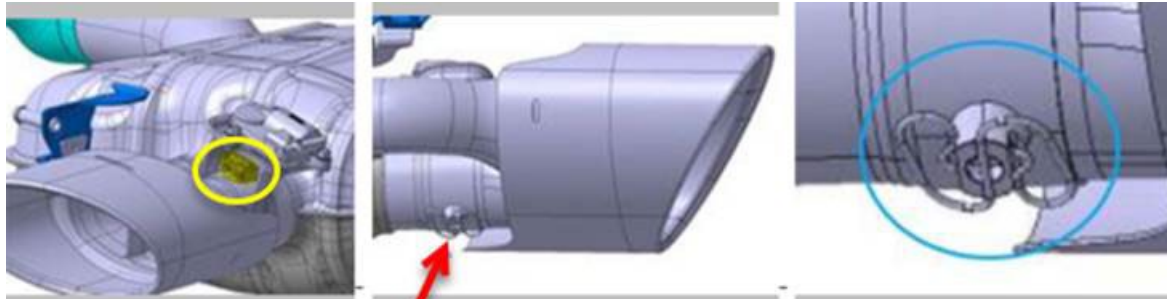
**Figure 3.** The optimized version of the rear silencer.

- B. Optimized version (Figure 3): claw coupling (marked yellow) with spring lock (blue). Check which version of the control motor is fitted: If the control motor fitted is not the new version (part number 8S0 133 246 D), replace it individually on the exhaust flap with the concern.
