Customer Satisfaction Program

N212346580 Block Heater Restore

Release Date: March 2022

Condition	Certain 2017-2019 model year Chevrolet Silverado 2500/3500 and GMC Sierra 2500/3500 vehicles equipped with the Duramax diesel 6.6 liter engine and the optional engine-block heater cord, may have a condition in which the block heater cable function was disabled.
Correction	Dealers will replace the engine block heater and cord.

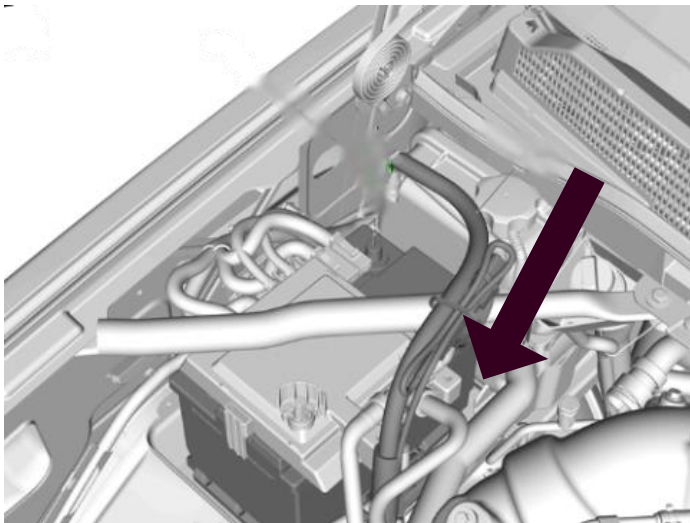
1. Remove the new service engine heater power cord from the box and uncoil the cord.
2. Lower the engine heater element end of the new power cord to the underside of the vehicle.

- Start lowering the cord inboard of the battery toward the front of dash.

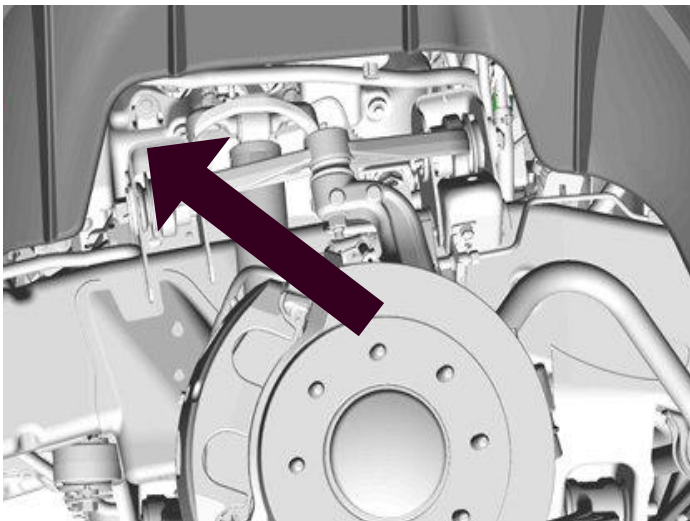
- It should come out in the area identified above.

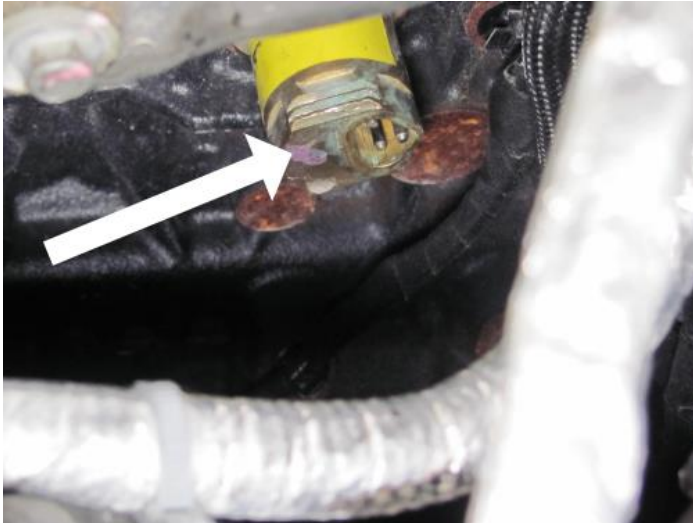
3. Raise the vehicle and remove the right front wheel. Refer to *Tire and Wheel Removal and Installation (8-Lug Wheel)* in SI.
4. Remove the right front wheelhouse liner. Refer to *Front Wheelhouse Liner Replacement - Right Side* in SI.
5. Looking through the area between the frame and suspension, locate the engine block heater.

Note: It is not necessary to drain the radiator. The engine block coolant will be drained when the engine coolant heater is removed.

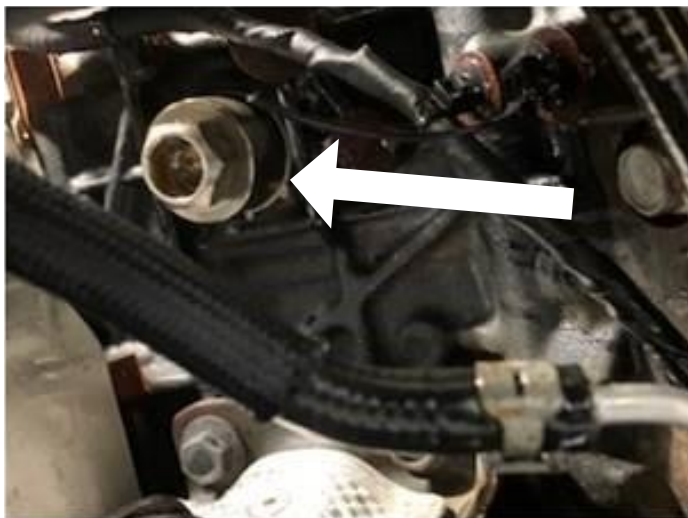
6. Place a large drain pan under the vehicle to capture the coolant. Remove the engine coolant heater. Refer to *Engine Coolant Heater Replacement (L5P)* in SI.
7. After removing the original block heater, take care to remove the old cured thread sealant in the block. Failure to remove the old thread sealant will result in cross threading or binding of the replacement block heater.

Caution: Do not under torque the engine coolant heater. This can result in a coolant leak. A torque wrench, with tactile or audible feedback when torque has been achieved, should be used. Tighten to 90 N.m. (66 lb ft). DO NOT OVERTIGHTEN. Hand start the block heater carefully and secure at least 3 full turns before further tightening with a socket wrench.

Note: The new engine block heater element has the thread sealer applied at the time of manufacture. DO NOT INSTALL ADDITIONAL SEALER to the threads.

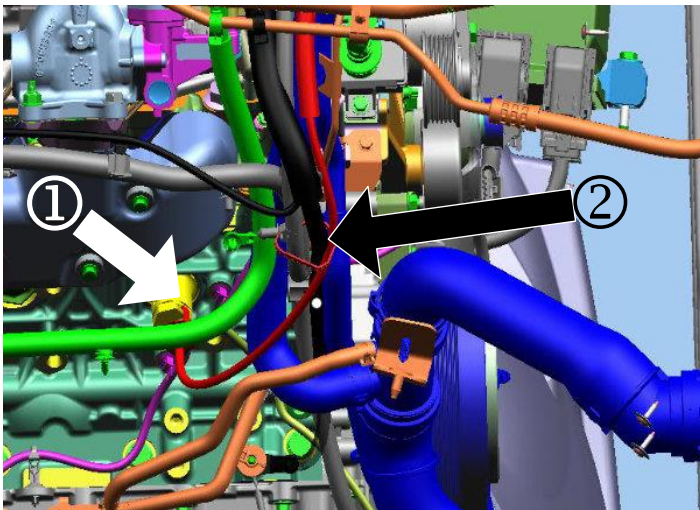
5495375

10. Slide the new power cord forward in the vehicle, toward the coolant heater element. Place the power cord connector near the coolant heater element. DO NOT CONNECT the power cord to the heater element at this time, it will be connected after the cooling system pressure test.

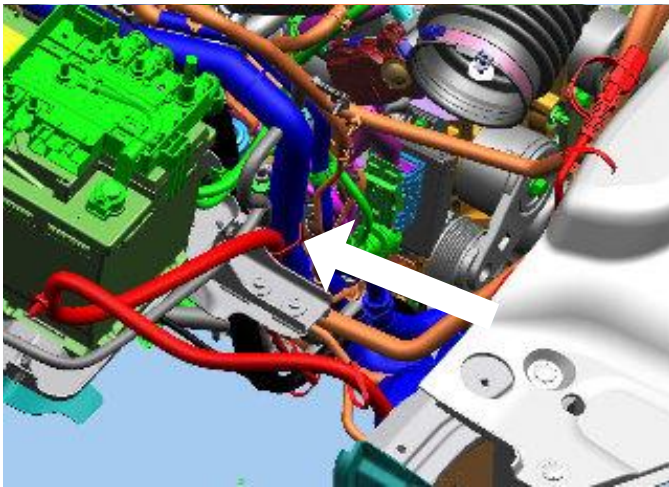
5495378

11. Route the new engine coolant heater power cord (shown in red) to the upper motor compartment. Begin at the Element (1) and secure the wire tie (2) around the negative battery cable (black) and the engine chassis harness (grey).
12. Lower the vehicle.

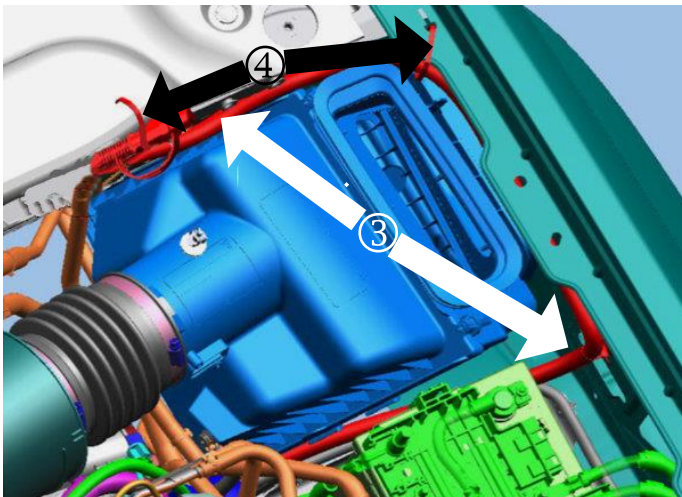
5946413

13. Route the power cord (shown in red) as shown and secure to the surge tank hose (blue) with a wire tie.

Engine Compartment Routing Overview

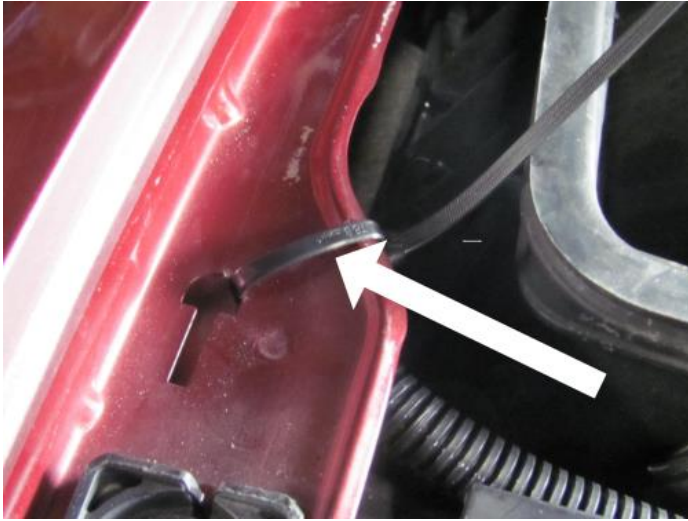
5420817

14. Position the power cord along the inner fender and secure to the existing hole using the first (closest to the heater element) push pin wire tie attached to the harness.

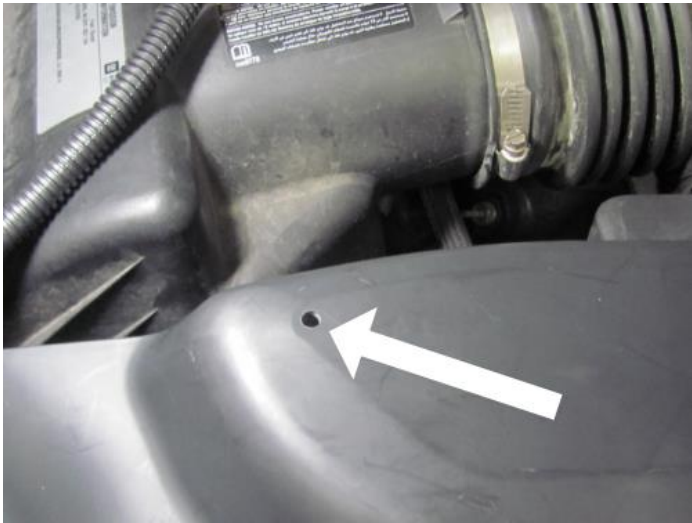
5420819

16. Locate the drill location on the front compartment front sight shield. Mark the location.

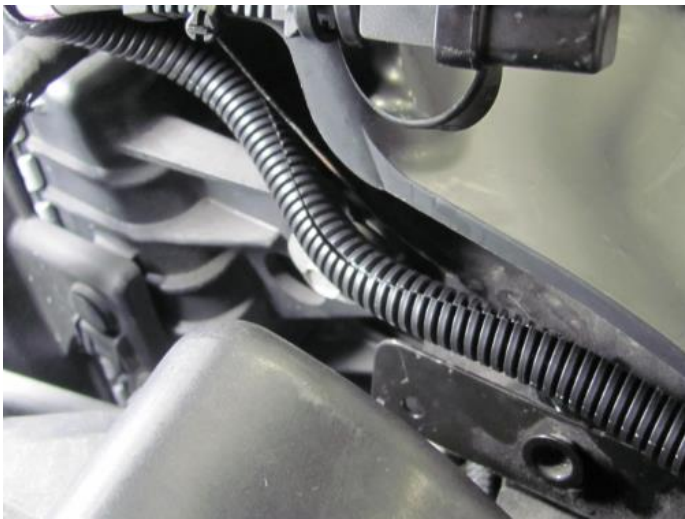
5420820

17. Drill a 5mm (13/64 in.) hole in the marked area. Use care to not damage components below the drill location.
18. Route the power cord from the fender flange area under the front compartment front sight shield.

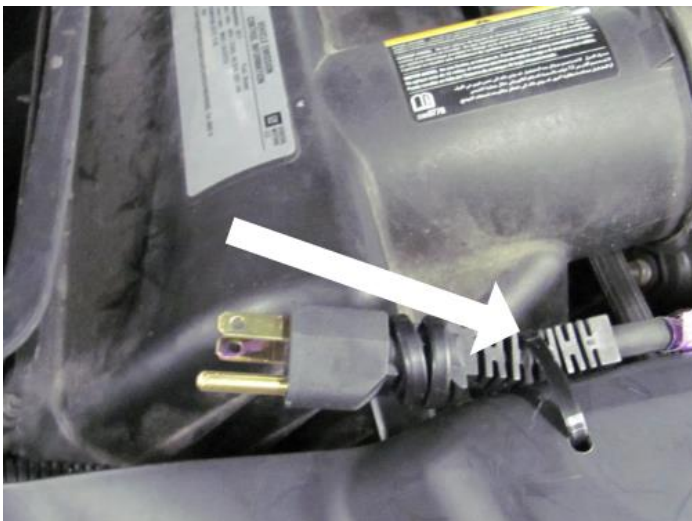
5420823

19. Create a gentle bend in the power cord and place the power cord plug over the hole in the site shield. Ensure the prongs on the power cord plug are facing toward the right fender.

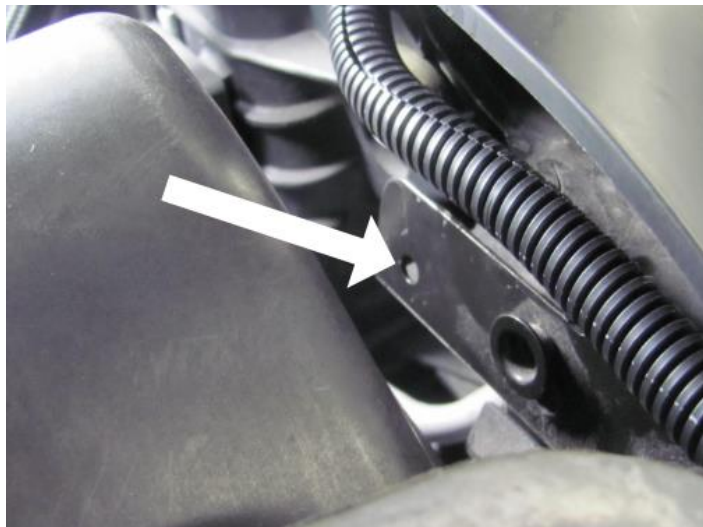
5420824

20. Secure the power cord plug to the to the front compartment front sight shield with a wire tie as shown. Ensure the prongs are facing toward the right front fender.

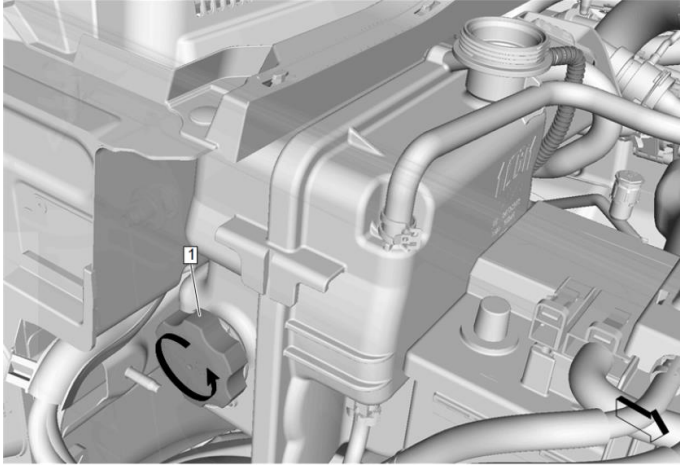
5443211

30. Remove the leak testing equipment from the surge tank.

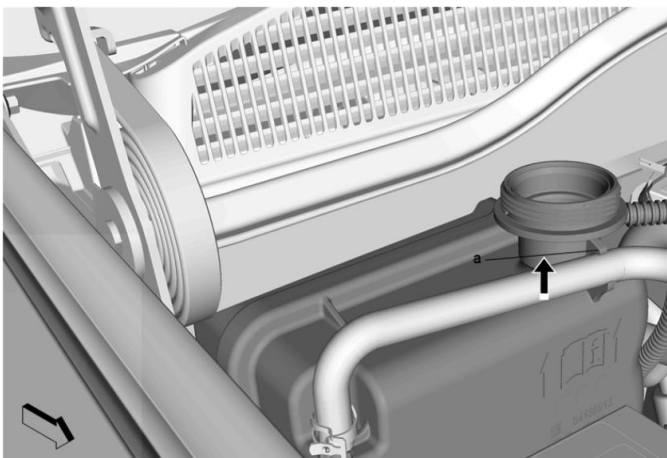
5443214

32. Using a funnel, slowly fill the radiator surge tank with **1.6 L (2 qt)** of coolant to fill the lower radiator surge tank chamber. The overflow tube will flow to the left and down as shown above, and slowly move to the lower radiator surge tank chamber.

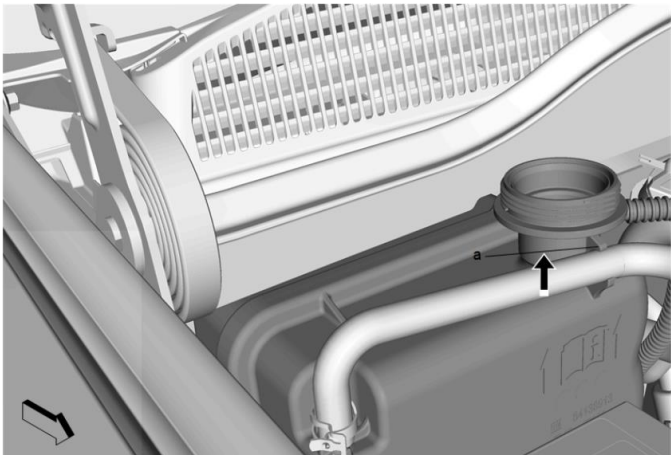
5443214

35. If the coolant level is below the fill neck level shown (a) add coolant to the fill neck level shown.
