Service Bulletin

Bulletin No.: 20-NA-219

Subject: Gurgle or Sloshing Noise Heard Coming from Front Sunroof Drain Hose Areas

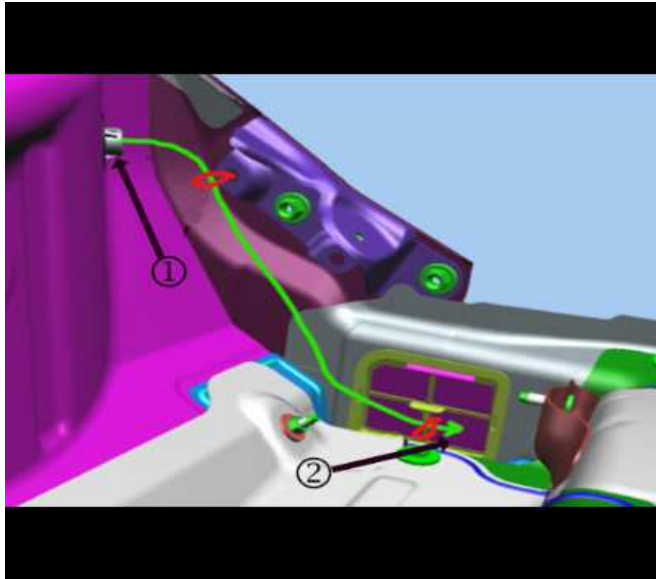
Involved Region or Country	North America, Middle East, Russia, Chile, Colombia, Peru, Thailand, Japan, Ecuador and S. Korea.
Additional Options (RPOs)	Equipped with ROOF-SUN, GLASS, SLIDING, ELEC, TRANSPARENT GLASS FIXED (C3U)
Condition	Some customers may comment on hearing a gurgle or sloshing noise coming from both, front right and front left, sunroof drain hose areas. The condition usually presents itself after a rain soak/car wash, and when driving approximately 80-112 km/h (50-70 mph). Also, the noise is commonly more evident with the HVAC OFF, and when HVAC and Recirculate is on.
Cause	The cause of the condition may be that where the sunroof front drain hose grommets exit in the plenum, the pressure in the plenum may potentially be too high to allow water to exit as designed.

<p>Note: An illustration of the driver side hose is shown in the graphic above.</p> <p>Following the steps in the Service Procedure below, add drain hose extensions to both the right and left sides. These extension hoses will attach to the existing sunroof front drain hose grommets (1) in the plenum and then exit out the plenum drain valve (2), on that side of the vehicle.</p> <p>5677469</p>
-------------------	--

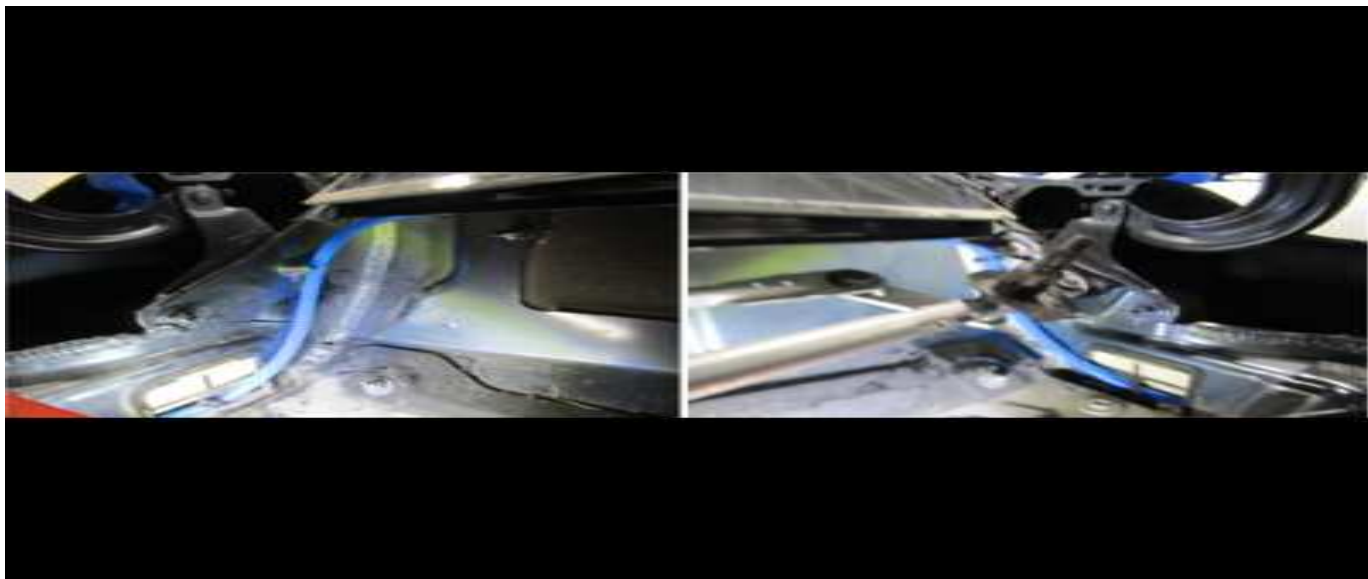
5677480

Note: The graphic above shows the hose installation completed on both the passenger and driver sides.
