39-20-01 - Bevel Box Case Half Leak

Release date: 3/17/2022

Applicable Vehicles					
Model(s)	Year	Eng. Code	Trans. Code	VIN Range From	VIN Range To
Arteon	2019-2021	All	All	All	All
Atlas Cross Sport	2020-2021	All	All	All	All
Atlas	2018-2021	All	All	All	All
Tiguan	2018-2021	All	All	All	All

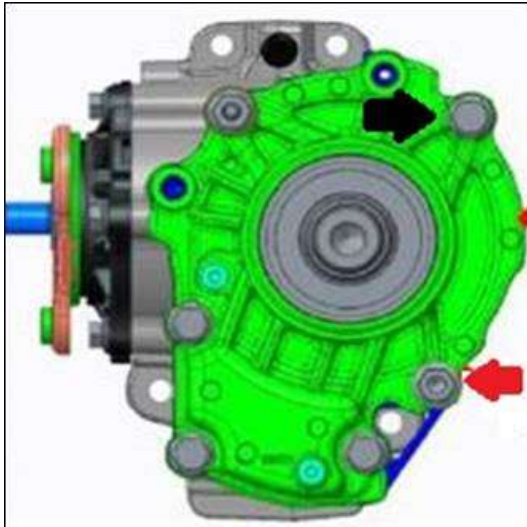
Figure 1.

Source of leak is between the case halves at the right side of the bevel box between the two bolts seen in Figure 1 (red and black arrows).
