Technical Service Bulletin

01 Noises/rattling from turbocharger (V6 2.9 L. TFSI)

01 22 18 2066547/1 March 21, 2022.

Model(s)	Year	VIN Range	Vehicle-Specific Equipment
RS 5, and RS 5 Sportback	2021	All	Not Applicable

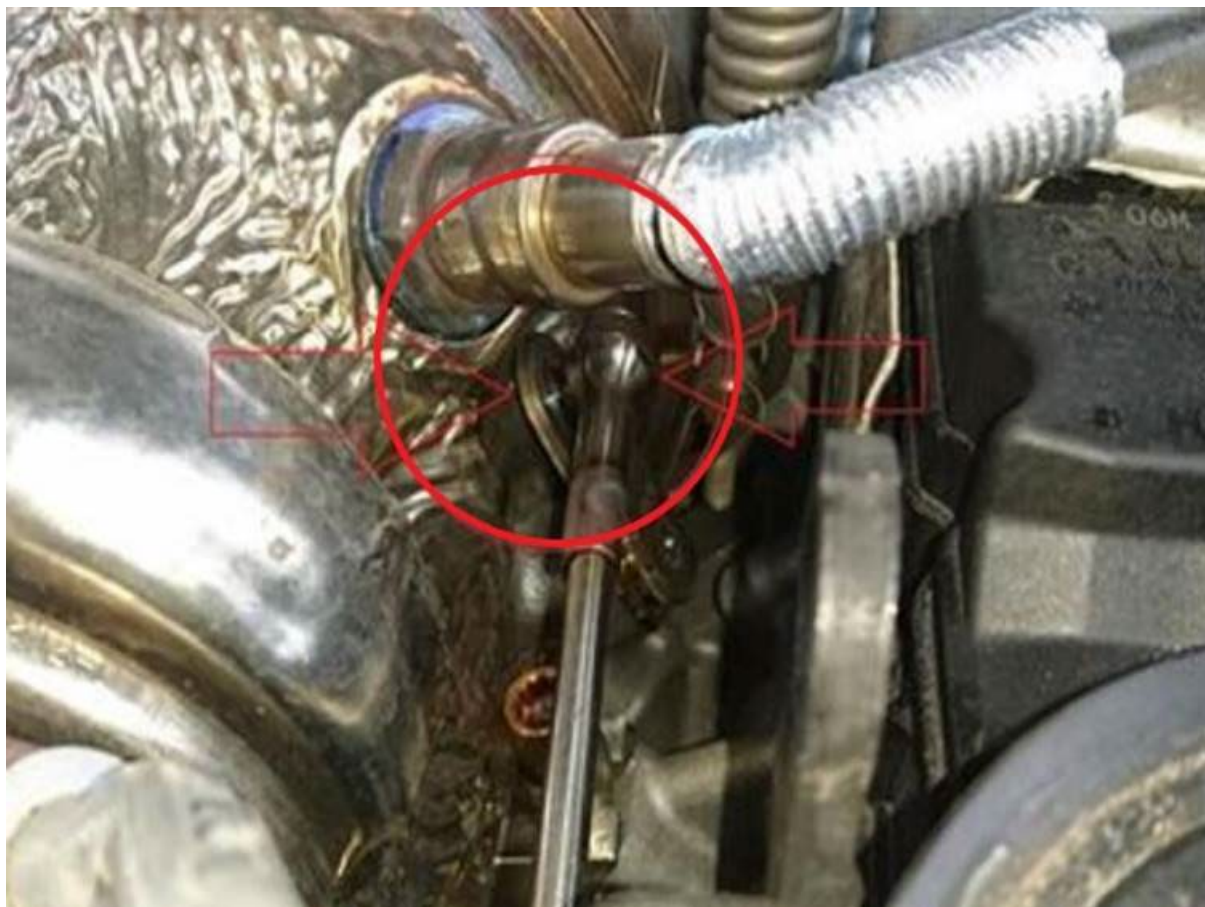
The customer complaint can be reproduced. Slight play at the turbocharger wastegate flap linkage causes a rattling noise when the engine speed tails off.

Please update the engine control module J623 (address word 0001) using the software code below.

SVM code: 01A264
