Technical Service Bulletin

63 Paint peeling from the rear bumper cover

63 22 09 2066451/1 March 16, 2022.

Model(s)	Year	VIN Range	Vehicle-Specific Equipment
A3, and S3	2022	All	Not Applicable

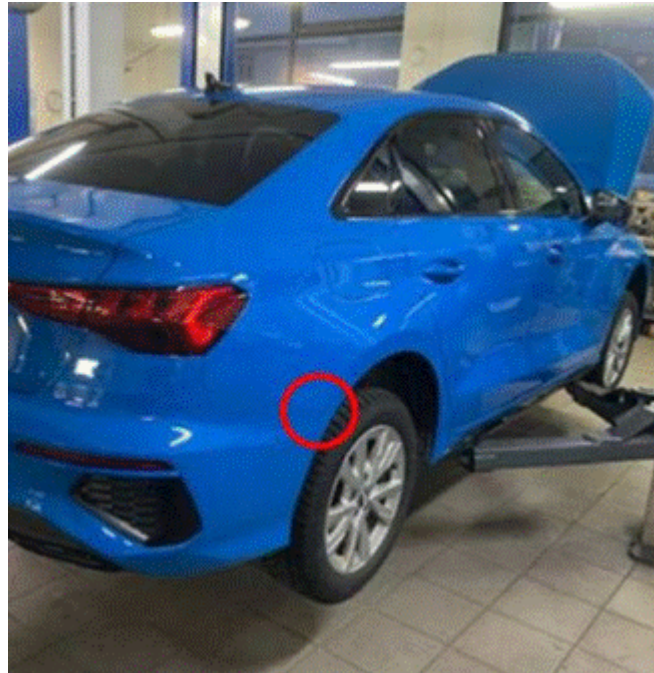
The rear bumper paint appears to have lost its adhesion. The paint peel is located on the right, left, or both sides of the cover specifically where the bumper cover meets the rear side panel.

An inconsistency in the production process of the rear bumper cover – specifically at the edges that meet the rear side panel – caused a weakness, making the painted surfaces on these edges prone to paint peel over time. Either the right side, left side, or both sides of the bumper cover are affected.

1. Figure 1 shows the area of the bumper cover affected.

Figure 1. Bumper cover edge affected.

Should the condition described in this TSB occur the rear bumper cover is to be replaced. Do not attempt to refinish the original bumper cover. Due to the technical nature of the root cause refinishing the original bumper cover will only reintroduce a subsequent paint peel in these areas of the rear bumper cover over time.

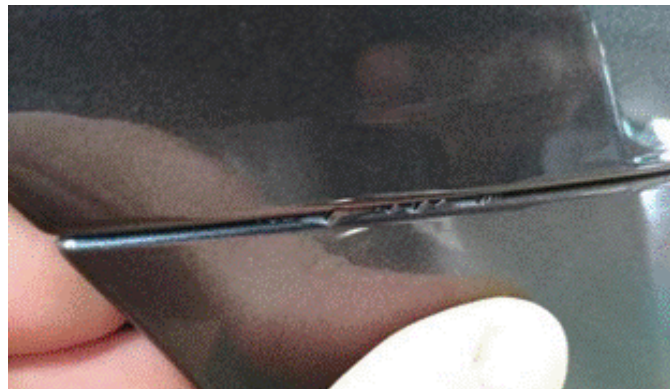
2. Figure 2 shows a close-up view of the paint peel.

Figure 2. Paint peel on the bumper cover edge.

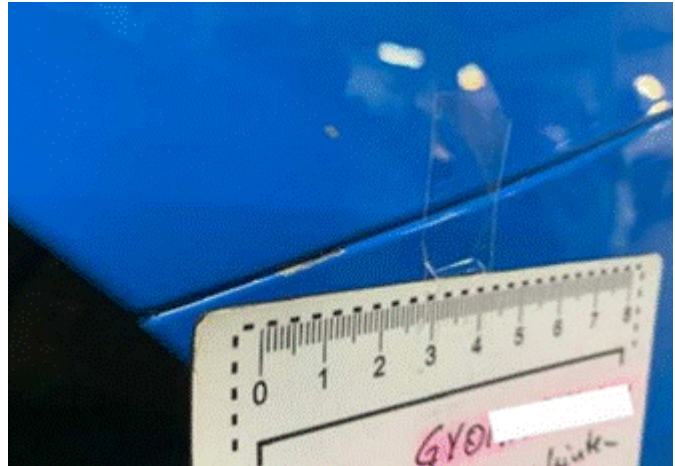
3. Figure 3 shows the condition in its early stages that may evade notice.

Figure 3. Early stages of the peel.

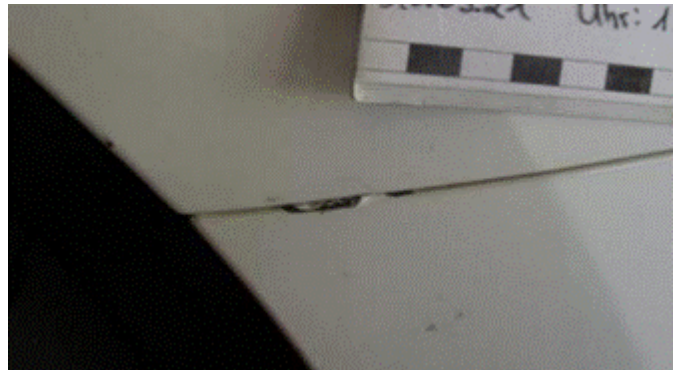
4. Figure 4 shows a more advanced level of paint loss from this area. It can be particularly unsightly with bright colored paints against the dark primer coat.

Figure 4. Advanced paint peel.
