# Service Bulletin

Bulletin No.: 19-NA-242

**Subject:** Information on High Voltage Battery Pack Refurbish Kit

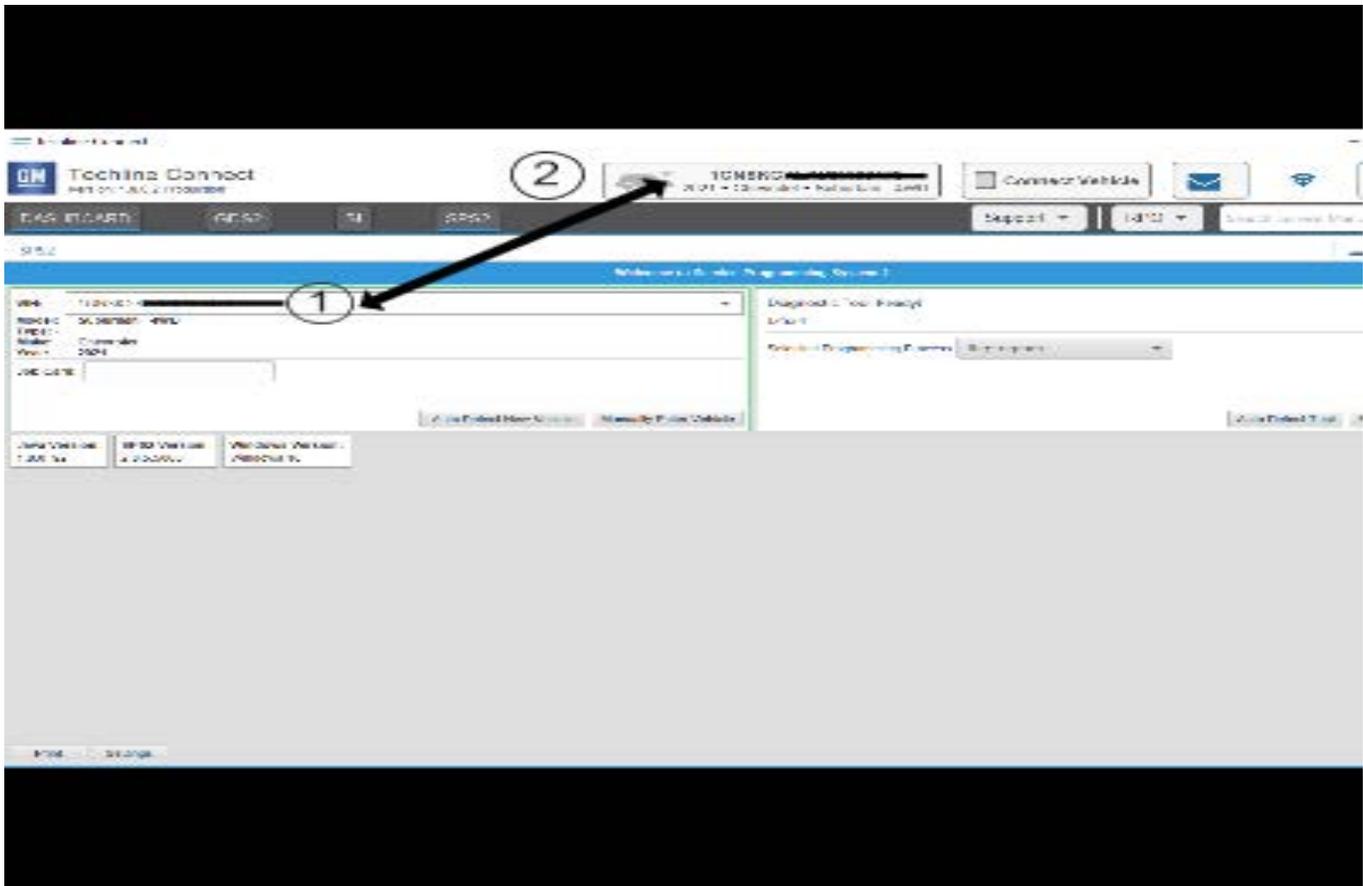
**Caution:** Be sure the VIN selected in the drop down menu (1) is the same as the vehicle connected (2) before beginning programming.

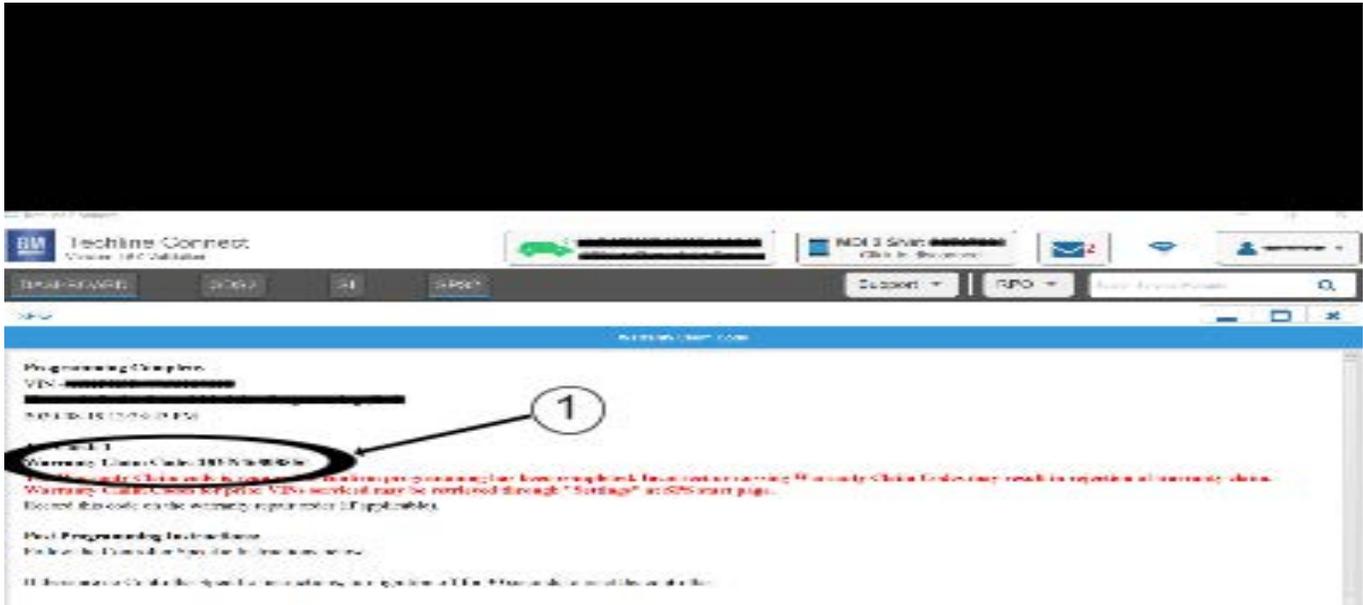
5644478

**Important:** To avoid warranty transaction rejections, you **MUST** record the warranty claim code provided on the Warranty Claim Code (WCC) screen shown above on the job card. Refer to callout 1 above for the location of the WCC on the screen.

2. Record the Warranty Claim Code on the job card for warranty transaction submission.
