# Service Bulletin

Bulletin No.: 20-NA-105

**Subject: 360 Camera Views go Blank with Tailgate Removed**

Brand:	Model:	Model Year:		VIN:		Engine:	Transmission:
		from	to	from	to		
Chevrolet	Silverado 2500HD/3500HD	2020	2022			All	All
GMC	Sierra 2500HD/3500HD	2020	2022

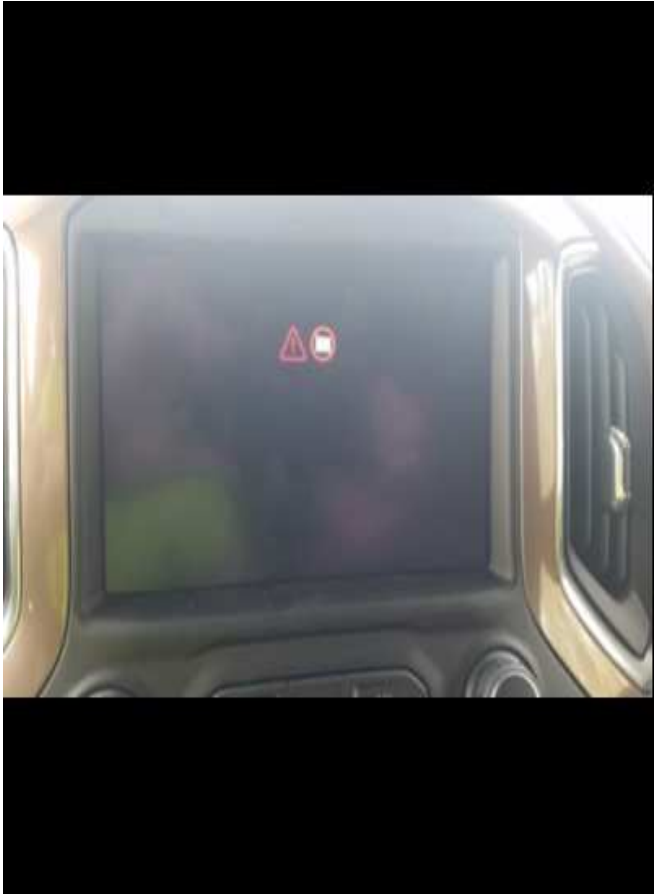
<p style="text-align: right;">5608080</p> <p>This is commonly done by customers who use slide in campers or a low clearance tailgate when pulling fifth wheel trailers</p>

<b>Involved Region or Country</b>	United States, Canada, Mexico, Middle East, Israel.
<b>Additional Options (RPOs)</b>	Equipped with RPO UVS
<b>Condition</b>	<p>Some customers may comment that the 360° camera option (RPO UVS) will lose all camera views when the tailgate is removed.</p>

<b>Cause</b>	The cause of the condition may be that the camera system alerts the customer to a rear camera issue by disabling all camera views if the rear camera is disabled.
<b>Correction</b>	<b>Important:</b> This repair is a customer pay alteration. All work and payment, authorization must come from the customer. For customers who remove the rear tailgate for use with a slide in camper or for clearance for a 5th wheel trailer, a jumper can be installed that will provide usage of the side and front camera. The rear camera view will be blacked out. The following steps must be performed to re-enable the remaining camera views without the tailgate/camera being presently installed.

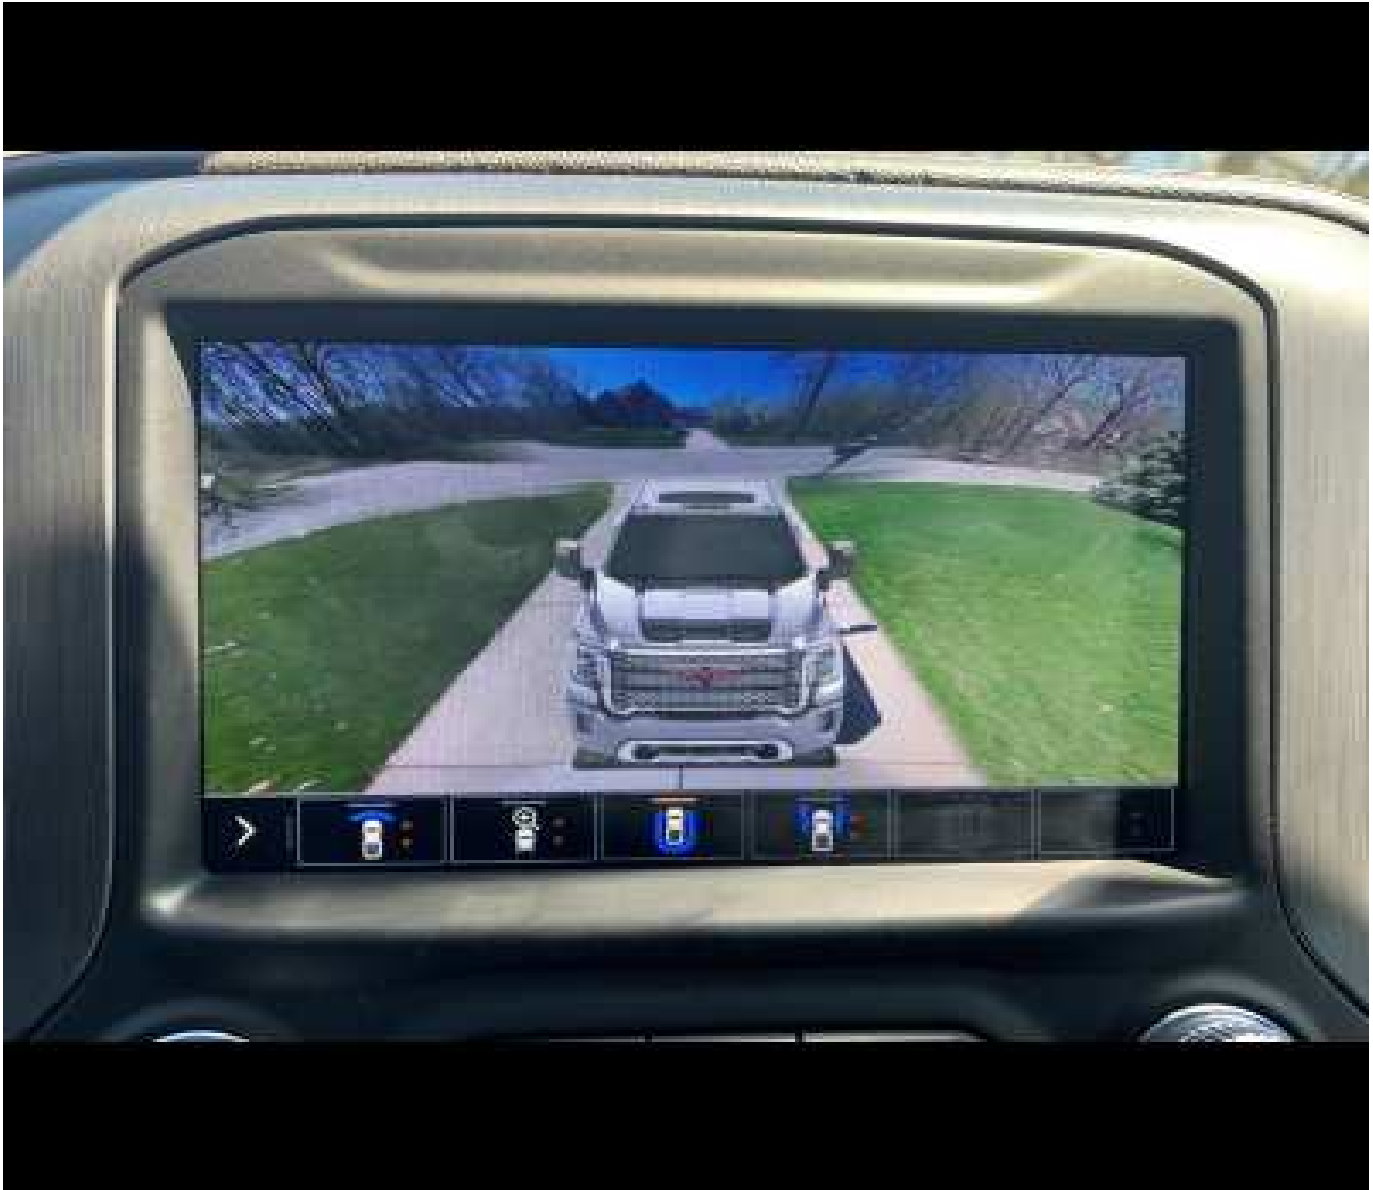
Frontend view, Tailgate equipped

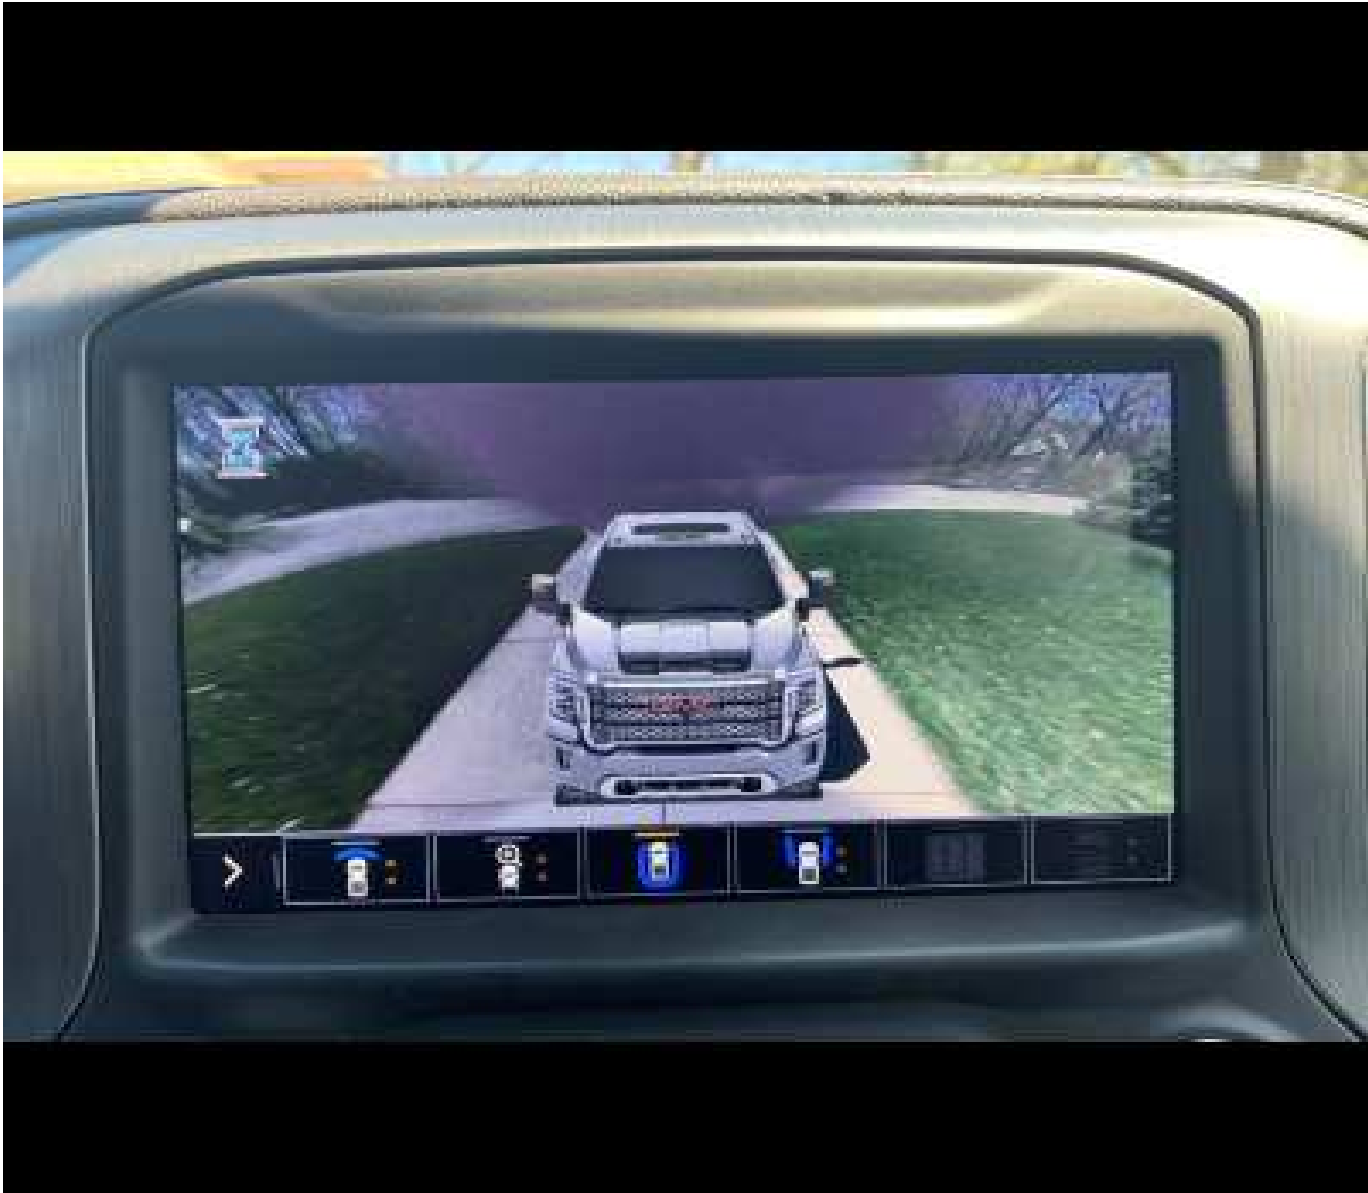
Frontend view, Tailgate removed

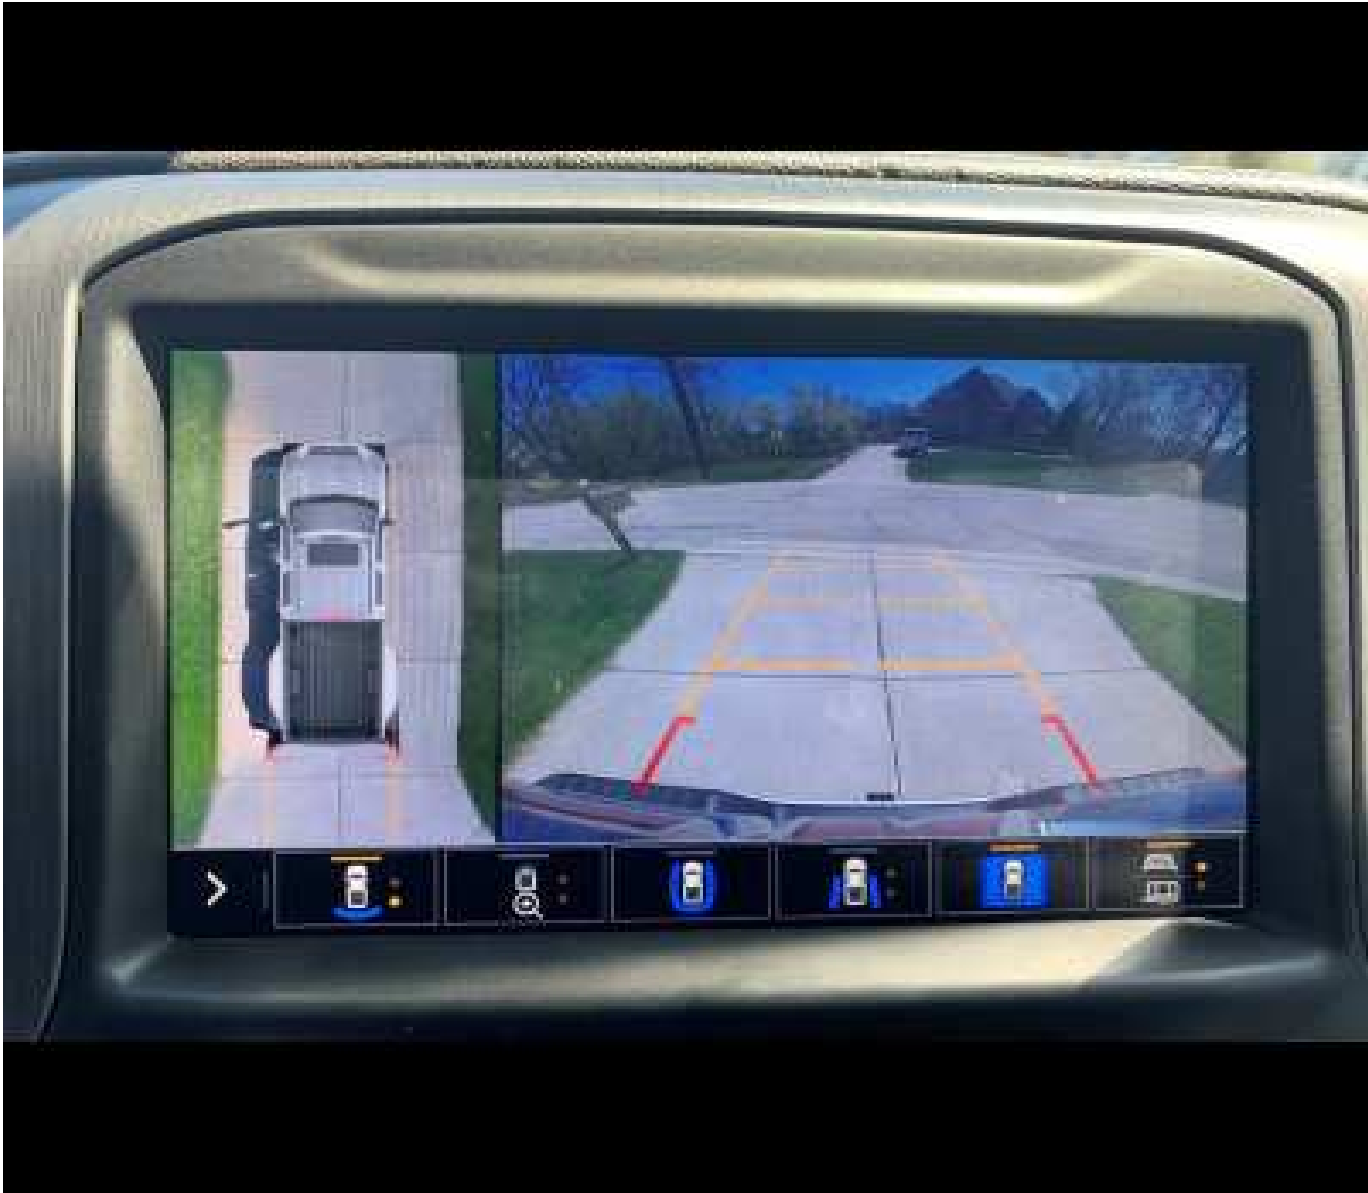
Tailgate backup camera, Tailgate equipped

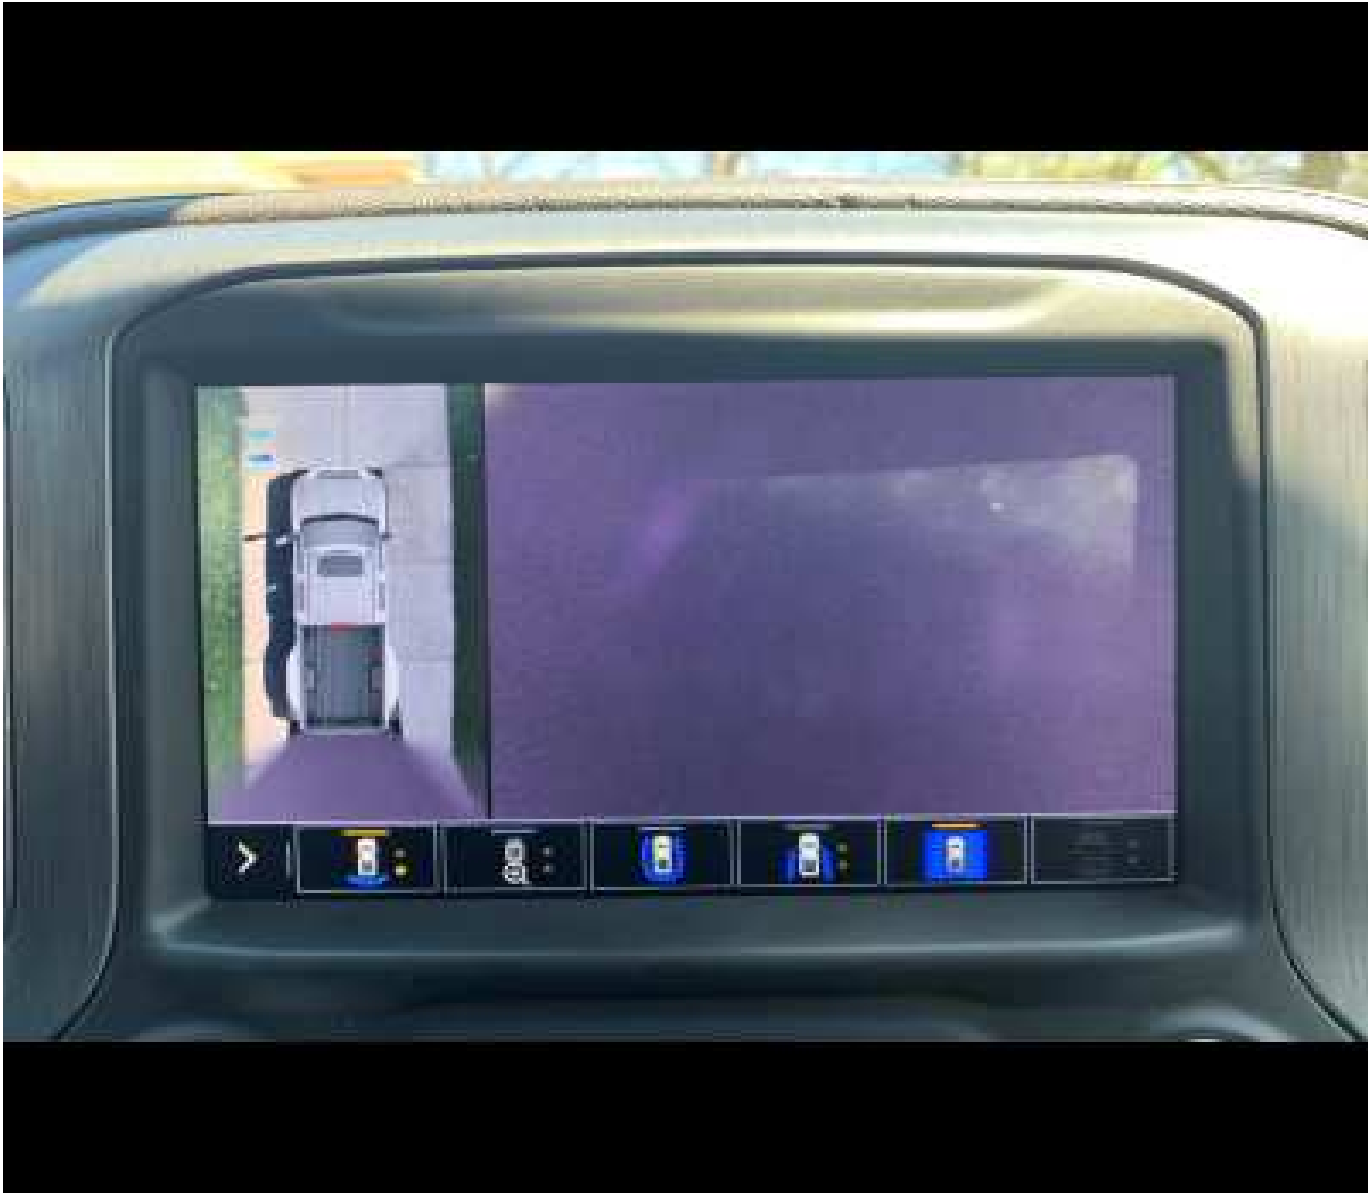
Tailgate backup camera, Tailgate removed

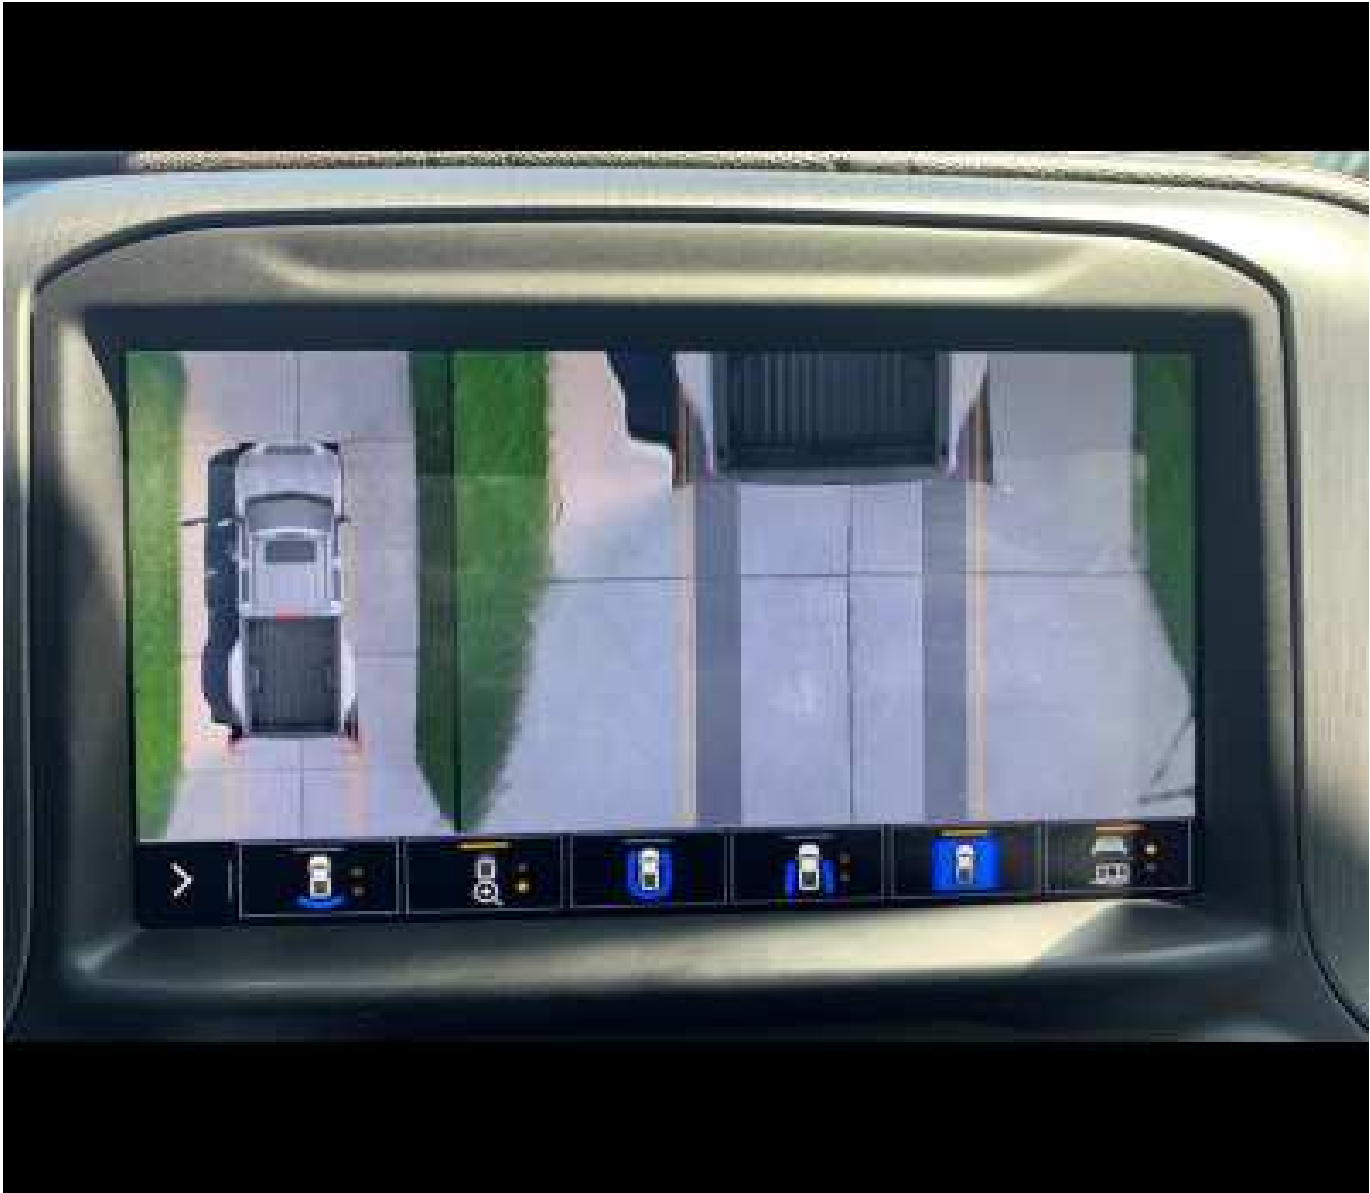
Tailgate overhead camera, Tailgate equipped

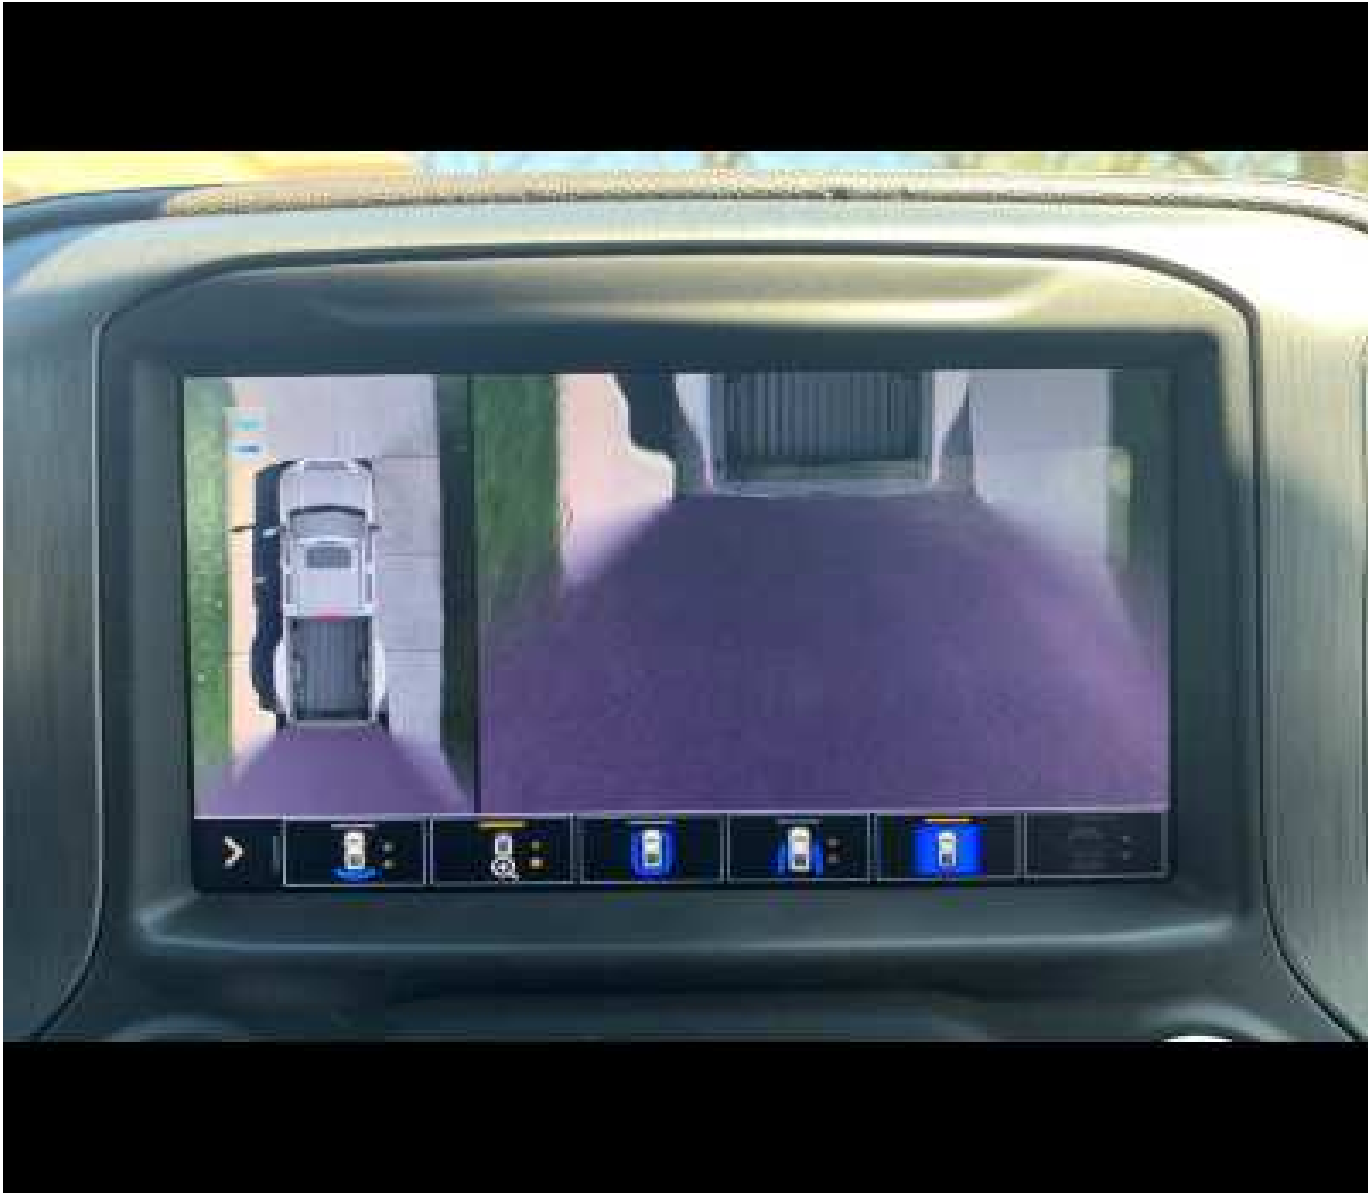
Tailgate overhead camera, Tailgate removed

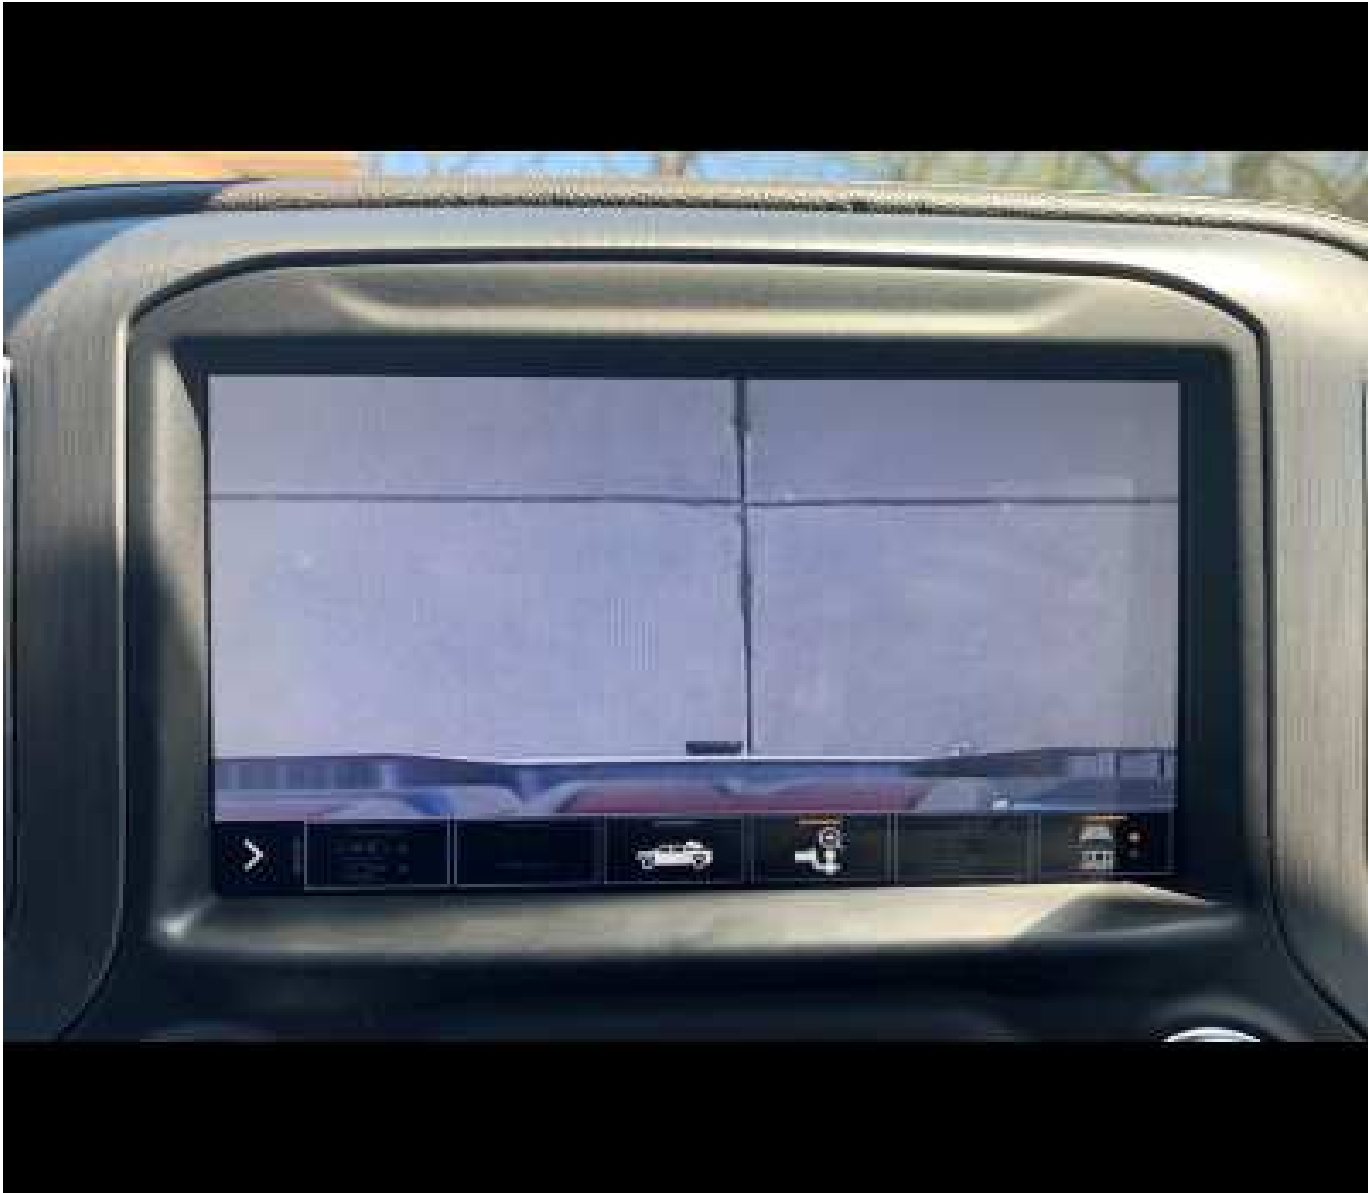
Trailer hitch camera, Tailgate equipped

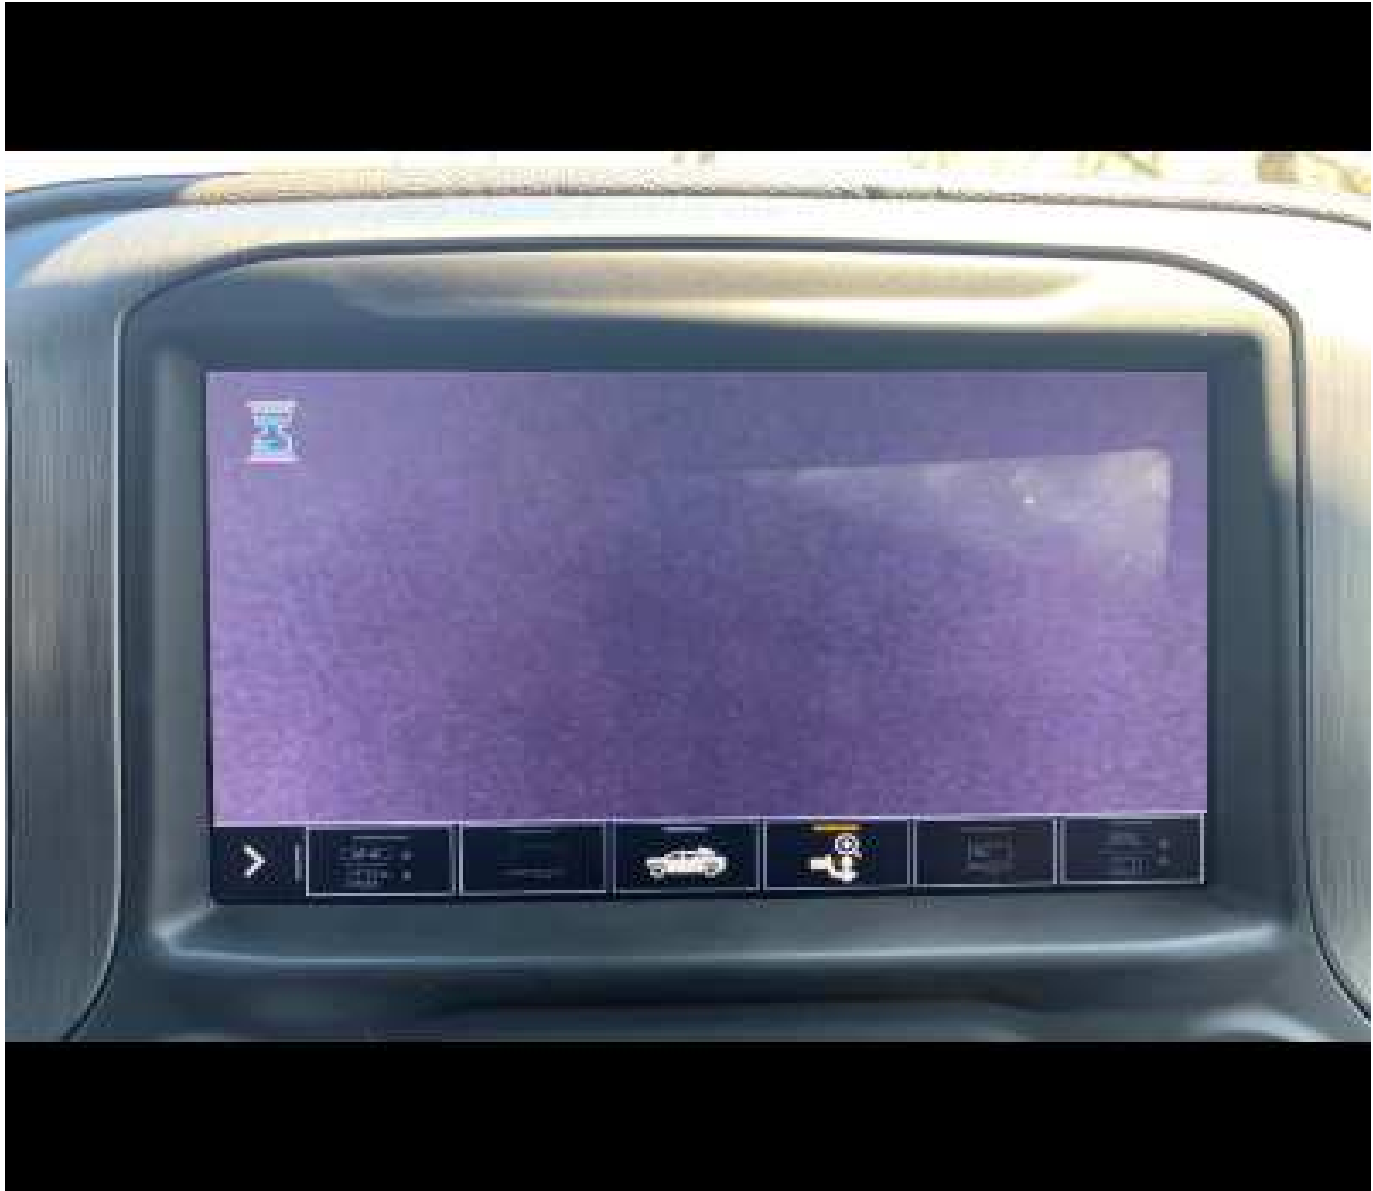
5608160

Trailer hitch camera, Tailgate removed
