Service Bulletin

Bulletin No.: 21-NA-226

Subject: Black Screen on Radio Display Shifting into Reverse

Brand:	Model:	Model Year:		VIN:		Engine:	Transmission:
		from	to	from	to		
Cadillac	XT4	2019	2022

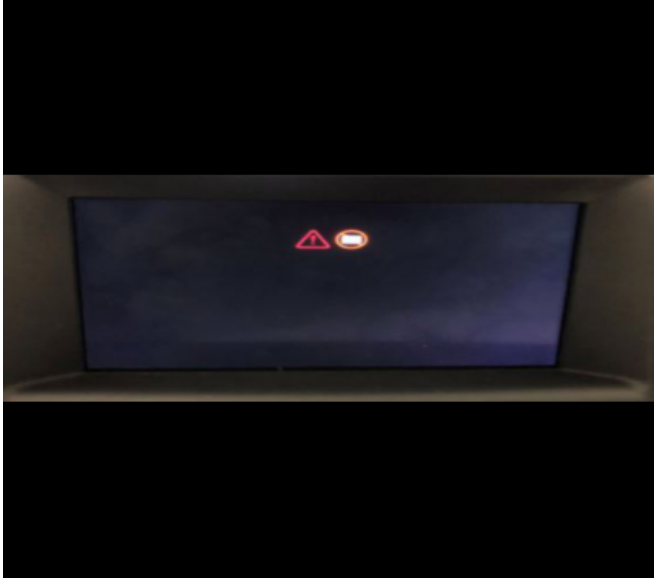
Involved Region or Country	United States, Canada, Mexico, Europe, Middle East, Israel, Palestine.
Additional Options (RPOs)	Equipped with RPO UV2
Condition	<p>Some customers may comment on an intermittent black screen on the radio display when shifting into Reverse.</p>

<p style="text-align: right;">5909927</p>
Cause	The causes of the condition may be a poor connection at the Liftgate coax cable.
Correction	Replace the rear Liftgate Wiring Harness which has an improved coax cable connector, refer to <i>Liftgate Wiring Harness Replacement</i> in SI.

Causal Part	Description	Part Number	Qty
X	Harness, Liftgate Wiring	84877228	1
