N222363820 – Driver’s Side Rear Wheel Liner Instructions

Vehicles Involved: 2022 Chevrolet Blazer

GLOBAL SAFETY FIELD INVESTIGATIONS
DCS6100
URGENT - DISTRIBUTE IMMEDIATELY

Subject: Update to Stop Delivery Order for N222363820 – Driver's Side Rear Wheel Liner – **Updated Instruction Sheet Attached**

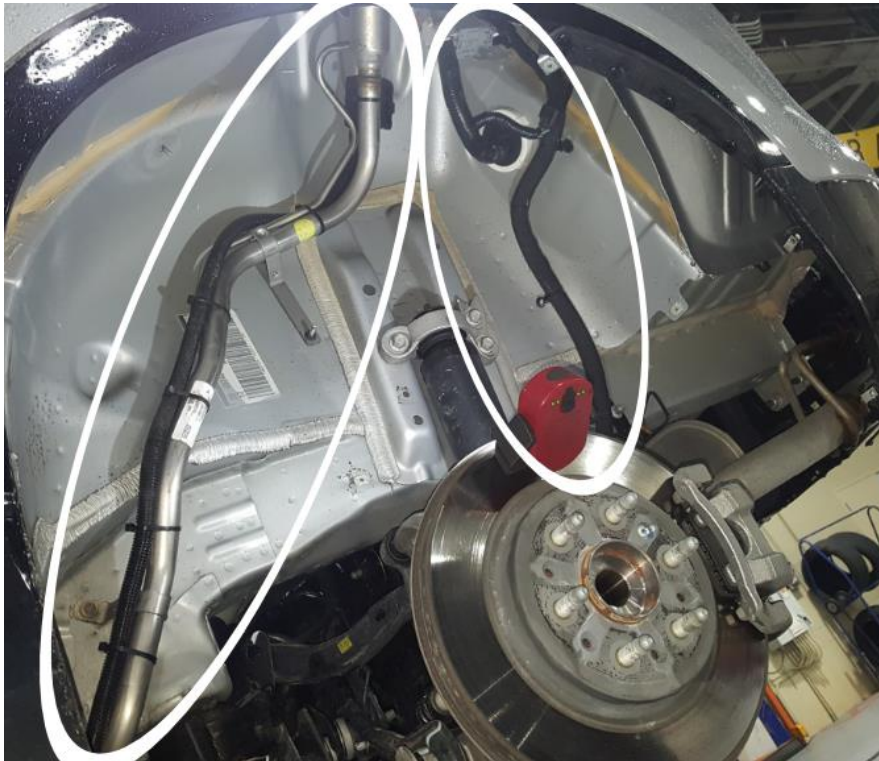
3. Inspect the fuel filler neck and wire harness circled above for any damage.
 - a. If damage is found, open a new warranty line and repair the components as necessary before proceeding to step 4.
 - b. If no damage is found, proceed directly to step 4.
4. Install the Left Rear Wheelhouse Liner. Refer to *Rear Wheelhouse Liner Replacement* in SI.
5. Reinstall the left rear wheel. Refer to *Tire and Wheel Removal and Installation* in SI.
6. Lower the vehicle.
