## N212345751 High Voltage Battery Software Update (New/Unsold Dealer Inventory Only)

Release Date: March 2022

**This bulletin is applicable to only certain model year 2022 Bolt EV and Bolt EUV vehicles.**

<b>Condition</b>	Certain 2022 model year Chevrolet Bolt EV and Bolt EUV vehicles require an Advanced Diagnostic Software package. There is no safety issue associated with this condition.
<b>Correction</b>	Dealers will reprogram modules using the ZFA – Field Action Multimodule Coordinated Sequence.

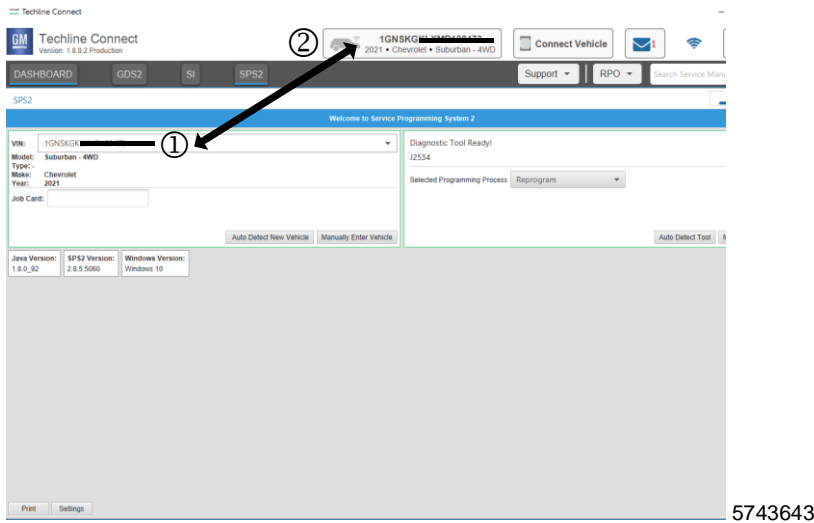
**Caution:** Be sure the VIN selected in the drop-down menu (1) is the same as the vehicle connected (2) before beginning programming.

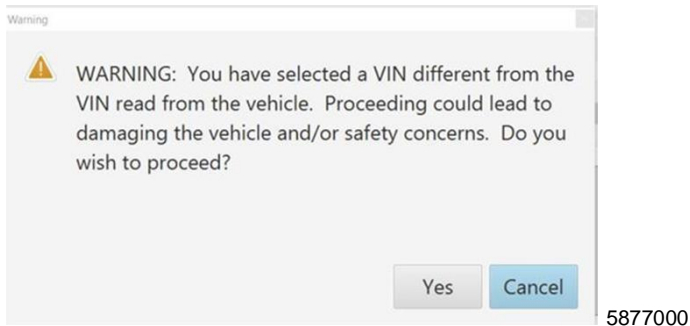
**Important:** If the vehicle VIN DOES NOT match, the message below will be shown.

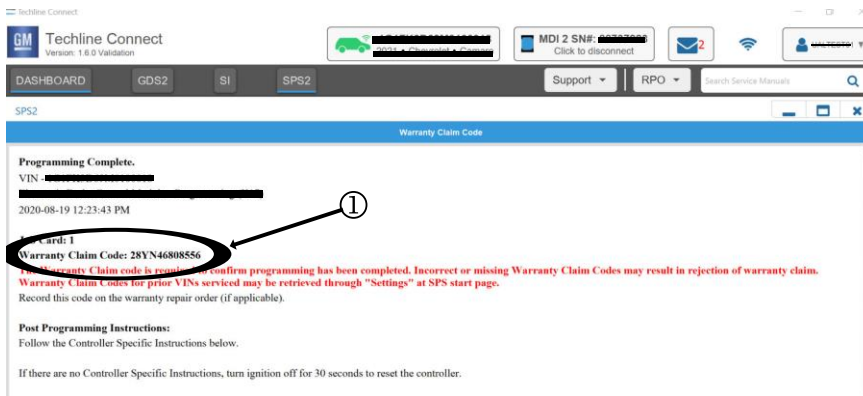
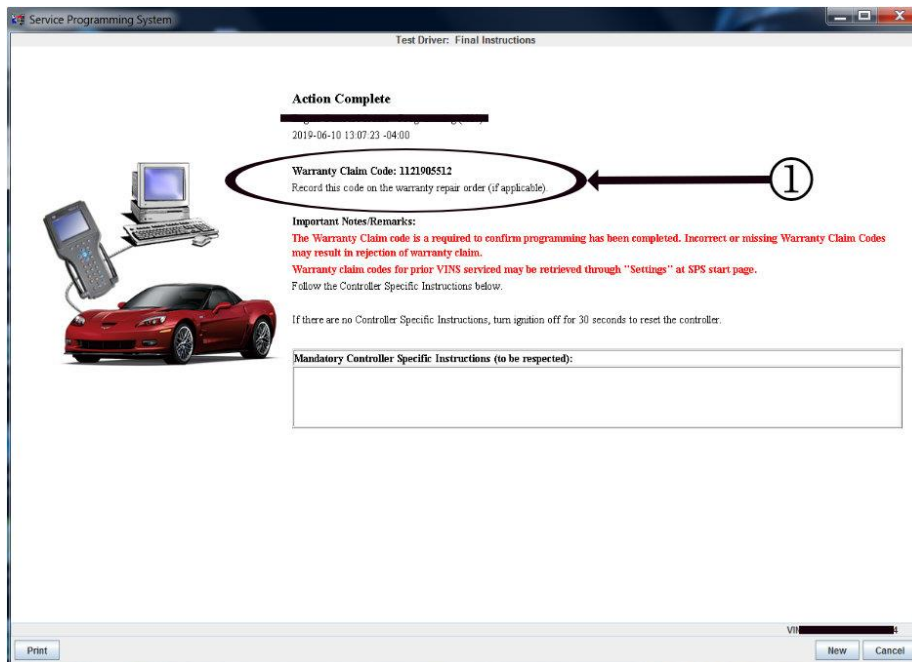
**Important:** If the same calibration/software warning is noted on the TLC or SPS Summary screen, select OK and follow screen instructions. After a successful programming event, the WCC is located in the Service Programming System dialogue box of the SPS Summary screen. No further action is required. Refer to the Warranty section of the bulletin.

**Important:** To avoid warranty transaction rejections, you **MUST** record the warranty claim code provided on the Warranty Claim Code (WCC) screen shown above on the job card. Refer to callout 1 above for the location of the WCC on the screen.

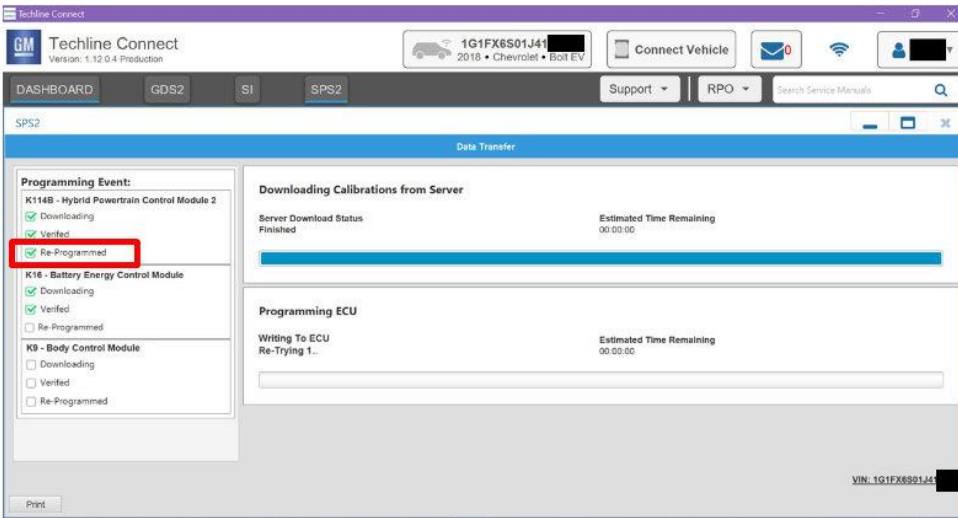
5924567

**Note:** The first module in the sequence is the K114B HPCM2 which is programmed with Ignition OFF and the brake pedal depressed to keep communications awake. The second module in the sequence is the K16 BECM, which is programmed with Ignition ON/Propulsion OFF. The third module is the K9 BCM, which is also programmed with Ignition ON/Propulsion OFF.

2. Remain in the vehicle with the brake pedal depressed during the programming of the K114B HPCM2. When the green check mark indicates the K114B HPCM2 has been re-programmed, as shown in the image, release the brake pedal and transition to Ignition ON/Propulsion OFF.
3. After programming has fully completed, clear DTCs. Let the vehicle sleep for 1 minute after removing the MDI, powering OFF, and closing all doors.
