Service Bulletin

Bulletin No.: 22-NA-008

Subject: Malfunction Indicator Lamp (MIL) Illuminated, Reduced Engine Power Message on Drivers Information Center (DIC) - DTCs U060F, U1346, P0101, P0102, P1101 and/or P14B6 Set

Brand:	Model:	Model Year:		VIN:		Engine:	Transmission:
		from	to	from	to		
Buick	Encore GX	2020	2022				
Chevrolet	Trailblazer (VIN M)	2021

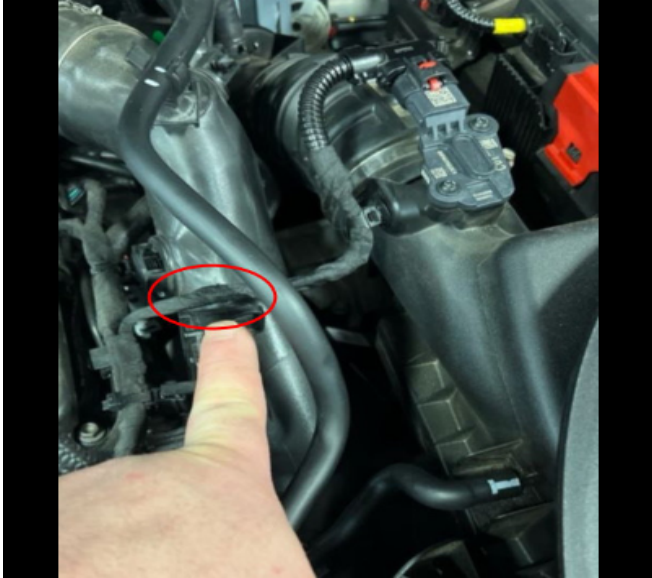
Involved Region or Country	North America
Condition	<p>Some customers may comment on one or more of the following conditions:</p> <ul style="list-style-type: none"> • MIL illuminated • Reduced Power displayed on DIC <p>Some technicians may find one or more of the following DTCs set:</p> <ul style="list-style-type: none"> • U060F • U1346 • P0101 • P0102 • P1101 • P14B6
Cause	<p>This condition may be caused by a possible broken wire in the harness in circuits 492 of the multifunction sensor.</p> <div style="text-align: center;">

</div> <p style="text-align: right;">5956039</p> <p>– The zip tie at the retainer may be pulled too tight and when the harness flexes on accelerations the wire can break at the zip tie.</p>

Correction	<p>Inspect the 2nd retainer back from the MAF sensor with the engine running. If the zip tie is too tight the wire may break at the zip tie during acceleration:</p> <ul style="list-style-type: none"> ⇒ Wiggle or pull on the harness to induce and identify a break inside the harness. ⇒ Repair circuit using published wire to wire repair for the MULTIFUNCTION INTAKE AIR SENSOR (MAF SENSOR). ⇒ Rewrap the wiring harness as required.
-------------------	---
