Service Bulletin

Bulletin No.: 22-NA-029

Subject: Poorly Fitted Tonneau Cover at the Front Edge of the Box Exposing Trim that Should be Covered

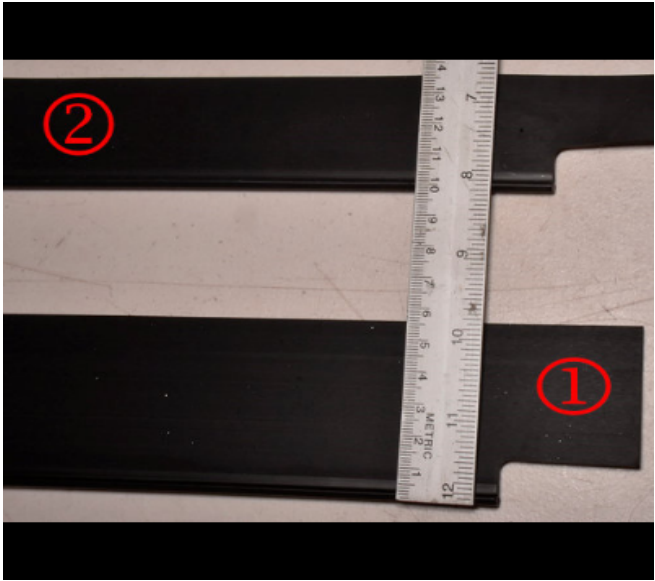
Involved Region or Country	North America, Australia, New Zealand
Additional Options (RPOs)	Equipped with ACCESSORY-TONNEAU - RR COMPT - VINYL W/ INTEGRAL CROSSBOW SUPPORTS (RPO VPB)
Condition	Some customers may comment on their poorly fitted tonneau cover at the front edge of the box exposing the trim that should be covered.
Cause	This condition may be due to the tonneau cover becomes too tight and pulls the front rail rearward when the tonneau cover is closed exposing the trim, as shown in the video above.
Correction	<div style="text-align: center;">

</div> <p style="text-align: right; font-size: small;">5956093</p> <p>Install the revised seal (1) that is 19 mm wider than the current seal (2), as shown in the picture above.</p>

Remove the tonneau and install the revised seal and reinstall the cover. Refer to *Pickup Box Folding Top Cover Package Installation* in SI.
