# Service Bulletin

Bulletin No.: 21-NA-036

**Subject:** Information on Malfunction Indicator Lamp (MIL) Illuminated – DTC P0300, P0302 and/or P0305 Set

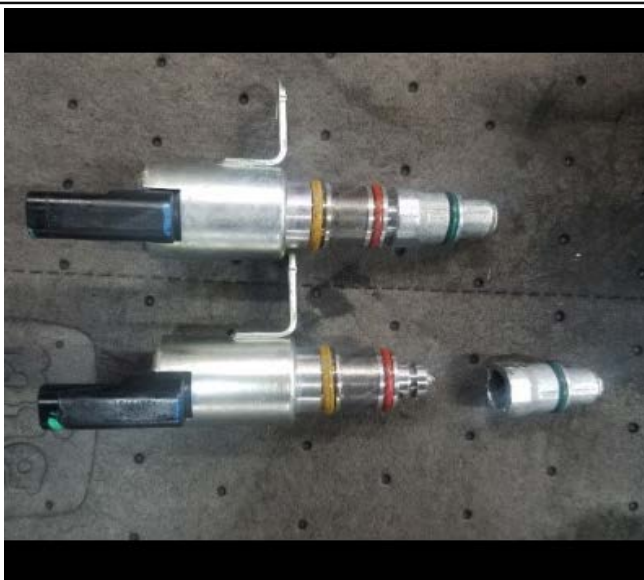
5732351

Refer to graphic above for a good solenoid end that came apart. This picture shows the solenoid both the way it should look on top and the way it looks pulled apart on the bottom.

- If you find a vehicle with the end of the solenoid stuck in the bore, it can usually be easily removed utilizing a pick tool or a pair of transmission snap ring pliers as it is only held in with the O-ring that came off with it.
- ⇒ If the solenoid is damaged, replace the solenoid.
- If you find the solenoid is not the cause of the misfire, then inspect the rockers:
- ⇒ Remove the camshaft cover for the affected bank.
- ⇒ Turn the engine over by hand while watching the affected cylinder rockers and valves to ensure the rockers are actually opening the valve.

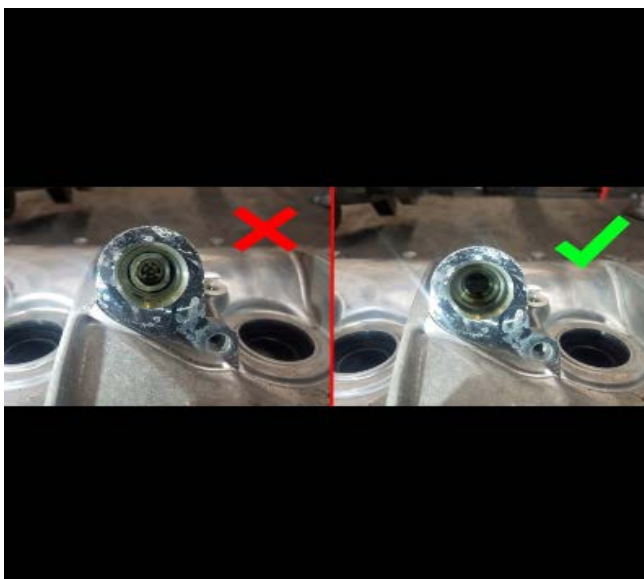
5732350

The graphic on the left shows the inside of the bore with the solenoid out, but with the end of the solenoid stuck in it. The graphic on the right shows how it should look.
