01-22-03 - Late Production - Update Programming Engine/Motor Control Module -J623-

Release date: 3/29/2022

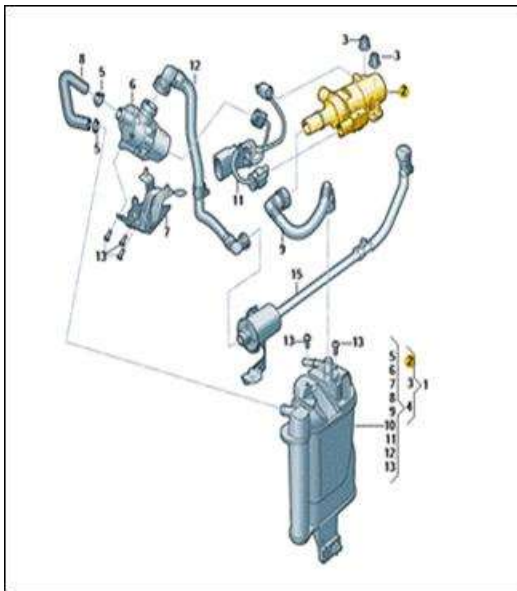
Figure 1.

In addition to the software improvement, there is also an improvement to the FTIV (fuel tank isolation valve/tank switch-off valve -**N288**-) (Figure 1.), which is necessary in preventing erroneous occurrences of the P2421 fault code.

The FTIV / Tank switch-off valve -**N288**- currently installed on the vehicle must be inspected, to verify whether an improved part has already been installed. The FTIV / Tank switch-off valve -**N288**- is mounted to the EVAP canister assembly, as shown below.

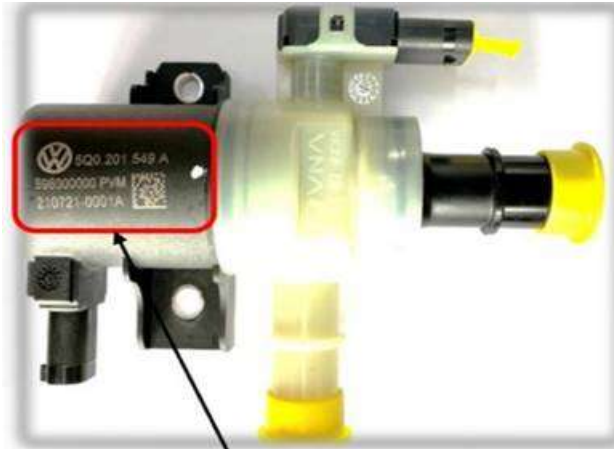
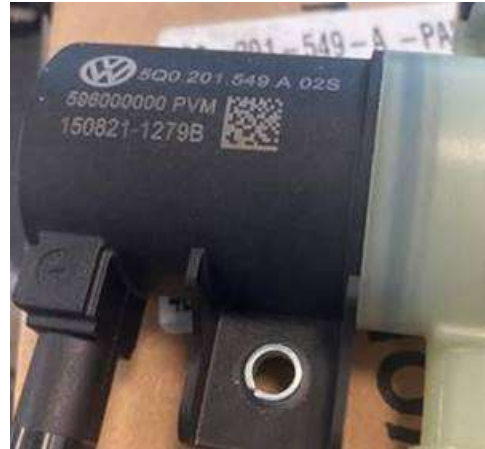
Remove the EVAP canister assembly and inspect the face of the FTIV / Tank switch-off valve -**N288**-. If the part is already updated, it will have a white paint marking or "02S" printed after the part number, as shown in Figure 2 and Figure 3.

- If the part has a white paint mark or "02S", the FTIV / Tank switch-off valve -**N288**- is already the updated component. In this case DO NOT replace it, and instead reinstall the EVAP canister assembly. Only the software update will be required.
- If there is no white paint mark or "02S" are visible on the FTIV / Tank switch-off valve -**N288**-, the component must also be replaced in addition to the software update. Always refer to ETKA for the most up to date part number information.
