**26-19-01 - AdBlue® Warning and or MIL ON - Ad Blue® Leakage at Reductant Injector**

Release date: 3/29/2022

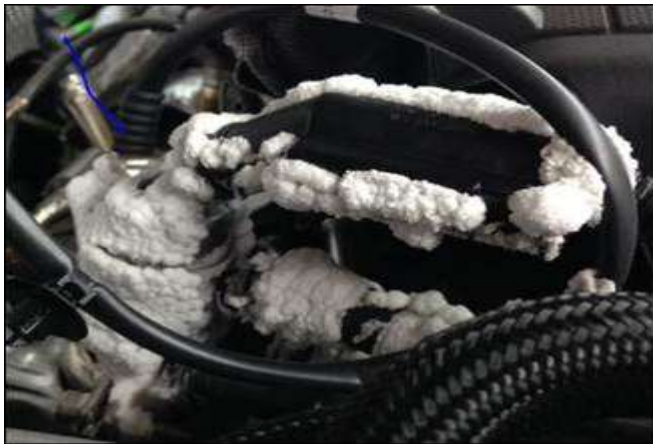
**Figure 1**

Welding process issues of the reductant line connector to the supply line may cause AdBlue® leakage at the reductant injector.

Inspect the connection of the reductant supply line connector at the reductant injector in the engine compartment. If white crystalized (dried) AdBlue® is found at the reductant injector (see Figure 1 & 2), it will be necessary to replace the reductant supply line.

- Thoroughly clean the area of the reductant supply line connection with water to remove the crystalized AdBlue®.
- Replace the reductant supply line.
- Refill reductant agent as required per part table quantity.
