GROUP	MODEL
BOD	2022MY Stinger (CK)
NUMBER	DATE
302 (Rev 1, 03/04/2022)	August 2021

TECHNICAL SERVICE BULLETIN

SERVICE ACTION: FRONT DOOR TRIM GRIP HANDLE REPAIR (SA483)

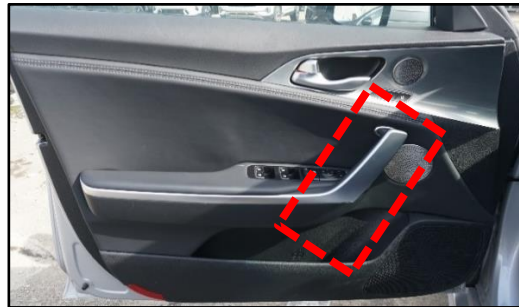
Door Trim Grip Handle (Left)

This bulletin provides information to repair the two (2) (LHS & RHS) front door trim grip handles on some 2022MY Stinger (CK) vehicles produced from February 25, 2021 through June 17, 2021, which may have the grip handle detached from the inside door trim. Follow the procedure outlined in this publication to repair the front door trim grip handles by replacing the door inside handle bracket screws as outlined in the inspection. Before conducting the procedure, verify that the vehicle is included in the list of affected VINs.
